# Hazardous Building Materials Register and Asbestos Management Plan

**Ashfield Aquatic Centre  
160 Elizabeth Street  
ASHFIELD NSW 2131**

**Survey Date: 28 September 2015**

**Report Number: 9206.09.HMSR**

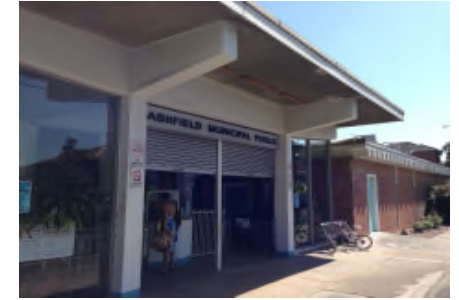
ID	Location	Material Type	Sample No.	Analysis Result	Extent	Condition	Friability	Disturbance Potential	Risk Status	Re-inspect Date	Control Priority	Control Recommendation	Removed	Photos
<b>Exterior</b>														
1	Door frames and window frames Throughout - White paint	Paint	9206.09/LP01	Negative Lead in Paint <1.0%	-	-	-	-	-	-	-	-	-	Photo 1

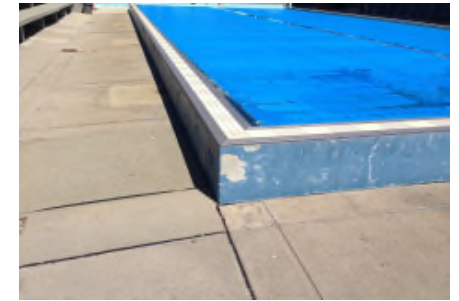
ID	Location	Material Type	Sample No.	Analysis Result	Extent	Condition	Friability	Disturbance Potential	Risk Status	Re-inspect Date	Control Priority	Control Recommendation	Removed	Photos
<b>Exterior</b>														
45	Outdoor pools Blue paint trim	Paint	9206.09/ LPST11	Negative Lead in Paint <1.0%	-	-	-	-	-	-	-	-	-	Photo 39

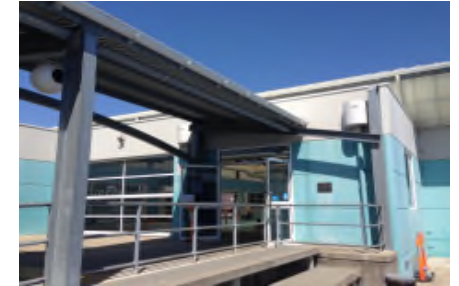
ID	Location	Material Type	Sample No.	Analysis Result	Extent	Condition	Friability	Disturbance Potential	Risk Status	Re-inspect Date	Control Priority	Control Recommendation	Removed	Photos
<b>Exterior/Interior</b>														
49	Throughout	Fibre Cement Sheeting	-	Negative No Asbestos Detected (Visually Assessed)	-	-	-	-	-	-	-	-	-	Photo 43

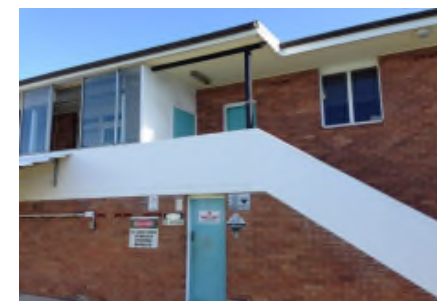
ID	Location	Material Type	Sample No.	Analysis Result	Extent	Condition	Friability	Disturbance Potential	Risk Status	Re-inspect Date	Control Priority	Control Recommendation	Removed	Photos
<b>Cottage - Exterior</b>														
52	Eaves Throughout	Asbestos Cement Sheeting	-	<b>Positive</b> <i>Asbestos Detected (Visually Assessed)</i>	~50m <sup>2</sup>	Good	Non-Friable	Low	Low	Sep 2018	P3	Label, maintain in good condition, and do not disturb (e.g. do not drill, cut grind or sand). Remove by a licensed Class A or Class B asbestos removalist as soon as practicable and prior to any refurbishment or demolition works.	Date: _____ Removed by: _____ Report: _____	 Photo 45
														<i>Asbestos Cement Sheeting</i>
53	Metal windows Throughout - Mastic	Mastic	9206.09/AS08	<b>Negative</b> No Asbestos Detected	-	-	-	-	-	-	-	-	-	 Photo 46
														<i>Mastic</i>
