# Hazardous Building Materials Register and Asbestos Management Plan

**Thirning Villa  
40 Arthur Street  
ASHFIELD NSW 2131**

**Report Number: 9206.04.HMSR**

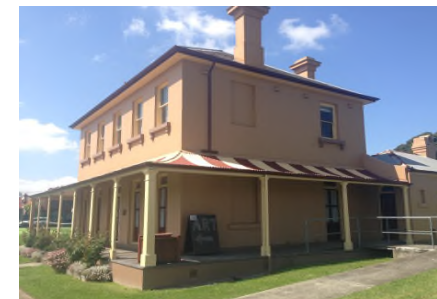
ID	Location	Material Type	Sample No.	Analysis Result	Extent	Condition	Friability	Disturbance Potential	Risk Status	Re-inspect Date	Control Priority	Control Recommendation	Removed	Photos
Exterior														
1	Door Steps Brown coloured paint - Throughout	Paint	9206.04/ LP04	Positive <i>Low Range Lead in Paint Level (1.2% Lead)</i>	-	Good Condition, Suitably Encapsulated	-	Low	Low	Sep 2018

<b>Photo 1</b>
														<b>Brown Coloured Paint</b>
2	Doors Red coloured paint - Throughout	Paint	9206.04/ LP03	Positive <i>Low Range Lead in Paint Level (4.5% Lead)</i>	-	Good Condition, Suitably Encapsulated	-	Low	Low	Sep 2018
