# Hazardous Building Materials Register and Asbestos Management Plan

**KU Kroydon Preschool  
6 Railway Street  
CROYDON NSW 2132**

**Report Date: 11 November 2015**

**Report Number: 9206.01.HMSR**

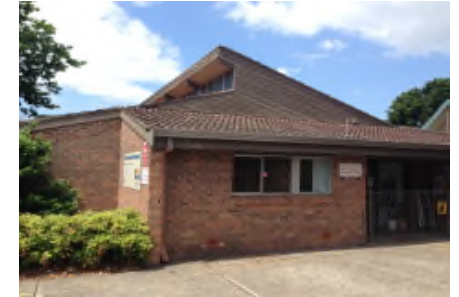
ID	Location	Material Type	Sample No.	Analysis Result	Extent	Condition	Friability	Disturbance Potential	Risk Status	Re-inspect Date	Control Priority	Control Recommendation	Removed	Photos
<b>Exterior</b>														
1	Doors and window frames Grey paint	Paint	9206.01/LP01	Negative Lead in Paint <1.0%	-	-	-	-	-	-	-	-	-	Photo 1
