Hazardous Building Materials Assessment

Cottage 11

11 Marion Street
Leichhardt NSW 2040

Inner West Council
January 2018

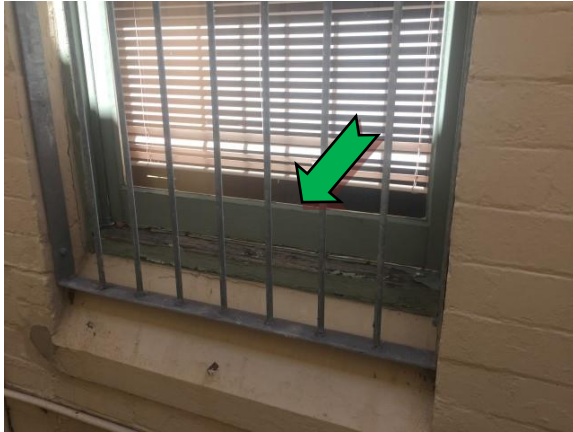
Photo 1. Exterior, ground level, throughout window frames – non asbestos-containing external window caulking.

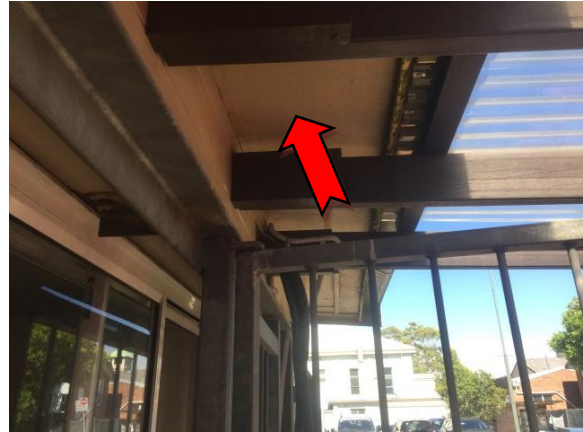
Photo 2. Exterior, ground level, northern elevation, eaves – asbestos-containing fibre cement sheeting.

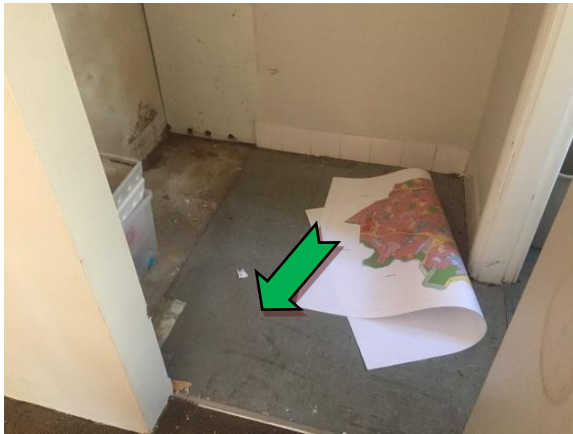
Photo 3. Interior, ground level, room adjacent northern WC, floor covering – non asbestos-containing blue vinyl floor tiles.

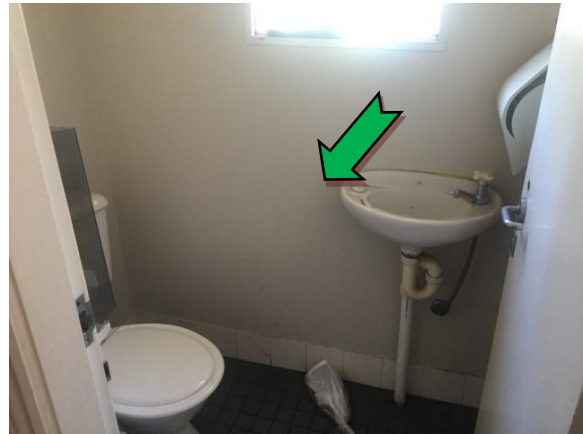
Photo 4. Interior, ground level, northern WC, walls – non asbestos-containing fibre cement sheeting.

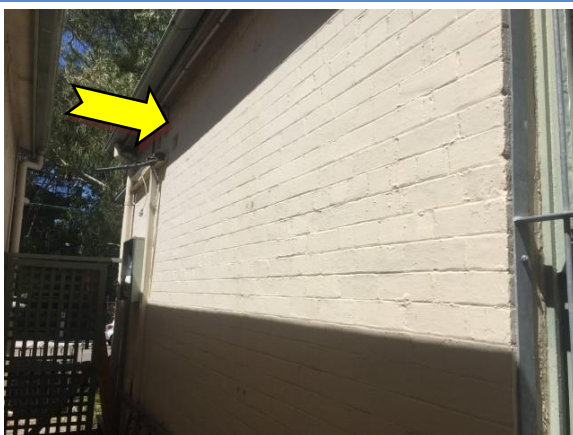
Photo 5. Exterior, ground level, throughout, walls – lead-containing cream upper paint system.

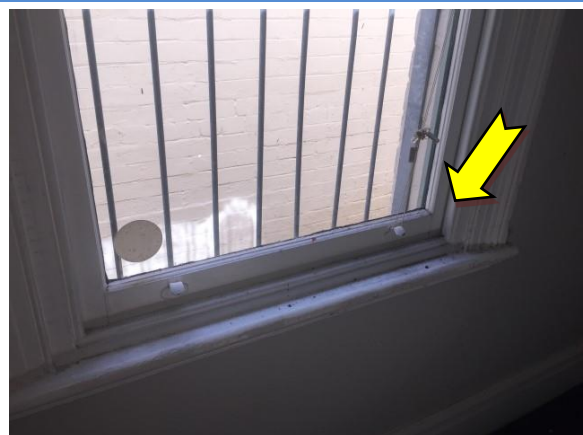
Interior, Ground level	Throughout	Window frames	White - lower coloured paint system	Lead Paint - Swab	-	Positive	-	Low	Fair	Low	49 m	Maintain in current condition, over paint with a lead-free paint as part of ongoing maintenance. Remove under controlled conditions in accordance with AS 4361.2:2017 Guide to hazardous paint management prior to renovation or demolition works.	-	-	6
Interior, Ground level	Throughout	Skirting	White - upper coloured paint system	Lead Paint - Swab	-	Suspected Positive	-	Low	Good	Low	30 m ²	Confirm status by quantitative test method, maintain in current condition, over paint with a lead-free paint as part of ongoing maintenance. Remove under controlled conditions in accordance with AS 4361.2:2017 Guide to hazardous paint management prior to renovation or demolition works.	-	-	-
Interior, Ground level	Rec room	Air conditioning unit	Unknown refrigerant	Ozone Depleting Substances	-	Suspected Positive	-	Low	Good	Low	1 unit	No data was visible at the time of the assessment. Confirm status of suspected ozone depleting substances identified in the assessment.	-	-	-

Photo 6. Interior, ground level, throughout, window frames – lead-containing white lower paint systems.

- Remove flaking lead containing paint to window surrounds throughout the property in accordance with AS4361.2-2017 Guide to Hazardous Paint Management and relevant legislation.
