Hazardous Building Materials Assessment

Cottage 9

9 Marion Street

Inner West Council
January 2018

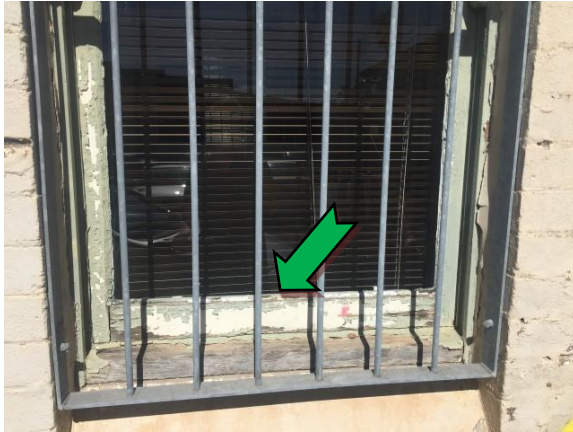
Photo 1. Exterior, ground level, throughout window frames – non asbestos-containing external window caulking.

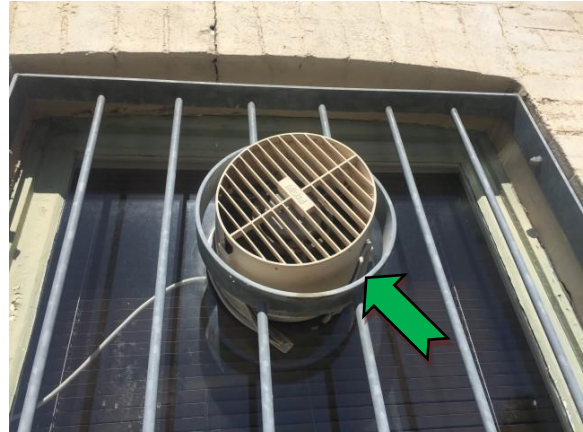
Photo 2. Exterior, ground level, east elevation, north window, window mounted extractor fan – non asbestos-containing mastic sealant.

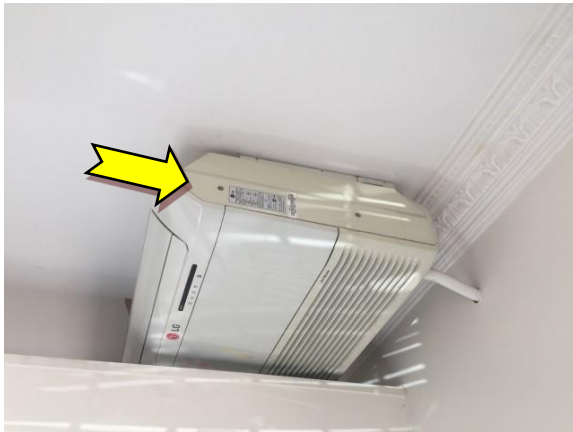
Photo 3. Interior, ground level, office, air conditioning unit – R22 ODS-containing refrigerant.

- One ODS-containing air conditioning unit was identified at the site.

- If the ozone depleting substances identified on-site unit require removal they should be appropriately decanted and disposed of by a licensed contractor in accordance with the *Ozone Protection and Synthetic Greenhouse Gas Management Amendment Regulation 2017* as amended from time to time.
- In accordance with the Commonwealth Ozone Protection Legislation, Prensa recommends, in line with Australia's commitment to phase out ODS-containing substances that units which are required to be replaced due to their age, damage or functionality, have their ODS-containing refrigerants replaced with a non-ODS alternative such as R410A.
- It is important to note that, if a system which utilises ODS-refrigerants is in good working order, there is no need to transition to an alternative refrigerant/system (until 2029).

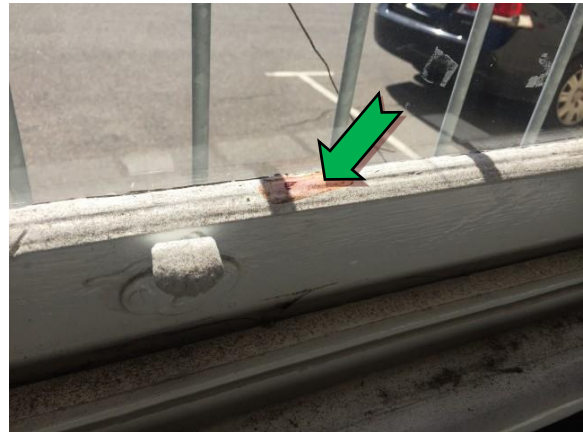
Photo 4. Interior, ground level, throughout, window frames – non asbestos-containing internal window caulking.

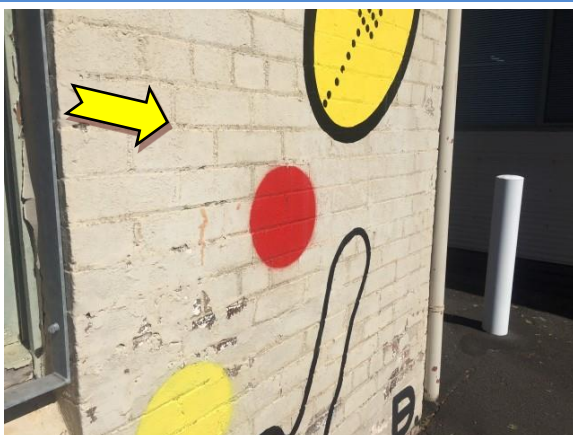
Photo 5. Exterior, ground level, throughout, walls – lead-containing cream upper paint systems.

- LCP was identified in white, green (light and dark) and cream paint systems to the exterior of the building on walls, window surrounds and decorative awnings.

- Remove flaking lead containing paint to window surrounds throughout the property in accordance with AS4361.2-2017 Guide to Hazardous Paint Management and relevant legislation.

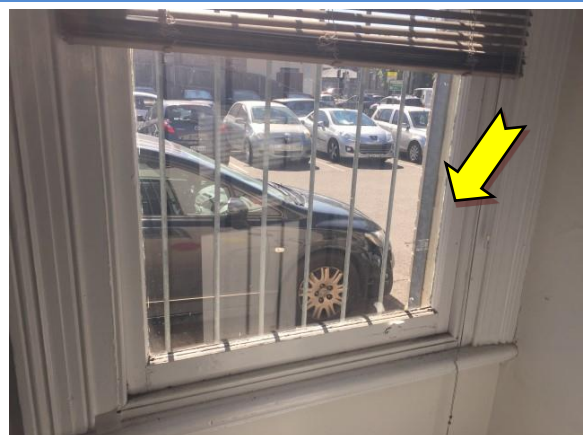
Photo 6. Interior, ground level, throughout, window frames – lead-containing white upper paint systems.
