# Hazardous Building Materials Assessment Leichhardt Town Hall Caretakers Flat 107 Norton Street Leichhardt NSW 2040

Inner West Council  
January 2018

Job No.: 57722-003

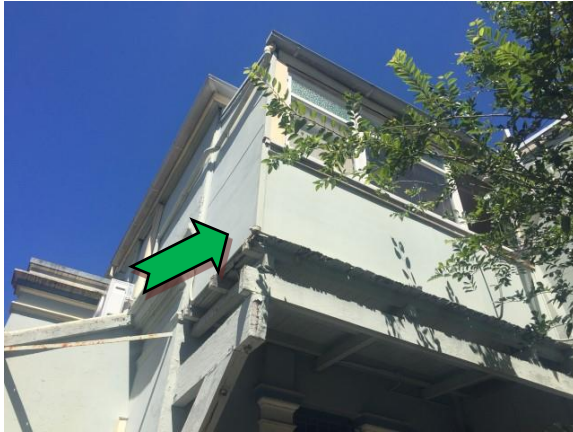
**Photo 1.** Exterior, level 1, external walls – assumed non asbestos-containing fibre cement sheeting.

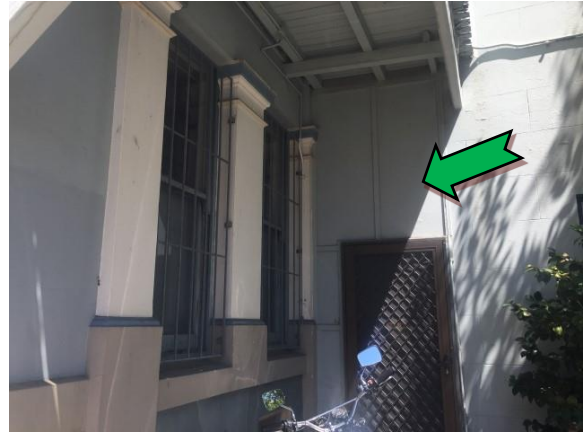
**Photo 2.** Exterior, ground level, northern entrance, external walls – assumed non asbestos-containing fibre cement sheeting.

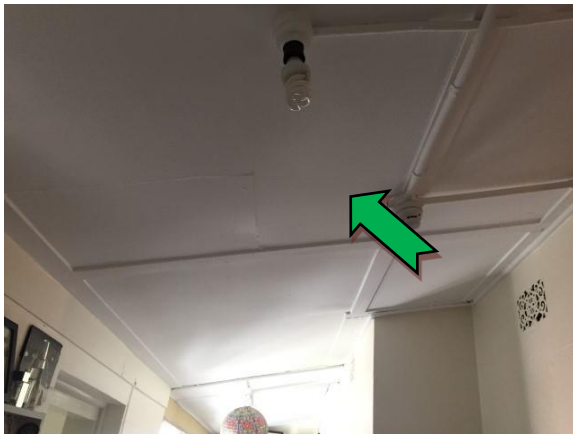
**Photo 3.** Level 1, western extension, ceiling lining – non asbestos-containing fibre cement sheeting.

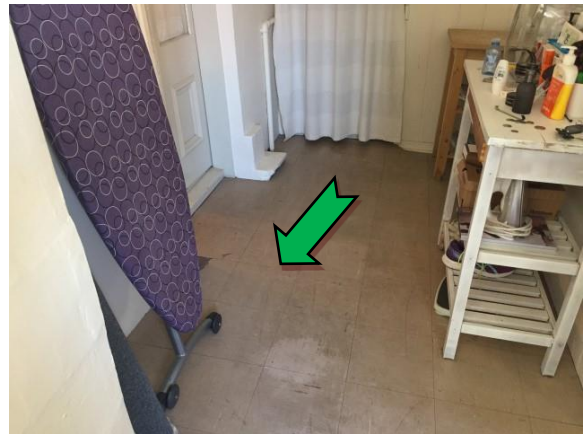
**Photo 4.** Level 1, western extension, floor covering – non asbestos-containing light brown vinyl floor tiles.

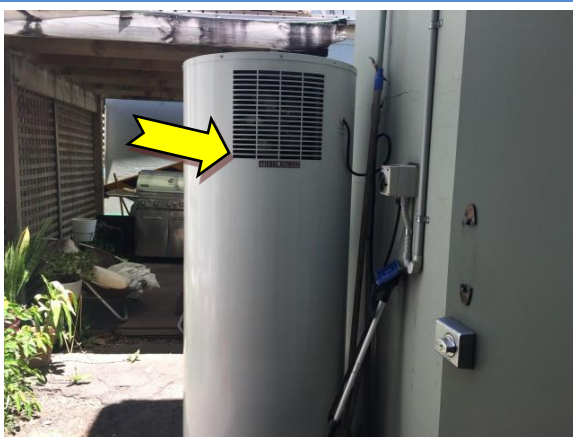
**Photo 5.** Exterior, ground level, western garden, hot water heater – suspected SMF internal insulation.

- Suspected SMF internal insulation material was present within the hot water heater located within the western garden area.

- SMF materials that are likely to be disturbed during any proposed demolition/refurbishment works should be handled in accordance with the *Code of Practice for the Safe Use of Synthetic Mineral Fibres* [NOHSC:2006(1990)]. If these materials are impacted upon by accident or by pre-planned works, the Inner West Council must be informed via the contact detailed within Section 7: *Accidental Disturbance of Known or Suspected Hazardous Building Materials*. Following disturbance, inspection by a competent person should be undertaken.

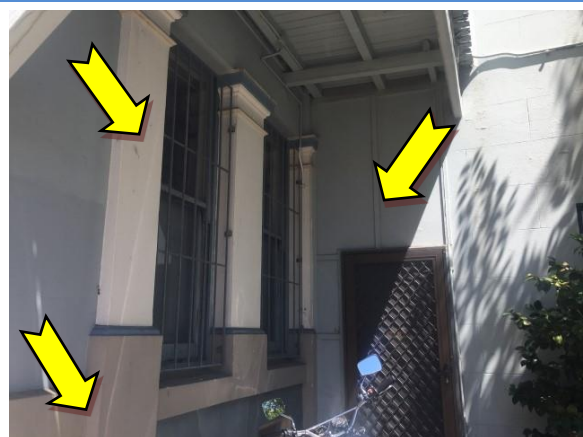
Exterior	Throughout	Walls and features	Beige - upper coloured paint system	Lead Paint - Swab	-	Suspected Positive	-	Low	Good	Low	20 m <sup>2</sup>	Confirm status by quantitative test method, maintain in current condition, over paint with a lead-free paint as part of ongoing maintenance. Remove under controlled conditions in accordance with AS 4361.2:2017 Guide to hazardous paint management prior to renovation or demolition works.	-	-	6
Exterior	Throughout	Walls and features	Brown (light) - upper coloured paint system	Lead Paint - Swab	-	Suspected Positive	-	Low	Good	Low	10 m <sup>2</sup>	Confirm status by quantitative test method, maintain in current condition, over paint with a lead-free paint as part of ongoing maintenance. Remove under controlled conditions in accordance with AS 4361.2:2017 Guide to hazardous paint management prior to renovation or demolition works.	-	-	6
Exterior	Throughout	Walls and features	Grey - upper coloured paint system	Lead Paint - Swab	-	Suspected Positive	-	Low	Good	Low	100 m <sup>2</sup>	Confirm status by quantitative test method, maintain in current condition, over paint with a lead-free paint as part of ongoing maintenance. Remove under controlled conditions in accordance with AS 4361.2:2017 Guide to hazardous paint management prior to renovation or demolition works.	-	-	6

**Photo 6.** Exterior, throughout, walls and features – suspected lead-containing paint systems (beige, light brown and grey).

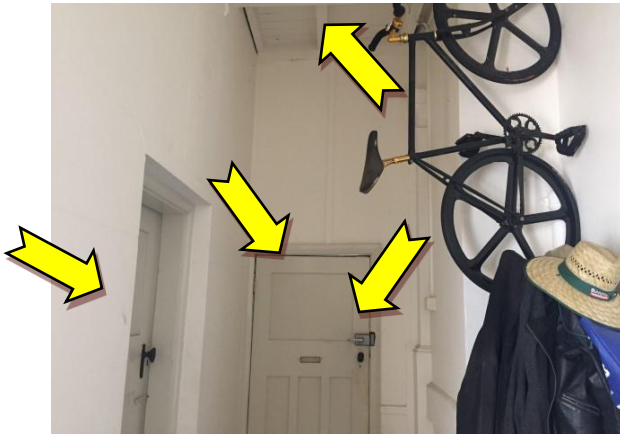
Area / Level	Room & Location	Feature	Item Description	Hazard Type	Sample No.	Sample Status	Friability	Disturb. Potential	Condition	Risk Status	Approx. Quantity	Recommendations & Comments	Control Priority	Reinspect Date	Photo No.
Exterior	Throughout	Walls and features	Blue (light) - upper coloured paint system	Lead Paint - Swab	-	Suspected Positive	-	Low	Good	Low	200 m <sup>2</sup>	Confirm status by quantitative test method, maintain in current condition, over paint with a lead-free paint as part of ongoing maintenance. Remove under controlled conditions in accordance with AS 4361.2:2017 Guide to hazardous paint management prior to renovation or demolition works.	-	-	-
Interior	Throughout	Walls and ceilings	White - upper coloured paint system	Lead Paint - Swab	-	Suspected Positive	-	Low	Good	Low	200 m <sup>2</sup>	Confirm status by quantitative test method, maintain in current condition, over paint with a lead-free paint as part of ongoing maintenance. Remove under controlled conditions in accordance with AS 4361.2:2017 Guide to hazardous paint management prior to renovation or demolition works.	-	-	7

**Photo 7.** Interior, throughout, walls and features – suspected lead-containing white upper paint systems.

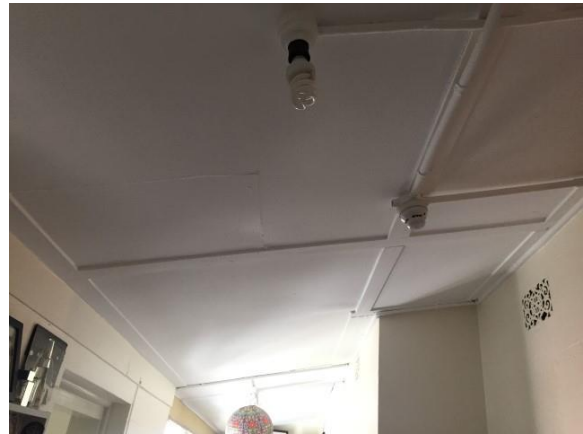
Level 1	Ceiling space	-	-	-	-	-	-	-	-	-	-	No access at the time of the assessment due to no access hatches.	-	-	8
Level 1	Southern bedroom, cupboard	-	-	-	-	-	-	-	-	-	-	No access at the time of the assessment due to no access hatches.	-	-	-
Ground level	Ceiling space	-	-	-	-	-	-	-	-	-	-	No access at the time of the assessment due to no access hatches.	-	-	-

**Photo 8.** No access – roof space throughout level 1 due to lack of access hatches.
