Hazardous Building Materials Assessment Birchgrove Park Tennis Pavilion Rose Street Birchgrove NSW 2041

Inner West Council
February 2018

Job No.: 57722-151

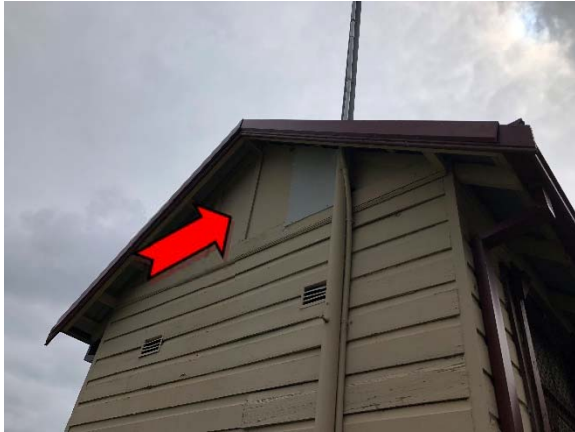
Photo 1. Exterior, northern and southern elevations, gable – suspected asbestos-containing fibre cement sheeting.

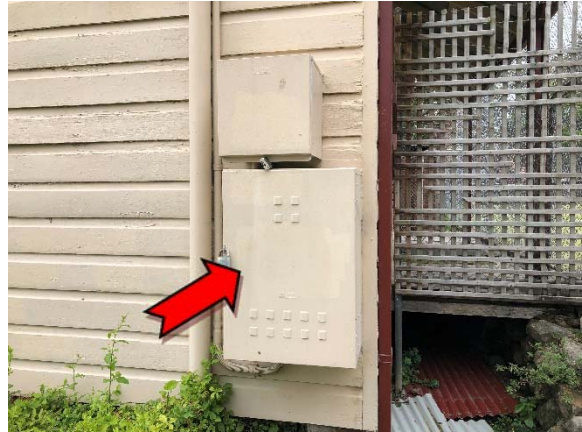
Photo 2. Exterior, southern elevation, electrical backing board – suspected asbestos-containing bituminous backing board.

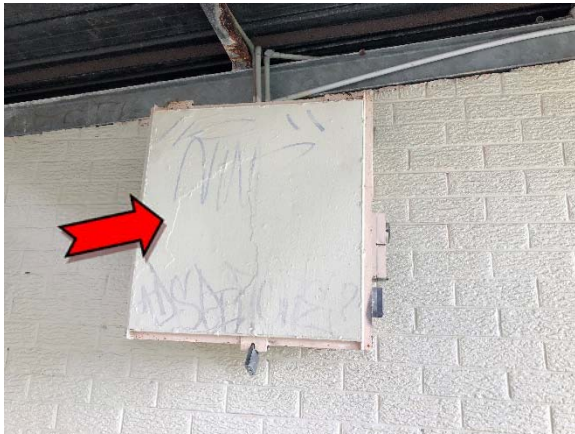
Photo 3. Exterior, northern elevation, electrical backing board – suspected asbestos-containing bituminous backing board.

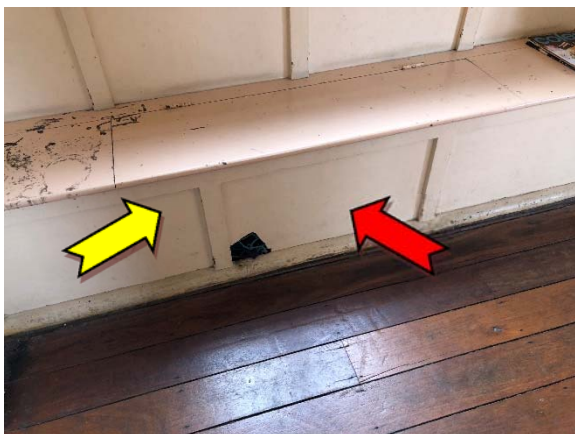
Photo 5. Interior, northern elevation, toilet, low level infill panel – asbestos-containing fibre cement sheeting and suspected lead-containing white upper paint system.

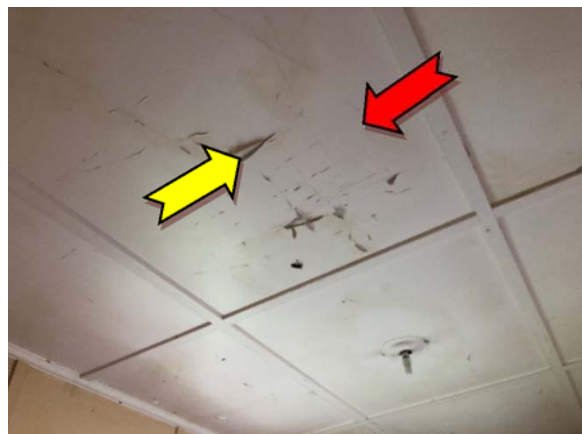
Photo 6. Interior, throughout, ceiling – suspected asbestos-containing fibre cement sheeting and suspected lead-containing white upper paint system.

- The ceiling lining is suspected asbestos-containing fibre cement sheeting with a suspected lead-containing white upper paint system which is noted to be in poor condition and flaking. Due to the paint being on the surface of ACM, remediation works cannot take place as scraping of flaking paint sections would disturb the ACM and potentially release airborne asbestos fibres. The ceiling should be removed in its entirety by a Class B (non-friable) licensed asbestos removal contractor.

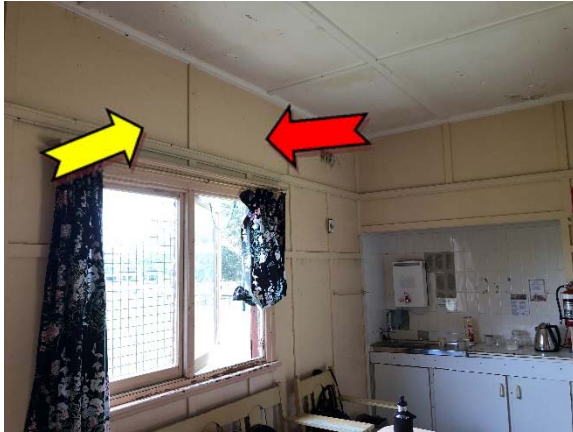
Interior	Northern elevation, toilet	Low level infill panel	Fibre cement sheeting	Asbestos	57722-151-002	Positive	Non-friable	Medium	Poor	High	2 m ²	Encapsulate exposed sections, label as containing asbestos and maintain in a good condition if to remain in-situ. Remove under controlled non-friable asbestos removal conditions prior to refurbishment or demolition works by a Class B (non-friable) licensed asbestos removal contractor.	P2	Aug-18	5
Interior	Throughout	Ceiling	Fibre cement sheeting	Asbestos	Not sampled: Occupied	Suspected Positive	Non-friable	Medium	Poor	High	30 m ²	Remove under controlled non-friable asbestos removal conditions prior to refurbishment or demolition works by a Class B (non-friable) licensed asbestos removal contractor.	P2	Aug-18	6
Interior	Throughout	Walls	Fibre cement sheeting	Asbestos	Same as: 57722-143-001	Assumed Positive	Non-friable	Medium	Poor	High	60 m ²	Encapsulate exposed sections, label as containing asbestos and maintain in a good condition if to remain in-situ. Remove under controlled non-friable asbestos removal conditions prior to refurbishment or demolition works by a Class B (non-friable) licensed asbestos removal contractor.	P2	Aug-18	7

Photo 7. Interior, throughout, walls – assumed asbestos-containing fibre cement sheeting and suspected lead containing white upper paint system

- Encapsulate exposed sections, label as containing asbestos and maintain in a good condition if to remain in-situ. Remove under controlled non-friable asbestos removal conditions prior to refurbishment or demolition works by a Class B (non-friable) licensed asbestos removal contractor.

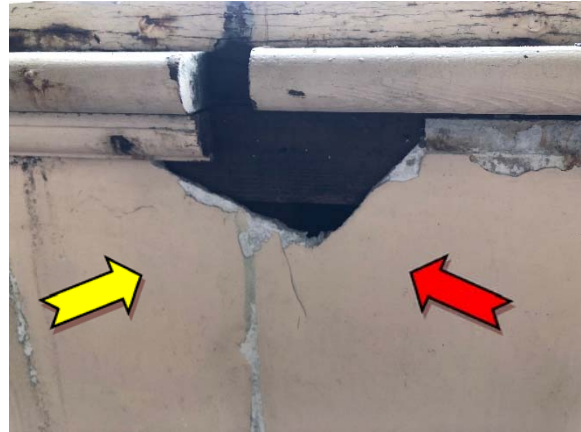
Photo 8. Interior, southern elevation, toilet, walls – assumed asbestos-containing fibre cement sheeting and suspected lead-containing white upper paint system

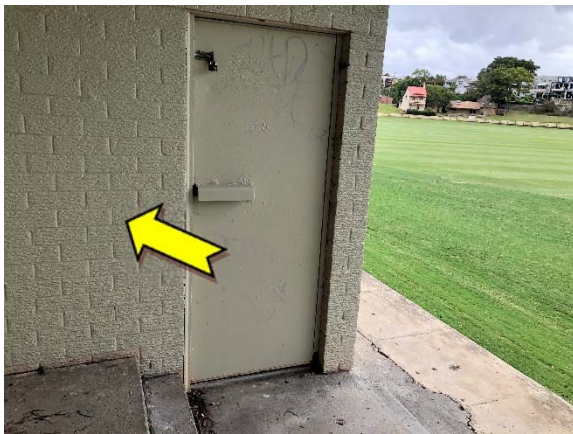
Interior	Southern elevation, toilet	Walls	Fibre cement sheeting	Asbestos	57722-143-001	Positive	Non-friable	Medium	Poor	High	10 m ²	Encapsulate exposed sections, label as containing asbestos and maintain in a good condition if to remain in-situ. Remove under controlled non-friable asbestos removal conditions prior to refurbishment or demolition works by a Class B (non-friable) licensed asbestos removal contractor.	P2	Aug-18	8
Throughout	-	-	-	SMF	-	-	-	-	-	-	-	No suspect SMF material identified at the time of the assessment.	-	-	-
Throughout	-	-	-	PCBs	-	-	-	-	-	-	-	No suspect PCB-containing capacitors identified at the time of the assessment.	-	-	-
Exterior	Shed, throughout	Walls	Beige - upper coloured paint system	Lead Paint - Swab	-	Suspected Positive	-	Low	Fair	Low	60 m ²	Confirm status by quantitative test method, maintain in current condition, over paint with a lead-free paint as part of ongoing maintenance. Remove under controlled conditions in accordance with AS 4361.2:2017 Guide to hazardous paint management prior to renovation or demolition works.	-	-	9

Photo 9. Exterior, shed, throughout, walls – suspected lead-containing beige upper coloured paint system.

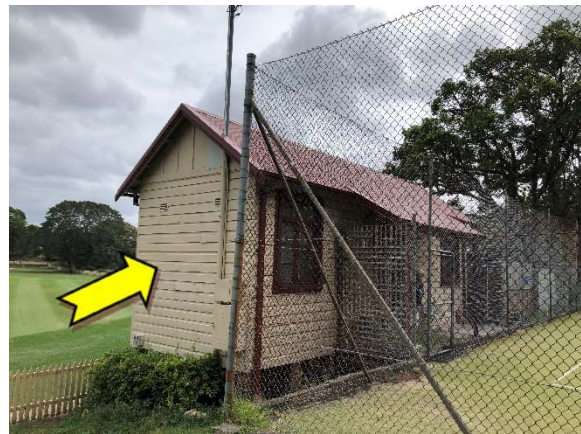
Exterior	Throughout	Walls	Beige - upper coloured paint system	Lead Paint - Swab	-	Suspected Positive	-	Low	Fair	Low	180 m ²	Confirm status by quantitative test method, maintain in current condition, over paint with a lead-free paint as part of ongoing maintenance. Remove under controlled conditions in accordance with AS 4361.2:2017 Guide to hazardous paint management prior to renovation or demolition works.	-	-	10

Photo 10. Exterior, throughout, walls – suspected lead-containing beige upper coloured paint system.

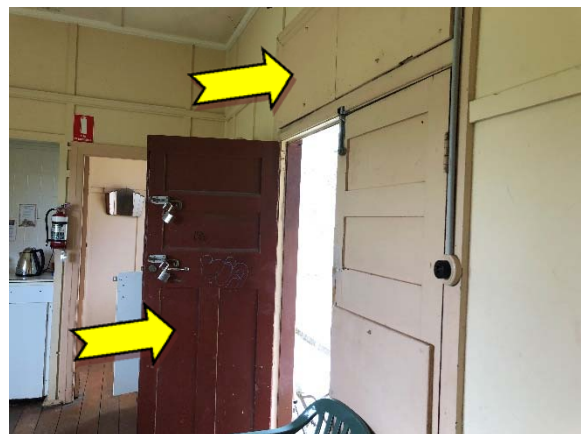
Area / Level	Room & Location	Feature	Item Description	Hazard Type	Sample No.	Sample Status	Friability	Disturb. Potential	Condition	Risk Status	Approx. Quantity	Recommendations & Comments	Control Priority	Reinspect Date	Photo No.
Exterior	Throughout	Windows & door frames	Red - upper coloured paint system	Lead Paint - Swab	-	Suspected Positive	-	Low	Fair	Low	30 m	Confirm status by quantitative test method, maintain in current condition, over paint with a lead-free paint as part of ongoing maintenance. Remove under controlled conditions in accordance with AS 4361.2:2017 Guide to hazardous paint management prior to renovation or demolition works.	-	-	11
Interior	Throughout	Walls	Cream - upper coloured paint system	Lead Paint - Swab	-	Suspected Positive	-	Low	Fair	Low	180 m ²	Confirm status by quantitative test method, maintain in current condition, over paint with a lead-free paint as part of ongoing maintenance. Remove under controlled conditions in accordance with AS 4361.2:2017 Guide to hazardous paint management prior to renovation or demolition works.	-	-	12

Photo 12. Interior, throughout, walls, windows and door frames – suspected lead-containing cream and pink upper coloured paint system.
