Hazardous Building Materials Assessment Leichhardt Depot Recycling Facility 229 Catherine Street Leichhardt NSW 2040

Inner West Council
February 2018

Job No: 57722-037

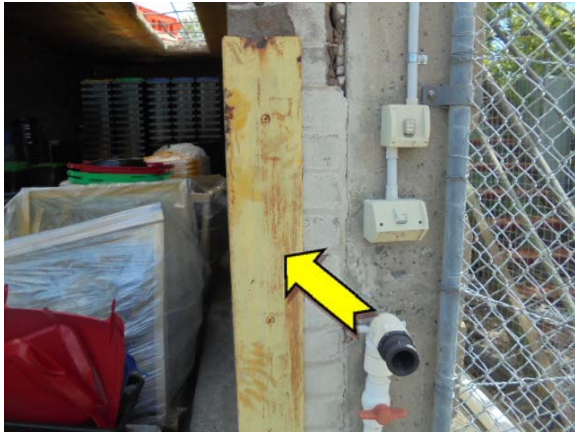
| Area / Level | Room & Location | Feature | Item Description | Hazard Type | Sample No. | Sample Status | Friability | Disturb. Potential | Condition | Risk Status | Approx. Quantity | Recommendations & Comments | Control Priority | Reinspect Date | Photo No. |
|---|---|---|---|---|---|---|---|---|---|---|---|--|---|---|---|
| Exterior | East elevation | Metal framework | Yellow - upper coloured paint system | Lead Paint - Swab | - | Suspected Positive | - | Low | Good | Low | 10 ^{m2} | Confirm status by quantitative test method, maintain in current condition, over paint with a lead-free paint as part of ongoing maintenance. Remove under controlled conditions in accordance with AS 4361.2:2017 Guide to hazardous paint management prior to renovation or demolition works. | - | - | - |

Photo 1. Exterior, east elevation, metal framework - suspected lead-containing yellow upper paint system.

- LCP was suspected in yellow upper coloured paint systems to metal framework located to the east elevation of the building.

- The *LeadCheck* paint swab method can detect lead in paint at concentrations of 0.5% and above, and may indicate lead in some paint films as low as 0.2%. As paint with a lead content greater than 0.1% by dry weight is now considered to be lead-containing, Prensa recommends confirming status of suspected LCP identified during the Assessment by quantitative test method.

- The safest method of dealing with LCP is to replace or remove the items in their entirety that have LCP on them and replace them with new items that do not contain lead. This allows the items to be disposed of as regular building or demolition unsegregated waste in accordance with the NSW Environment Protection Authority (EPA) *Waste Classification Guidelines 2014 Part 1 – Classifying Waste*. The advantage of this method is the reduction in labour requirements to remove the lead paint and also this reduces the risk to workers from exposure to lead dust or fumes. If the removal of the LCP or coatings is the preferred or required option this may generate significant amounts of potential hazardous waste. This waste must be removed, collected and disposed of by an appropriately licensed contractor under controlled conditions that minimises the release to air, water and soil. Disposal of lead waste must be disposed of as hazardous waste at an approved waste facility.
