# Hazardous Building Materials Assessment Leichhardt Town Hall 107 Norton Street Leichhardt NSW 2040

Inner West Council  
February 2018

Job No.: 57722-004

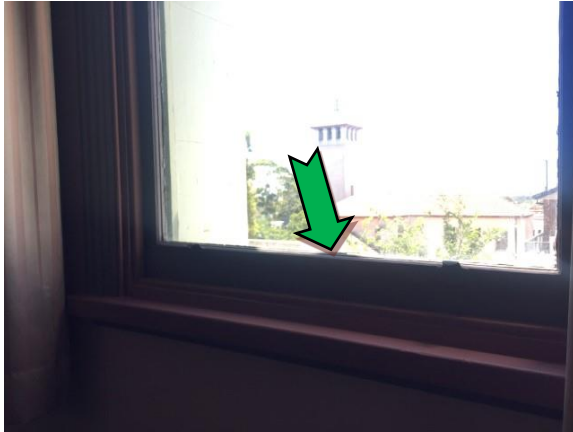
**Photo 1.** Exterior, level 1, reception room, windows – non asbestos-containing window caulking

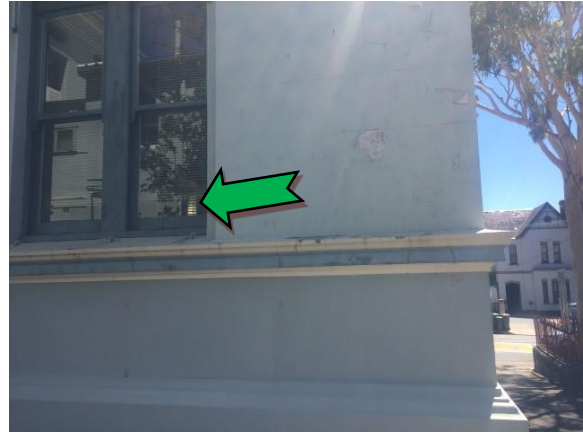
**Photo 2.** Exterior, throughout, windows – assumed non asbestos-containing window caulking

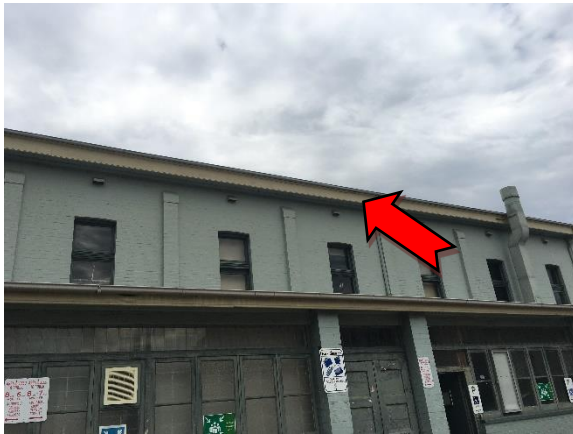
**Photo 3.** Exterior, main hall, surrounding eaves – suspected asbestos-containing fibre cement sheeting

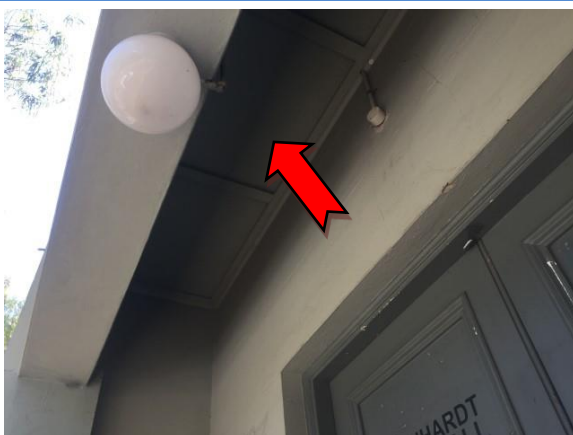
Exterior	Southern elevation, fire exit	Awning	Fibre cement sheeting	Asbestos	Not sampled: Height Restriction	Suspected Positive	Non-friable	Low	Good	Low	5 m <sup>2</sup>	Label as containing asbestos and maintain in current condition if to remain in-situ. Remove under controlled non-friable asbestos removal conditions prior to refurbishment or demolition works by a Class B (non-friable) licensed asbestos removal contractor.	P4	Jan-23	5
Exterior	Eastern extension, north end	Gable end	Fibre cement sheeting	Asbestos	Not sampled: Height Restriction	Suspected Positive	Non-friable	Low	Good	Low	2 m <sup>2</sup>	Confirm status, label as containing asbestos and maintain in current condition if to remain in-situ. Remove under controlled non-friable asbestos removal conditions prior to refurbishment or demolition works by a Class B (non-friable) licensed asbestos removal contractor.	P4	Jan-23	-
Ground level	Eastern extension, (excluding kitchen)	Ceiling lining	Fibre cement sheeting	Asbestos	57722-003-001	Positive	Non-friable	Low	Good	Low	225 m <sup>2</sup>	Label as containing asbestos and maintain in current condition if to remain in-situ. Remove under controlled non-friable asbestos removal conditions prior to refurbishment or demolition works by a Class B (non-friable) licensed asbestos removal contractor.	P4	Jan-23	6

**Photo 5.** Exterior, southern elevation, fire exit, awning – assumed asbestos-containing fibre cement sheeting

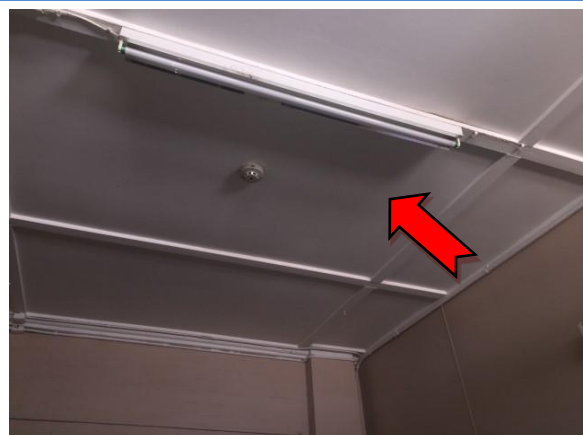
**Photo 6.** Ground level, eastern extension (excluding kitchen), ceiling lining – asbestos-containing fibre cement sheeting

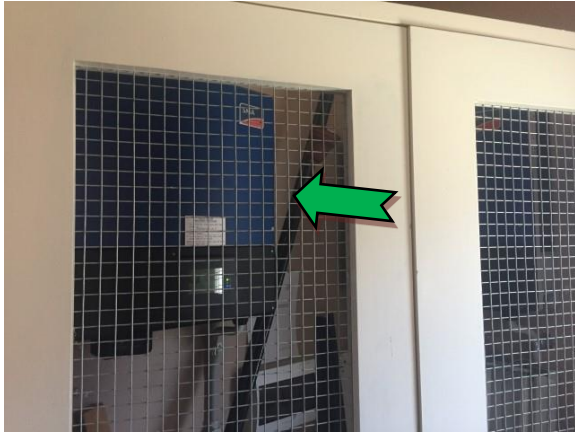
Ground level	Main hall	Behind stage	Bituminous backing board	Asbestos	Not sampled: Electrical hazard	Suspected Negative	-	-	-	-	-	Suspected negative due to age and appearance.	-	-	7
Ground level	Main hall	Switchboard	Bituminous backing board	Asbestos	Not sampled: Electrical hazard	Suspected Negative	-	-	-	-	-	Suspected negative due to age and appearance.	-	-	8
Ground level	Main hall, east elevation	Windows	Caulking	Asbestos	57722-003-004	Negative	-	-	-	-	-	-	-	-	9
Ground level	Councillors lounge	Floor covering - green	Vinyl floor sheeting	Asbestos	Not sampled: Age and Appearance	Suspected Negative	-	-	-	-	-	Suspected negative due to age and appearance.	-	-	10
Ground level	Inner west council offices, kitchen, lunch room & security room	Floor covering	Vinyl floor sheeting	Asbestos	Not sampled: Age and Appearance	Suspected Negative	-	-	-	-	-	Suspected negative due to age and appearance.	-	-	11
Level 1	Kitchen	Hot water boiler	Internal insulation	SMF	-	Suspected Positive	Bonded	Low	Good	Low	1 unit	Maintain in current condition if to remain in-situ. Remove under controlled SMF conditions as per the Code of Practice for the Safe Use of Synthetic Mineral Fibres [NOHSC: 2006 (1990)].	-	-	12

**Photo 7.** Ground level, main hall, behind stage, electrical backing boards – suspected non asbestos-containing bituminous backing boards

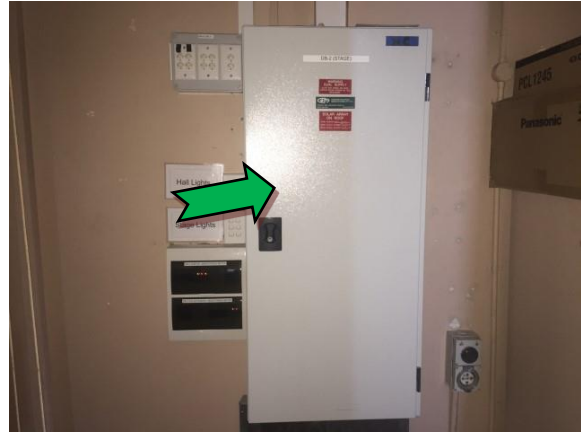
**Photo 8.** Ground level, main hall, switchboard – suspected non asbestos-containing bituminous backing boards

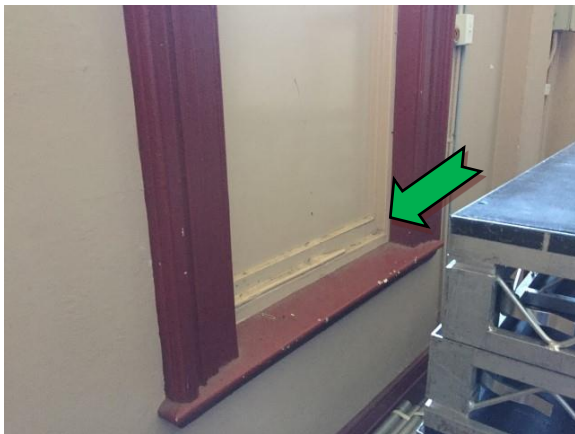
**Photo 9.** Ground level, main hall, east elevation, windows – non asbestos-containing window caulking

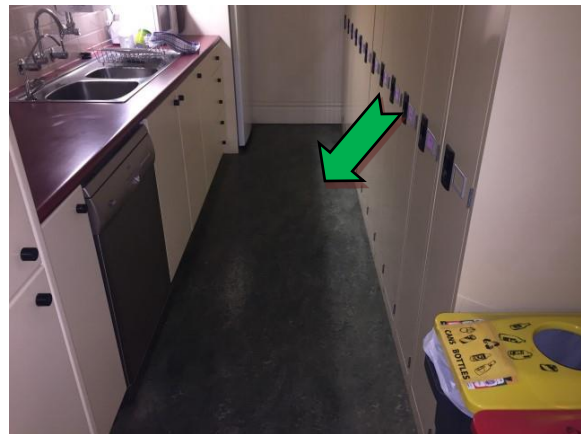
**Photo 10.** Ground level, councillors lounge, floor coverings – suspected non asbestos-containing green vinyl sheeting

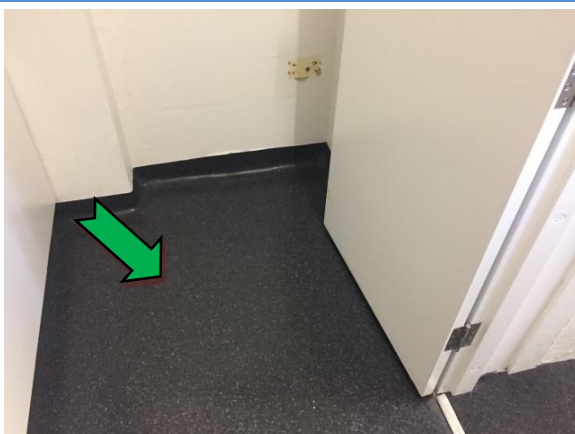
**Photo 11.** Ground level, Inner West Council offices, kitchen, lunch room & security room, floor covering – suspected non asbestos-containing black vinyl sheeting

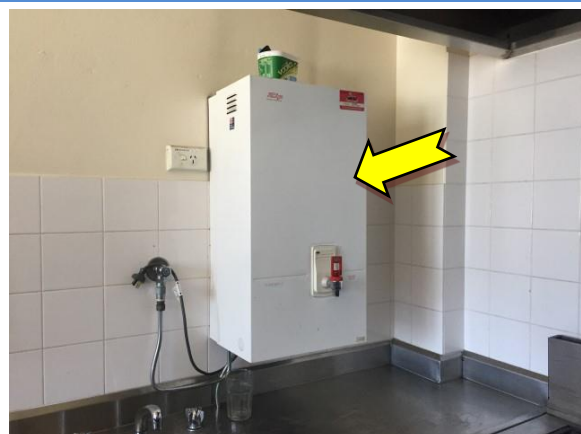
**Photo 12.** Ground level, kitchen, hot water boiler – suspected SMF internal insulation

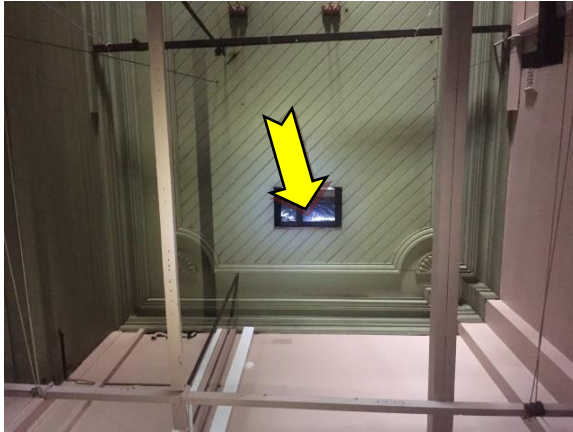
**Photo 13.** Ground level, main hall, roof space, roof lining – suspected SMF sarking

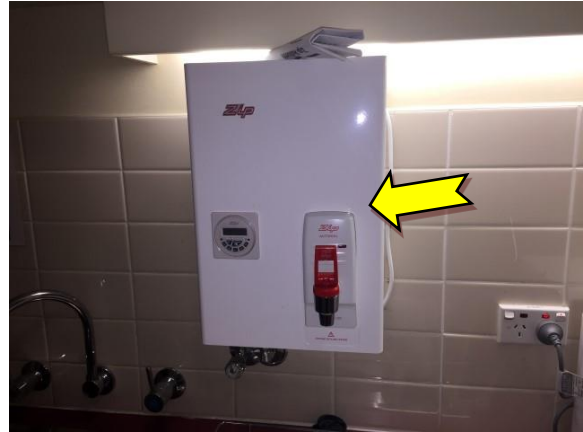
**Photo 14.** Ground level, north-east kitchen, south wall, hot water boiler – suspected SMF internal insulation

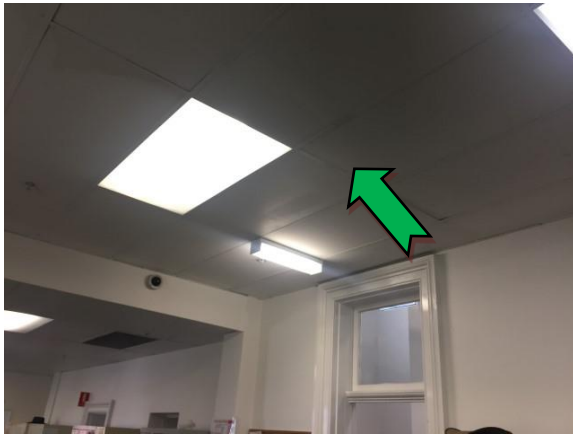
**Photo 15.** Ground level, Inner West Council Offices, north-west office, ceiling lining – suspected non SMF compressed ceiling tiles

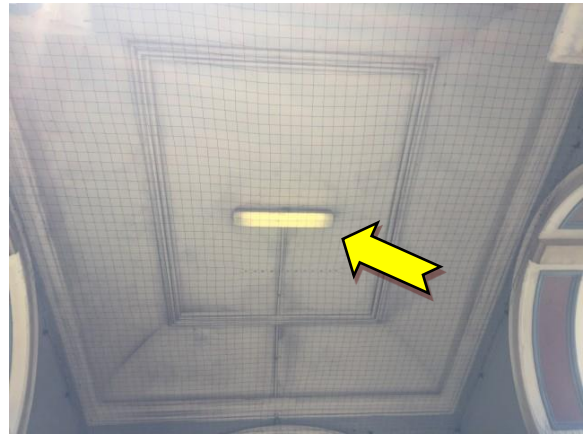
**Photo 16.** Exterior, western elevation, entrance – suspected PCB-containing single tube fluorescent light fitting

- Electrical fittings that contain or suspected to contain PCB oil-containing capacitors should be removed as hazardous/regulated waste under controlled working conditions prior to the demolition or refurbishment works in accordance with the *Polychlorinated Biphenyls Management Plan, Revised Edition April 2*.

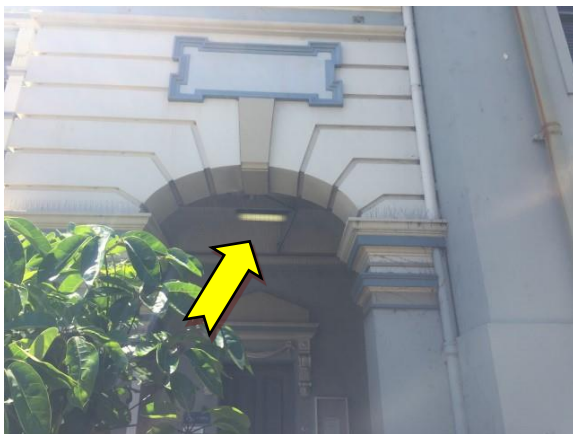
**Photo 17.** Exterior, southern elevation, disabled toilet – suspected PCB-containing single tube fluorescent light fitting

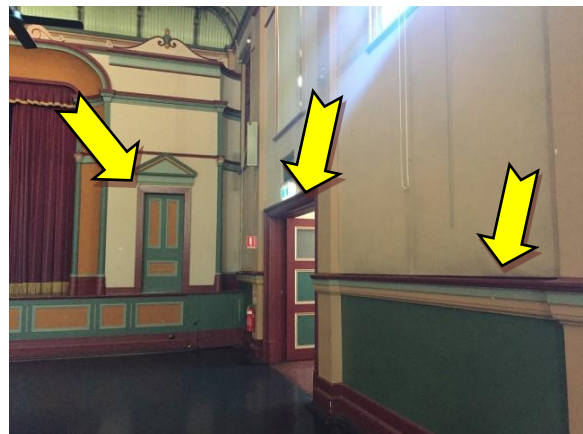
Interior	Throughout	Walls	Green (dark) - upper coloured paint system	Lead Paint - Swab	-	Suspected Positive	-	Low	Good	Low	180 m <sup>2</sup>	Confirm status by quantitative test method, maintain in current condition, over paint with a lead-free paint as part of ongoing maintenance. Remove under controlled conditions in accordance with AS 4361.2:2017 Guide to hazardous paint management prior to renovation or demolition works.	-	-	18
Interior	Throughout	Walls	Peach - upper coloured paint system	Lead Paint - Swab	-	Suspected Positive	-	Low	Good	Low	500 m <sup>2</sup>	Confirm status by quantitative test method, maintain in current condition, over paint with a lead-free paint as part of ongoing maintenance. Remove under controlled conditions in accordance with AS 4361.2:2017 Guide to hazardous paint management prior to renovation or demolition works.	-	-	18
Interior	Throughout	Walls	Peach (light) - upper coloured paint system	Lead Paint - Swab	-	Suspected Positive	-	Low	Good	Low	500 m <sup>2</sup>	Confirm status by quantitative test method, maintain in current condition, over paint with a lead-free paint as part of ongoing maintenance. Remove under controlled conditions in accordance with AS 4361.2:2017 Guide to hazardous paint management prior to renovation or demolition works.	-	-	18

**Photo 18.** Interior, walls throughout – suspected lead-containing paint systems (red, dark green, peach, light peach, white, beige)

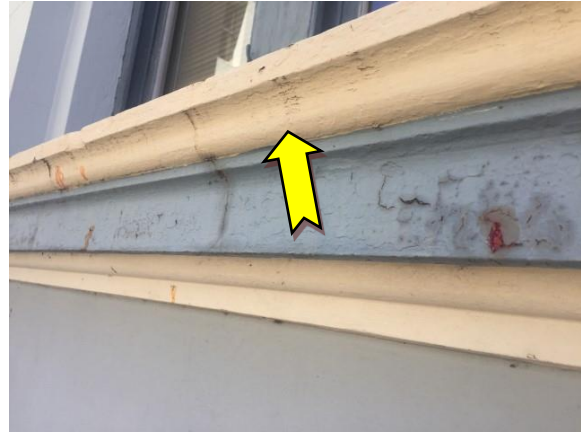
**Photo 20.** Exterior, throughout, walls – lead-containing light yellow upper paint systems

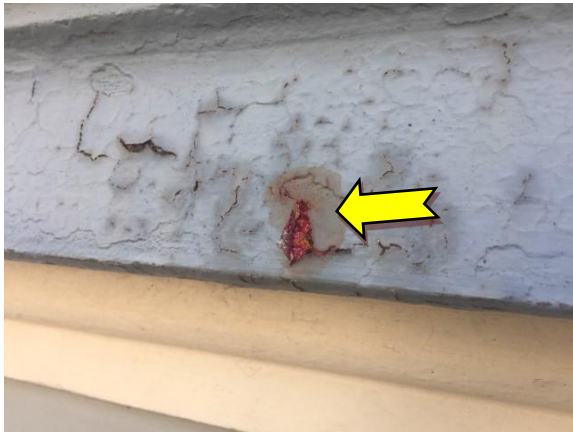
Area / Level	Room & Location	Feature	Item Description	Hazard Type	Sample No.	Sample Status	Friability	Disturb. Potential	Condition	Risk Status	Approx. Quantity	Recommendations & Comments	Control Priority	Reinspect Date	Photo No.
Exterior	Throughout	Walls	Yellow (light) - upper coloured paint system	Lead Paint - Swab	-	Positive	-	Low	Good	Low	400 m <sup>2</sup>	Maintain in current condition, over paint with a lead-free paint as part of ongoing maintenance. Remove under controlled conditions in accordance with AS 4361.2:2017 Guide to hazardous paint management prior to renovation or demolition works.	-	-	20
Exterior	Throughout	Walls	White - lower coloured paint system	Lead Paint - Swab	-	Positive	-	Low	Good	Low	1000 m <sup>2</sup>	Maintain in current condition, over paint with a lead-free paint as part of ongoing maintenance. Remove under controlled conditions in accordance with AS 4361.2:2017 Guide to hazardous paint management prior to renovation or demolition works.	-	-	21

**Photo 21.** Exterior, throughout, walls – lead-containing lower white paint systems

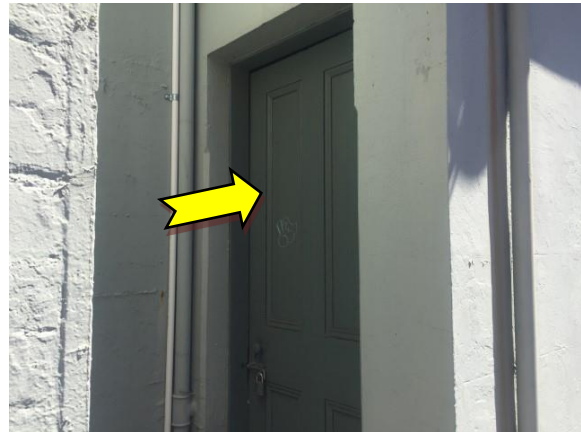
**Photo 22.** Exterior, throughout, walls – lead-containing dark green paint systems

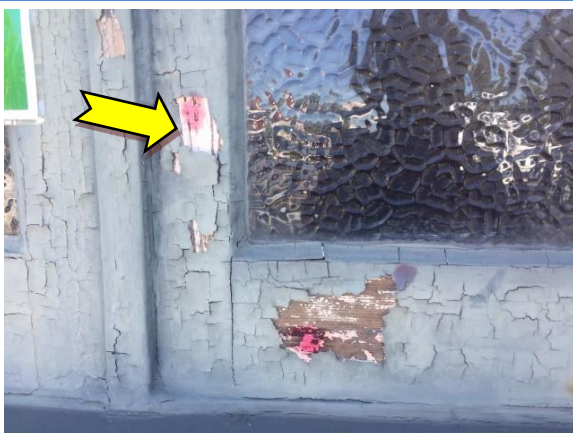
Exterior	Throughout	Walls	Green (dark) - upper coloured paint system	Lead Paint - Swab	-	Positive	-	Low	Good	Low	50 m <sup>2</sup>	Maintain in current condition, over paint with a lead-free paint as part of ongoing maintenance. Remove under controlled conditions in accordance with AS 4361.2:2017 Guide to hazardous paint management prior to renovation or demolition works.	-	-	22
Exterior	Throughout	Window frames	White - lower coloured paint system	Lead Paint - Swab	-	Positive	-	Medium	Poor	Medium	150 m <sup>2</sup>	Remove flaking sections and over paint with a lead-free paint. Remove under controlled conditions in accordance with AS 4361.2:2017 Guide to hazardous paint management prior to renovation or demolition works.	-	-	23

**Photo 23.** Exterior, throughout, window frames – lead-containing white lower paint systems

- Remove flaking lead containing paint to window surrounds throughout the property in accordance with AS4361.2-2017 Guide to Hazardous Paint Management and relevant legislation.

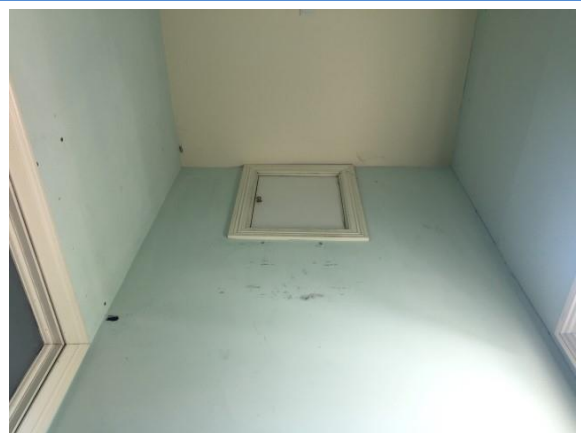
**Photo 24.** No access – ceiling space to level 1 female bathroom (access hatch at on wall)
