Hazardous Building Materials Assessment Tempe Reserve - Tempe Jets Club Holbeach Avenue Tempe NSW 2044

Inner West Council
February 2018

Job No.: 57722-143

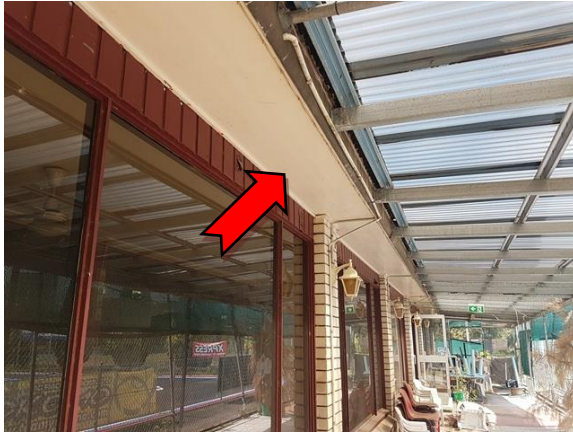
Photo 1. Exterior, throughout, eave lining – asbestos containing fibre cement sheeting.

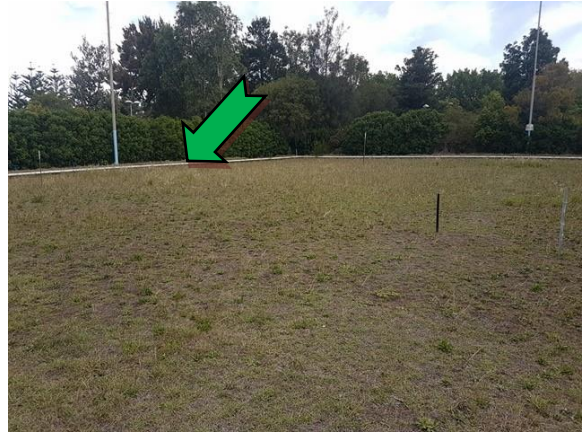
Photo 2. Exterior, bowling green, guttering – non asbestos-containing fibre cement sheeting.

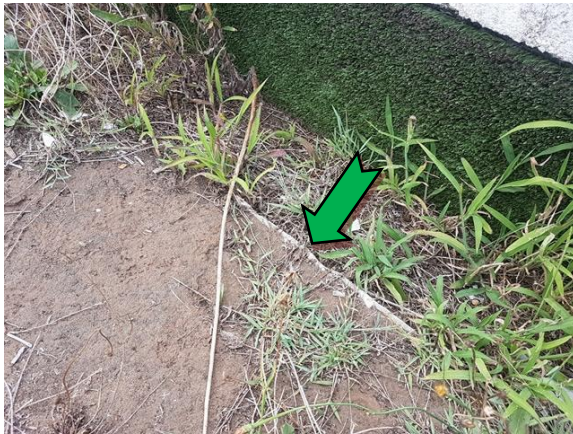
Photo 3. Exterior, bowling green, guttering – non asbestos-containing fibre cement sheeting.

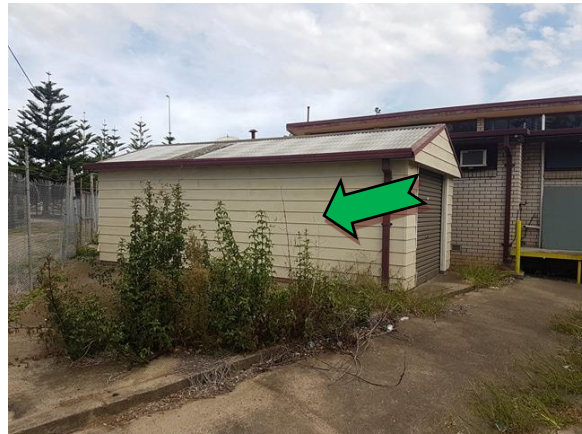
Photo 4. Exterior, central east garage, walls – no materials suspected of containing asbestos identified. Materials formed of masonite.

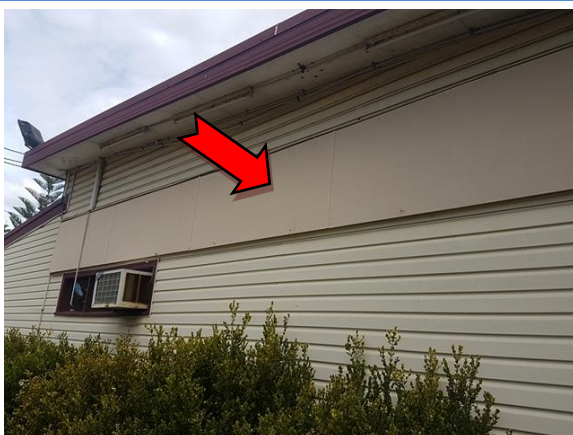
Photo 5. Exterior, north elevation, façade – suspected asbestos-containing fibre cement sheeting.

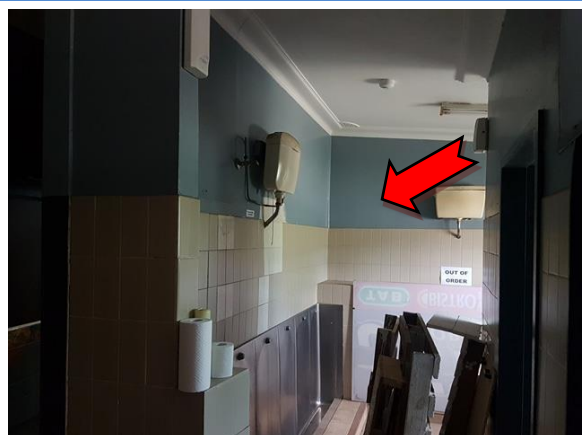
Photo 6. Interior, north-east elevation, toilet walls – asbestos-containing fibre cement sheeting.

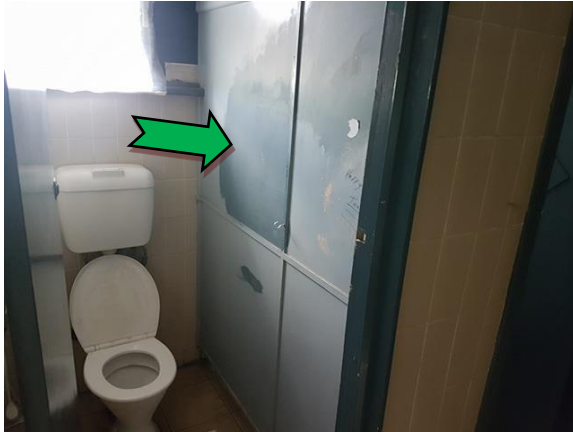
Photo 7. Interior, north-east elevation, toilet, cubicle walls – non asbestos-containing fibre cement sheeting.

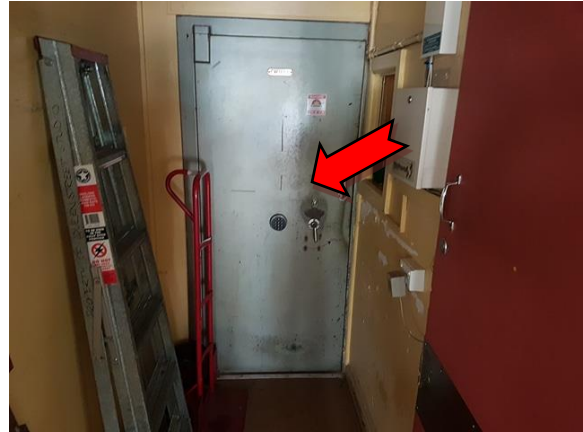
Photo 8. Interior, central east elevation, security room, door – suspected asbestos-containing internal insulation.

Interior	North-east elevation, toilet	Wall	Fibre cement sheeting	Asbestos	57722-143-001	Positive	Non-friable	Low	Good	Low	50m ²	Label as containing asbestos and maintain in current condition if to remain in-situ. Remove under controlled non-friable asbestos removal conditions prior to refurbishment or demolition works by a Class B (non-friable) licensed asbestos removal contractor.	P4	Mar-23	6
Interior	North-east elevation, toilet	Toilet cubicle	Fibre cement sheeting	Asbestos	57722-143-002	Negative	-	-	-	-	-	-	-	-	7
Interior	Central east elevation, security room	Door	Insulation material - internal	Asbestos	Not Sampled: Sealed Unit	Suspected Positive	Friable	Low	Good	Low	1 unit	Confirm status, label as containing asbestos and maintain in current condition if to remain in-situ. Remove under controlled friable asbestos removal conditions prior to refurbishment or demolition works by a Class A (friable) licensed asbestos removal contractor.	P4	Mar-23	8

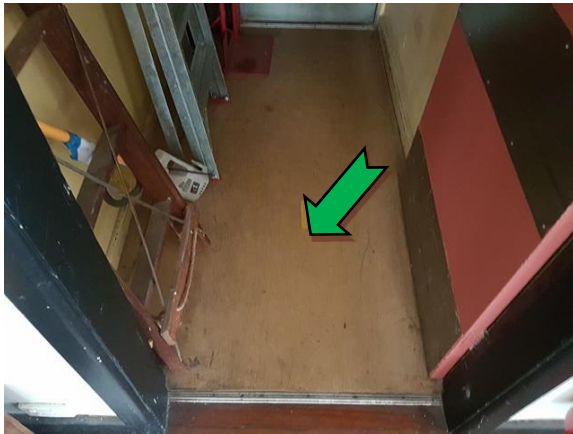
Photo 9. Interior, central east elevation, security room, floor – non asbestos-containing vinyl sheet.

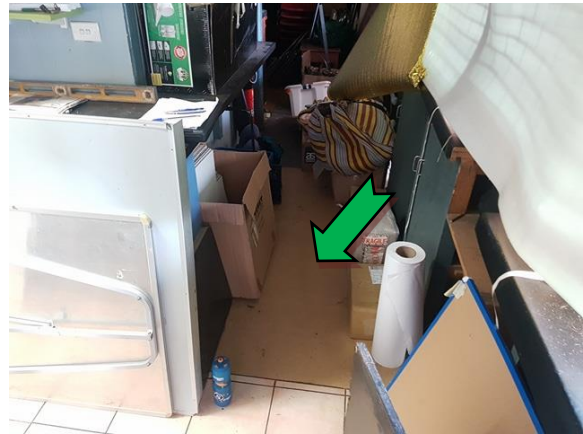
Photo 10. Interior, central south elevation, bar area, floor – non asbestos containing vinyl sheet and adhesive.

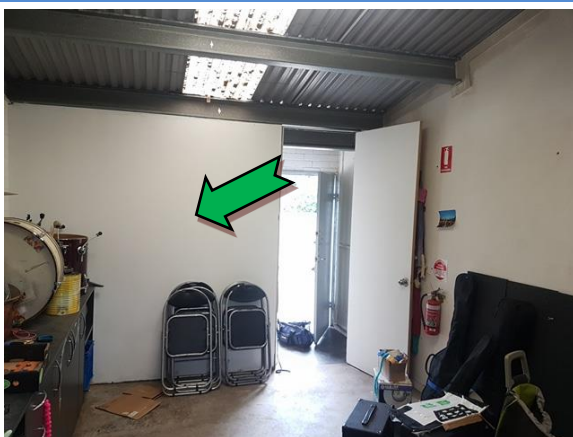
Photo 11. Interior, south-east elevation, garage, wall – non asbestos-containing fibre cement sheeting.

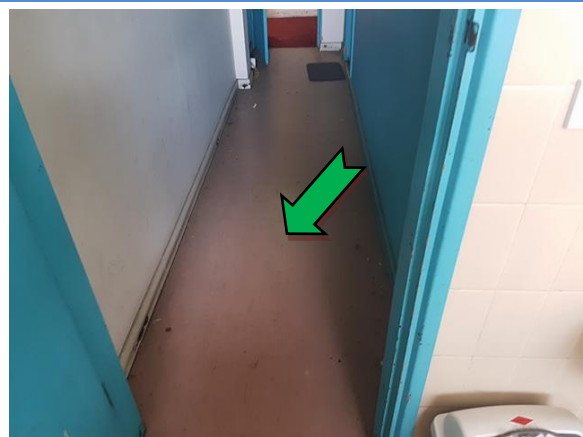
Photo 12. Interior, east elevation, hallway, floor – suspected non asbestos-containing vinyl sheet.

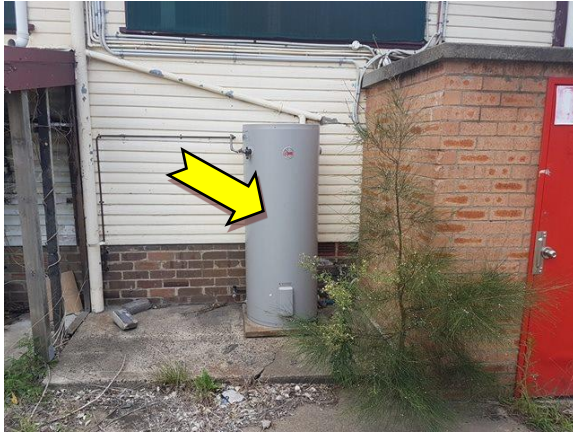
Photo 13. Exterior, north-east elevation, hot water heater – suspected SMF-containing internal insulation.

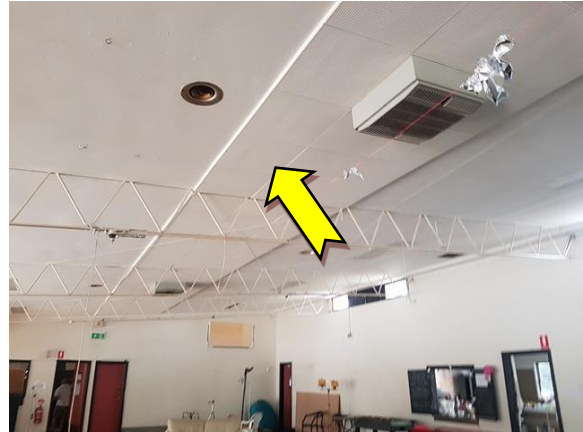
Photo 14. Interior, main hall, ceiling – suspected SMF-containing compressed ceiling tiles.

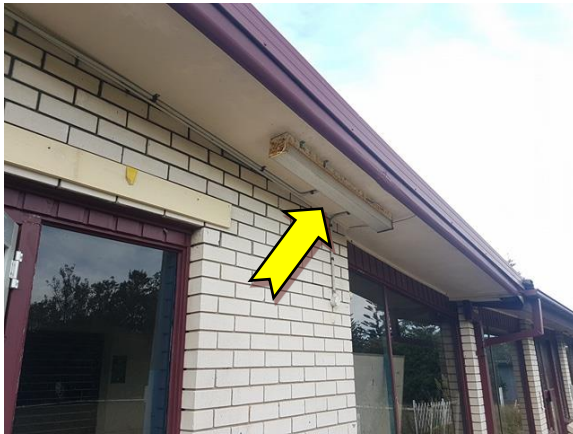
Photo 15. Exterior, throughout, double tube fluorescent light fittings – suspected PCB-containing capacitors.

- Electrical fittings suspected of containing PCB oil capacitors should be treated as containing PCB oils until such time as evidence suggest otherwise e.g. further assessed.
- Electrical fittings that contain or suspected to contain PCB oil-containing capacitors should be removed as hazardous/regulated waste under controlled working conditions prior to the demolition or refurbishment works in accordance with the *Polychlorinated Biphenyls Management Plan, Revised Edition April 2003*.

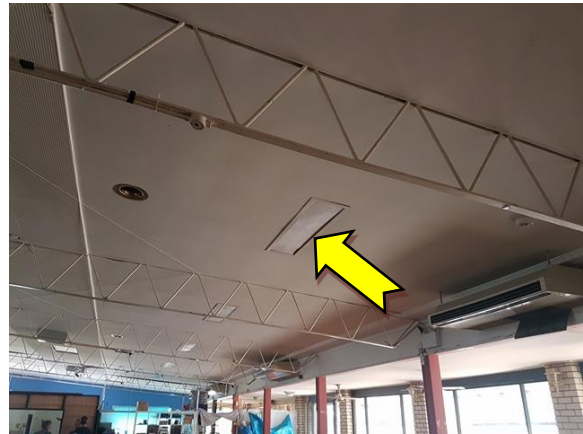
Photo 16. Interior, throughout, double tube fluorescent light fittings – suspected PCB-containing capacitors.

Area / Level	Room & Location	Feature	Item Description	Hazard Type	Sample No.	Sample Status	Friability	Disturb. Potential	Condition	Risk Status	Approx. Quantity	Recommendations & Comments	Control Priority	Reinspect Date	Photo No.
Interior	Main hall	Ceiling	Compressed ceiling tiles	SMF	-	Suspected Positive	Bonded	Low	Good	Low	30m ²	Maintain in current condition if to remain in-situ. Remove under controlled SMF conditions as per the Code of Practice for the Safe Use of Synthetic Mineral Fibres [NOHSC: 2006 (1990)].	-	-	14
Exterior	Throughout	Fluorescent light fitting - double tube	Capacitor	PCBs	Not Sampled: Electrical Hazard	Suspected Positive	-	-	-	-	20 units	PCB-containing capacitors are suspected due to age & appearance of electrical fittings. Remove and dispose of in accordance with the Polychlorinated Biphenyls Management Plan, Revised Edition April 2003.	-	-	15
Interior	Throughout	Fluorescent light fitting - double tube	Capacitor	PCBs	Not Sampled: Electrical Hazard	Suspected Positive	-	-	-	-	20 units	PCB-containing capacitors are suspected due to age & appearance of electrical fittings. Remove and dispose of in accordance with the Polychlorinated Biphenyls Management Plan, Revised Edition April 2003.	-	-	16

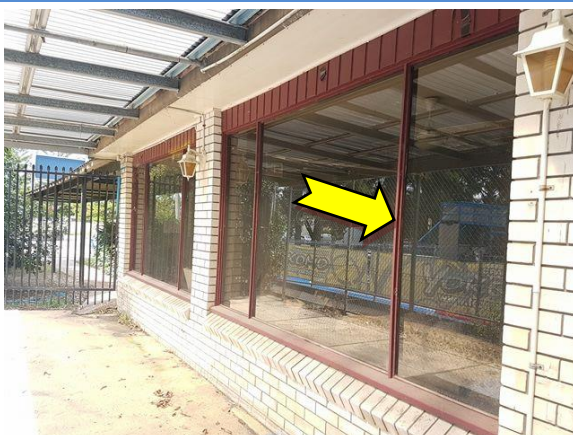
Photo 17. Exterior, throughout, windows and door frames – suspected lead-containing red upper coloured paint system.

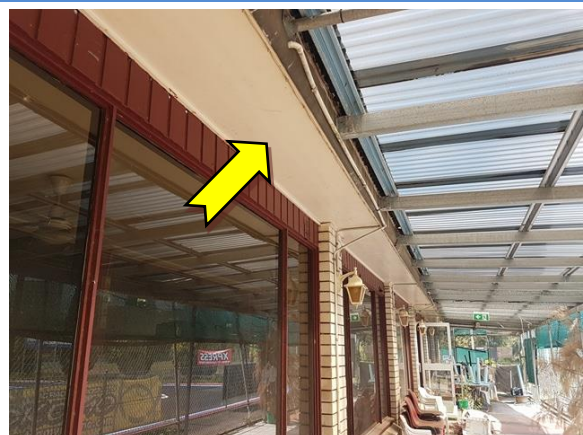
Photo 18. Exterior, throughout, eaves – suspected lead-containing cream upper coloured paint system.

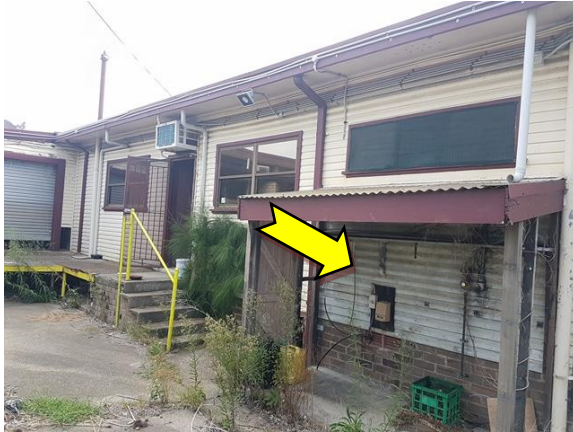
Photo 19. Exterior, throughout, walls – suspected lead-containing cream upper coloured paint system.

Exterior	Throughout	Windows & door frames	Red - upper coloured paint system	Lead Paint - Swab	-	Suspected Positive	-	Low	Good	Low	100m	Confirm status by quantitative test method, maintain in current condition, over paint with a lead-free paint as part of ongoing maintenance. Remove under controlled conditions in accordance with AS 4361.2:2017 Guide to hazardous paint management prior to renovation or demolition works.	-	-	17
Exterior	Throughout	Eaves	Cream - upper coloured paint system	Lead Paint - Swab	-	Suspected Positive	-	Low	Good	Low	150m ²	Confirm status by quantitative test method, maintain in current condition, over paint with a lead-free paint as part of ongoing maintenance. Remove under controlled conditions in accordance with AS 4361.2:2017 Guide to hazardous paint management prior to renovation or demolition works.	-	-	18
Exterior	Throughout	Walls	Yellow - upper coloured paint system	Lead Paint - Swab	-	Suspected Positive	-	Low	Good	Low	300m ²	Confirm status by quantitative test method, maintain in current condition, over paint with a lead-free paint as part of ongoing maintenance. Remove under controlled conditions in accordance with AS 4361.2:2017 Guide to hazardous paint management prior to renovation or demolition works.	-	-	19

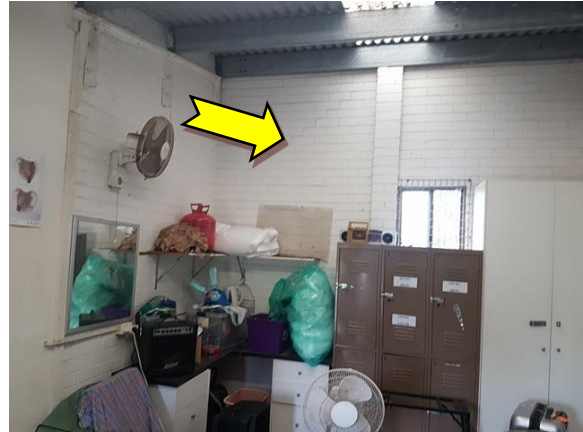
Photo 20. Interior, south-east elevation, garage, walls – suspected lead containing white upper coloured paint system.

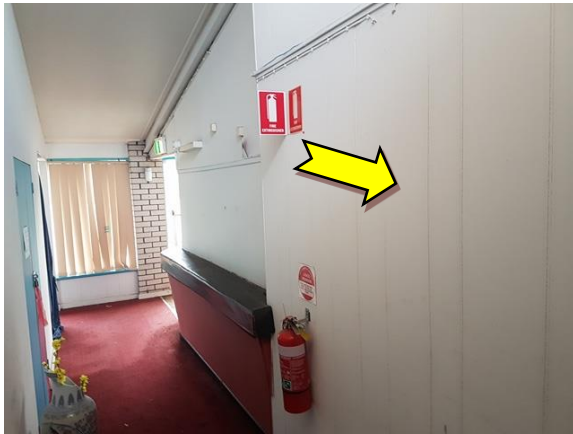
Photo 21. Interior, throughout, walls – suspected lead containing white upper coloured paint system.

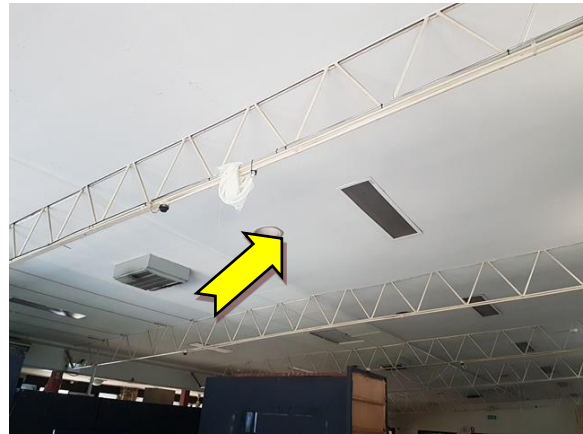
Photo 22. Interior, throughout, ceiling – suspected lead containing white upper coloured paint system.

Interior	South-east elevation, garage	Wall	White - upper coloured paint system	Lead Paint - Swab	-	Suspected Positive	-	Low	Good	Low	50m ²	Confirm status by quantitative test method, maintain in current condition, over paint with a lead-free paint as part of ongoing maintenance. Remove under controlled conditions in accordance with AS 4361.2:2017 Guide to hazardous paint management prior to renovation or demolition works.	-	-	20
Interior	Throughout	Walls	White - upper coloured paint system	Lead Paint - Swab	-	Suspected Positive	-	Low	Good	Low	600m ²	Confirm status by quantitative test method, maintain in current condition, over paint with a lead-free paint as part of ongoing maintenance. Remove under controlled conditions in accordance with AS 4361.2:2017 Guide to hazardous paint management prior to renovation or demolition works.	-	-	21
Interior	Throughout	Ceiling	White - upper coloured paint system	Lead Paint - Swab	-	Suspected Positive	-	Low	Good	Low	400m ²	Confirm status by quantitative test method, maintain in current condition, over paint with a lead-free paint as part of ongoing maintenance. Remove under controlled conditions in accordance with AS 4361.2:2017 Guide to hazardous paint management prior to renovation or demolition works.	-	-	22

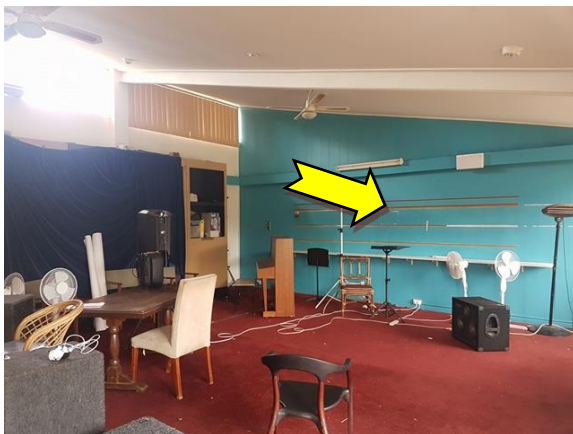
Photo 23. Interior, central east elevation, walls – suspected lead containing blue upper coloured paint system.

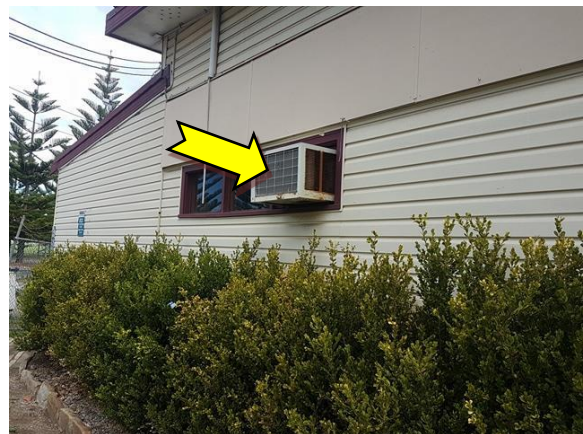
Photo 24. Exterior, throughout, air conditioning units, refrigerant R22 – ozone depleting substance.

Interior	Central east elevation, rooms	Walls	Blue (light) - upper coloured paint system	Lead Paint - Swab	-	Suspected Positive	-	Low	Good	Low	50m ²	Confirm status by quantitative test method, maintain in current condition, over paint with a lead-free paint as part of ongoing maintenance. Remove under controlled conditions in accordance with AS 4361.2:2017 Guide to hazardous paint management prior to renovation or demolition works.	-	-	23
Exterior	Throughout	Air conditioning unit	R22 Hydrochlorofluorocarbon (HCFC)	Ozone Depleting Substances	-	Positive	-	-	-	-	5 units	Hydrochlorofluorocarbon (HCFC), ozone depleting substances identified in the assessment that require removal during refurbishment or demolition works should be appropriately decanted and disposed of by a licensed contractor in accordance with the Ozone Protection and Synthetic Greenhouse Gas Management Amendment Regulation 2017.	-	-	24

- If the ozone depleting substances identified on-site unit require removal they should be appropriately decanted and disposed of by a licensed contractor in accordance with the *Ozone Protection and Synthetic Greenhouse Gas Management Amendment Regulation 2017* as amended from time to time.
- In accordance with the Commonwealth Ozone Protection Legislation, Prensa recommends, in line with Australia's commitment to phase out ODS-containing substances that units which are required to be replaced due to their age, damage or functionality, have their ODS-containing refrigerants replaced with a non-ODS alternative such as R410A.
- It is important to note that, if a system which utilises ODS-refrigerants is in good working order, there is no need to transition to an alternative refrigerant/system (until 2029).

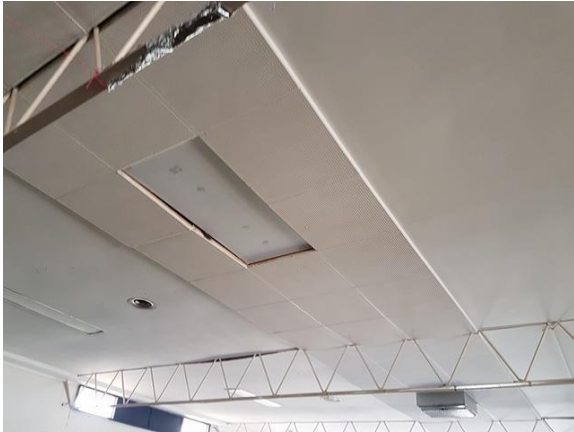
Photo 25. Interior, roof space – no access at time of assessment due to height restrictions.

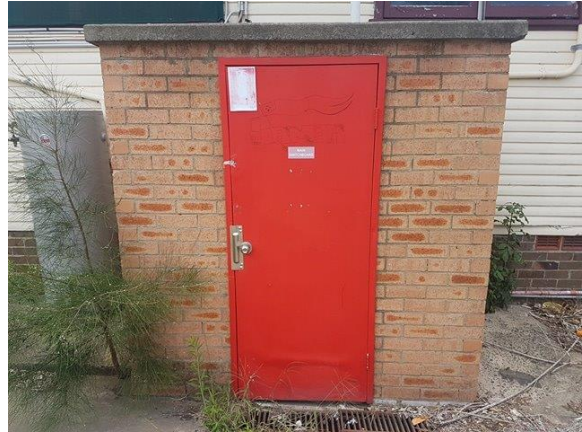
Photo 26. Exterior, north-east elevation, electrical switch room – no access at time of assessment due to locked door.
