# Hazardous Building Materials Assessment

## Pratten Park Bowling Club

Arthur Street  
Ashfield NSW 2131

Inner West Council  
March 2018

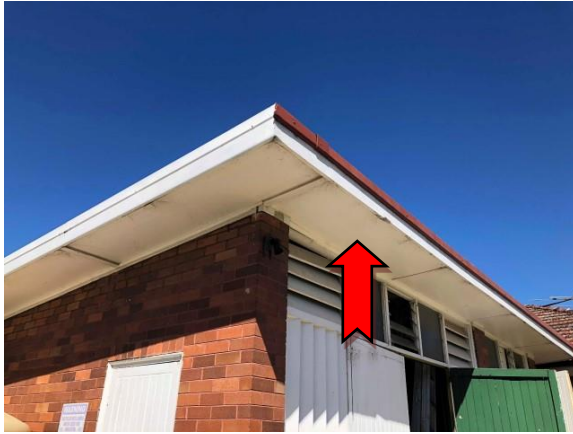
**Photo 1.** Exterior, eastern elevation, shed, eaves – asbestos-containing fibre cement sheeting.

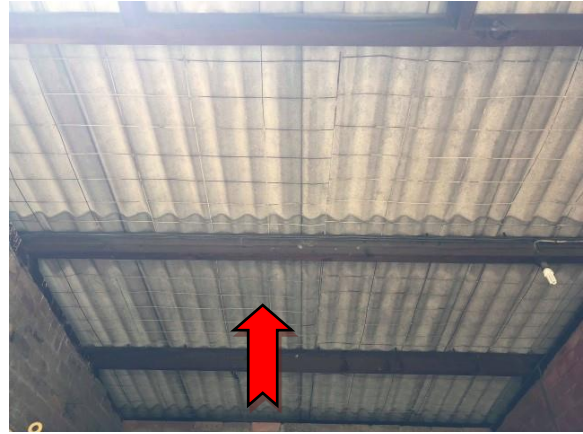
**Photo 2.** Exterior, eastern elevation, shed, roof – asbestos-containing moulded fibre cement.

Area / Level	Room & Location	Feature	Item Description	Hazard Type	Sample No.	Sample Status	Friability	Disturb. Potential	Condition	Risk Status	Approx. Quantity	Recommendations & Comments	Control Priority	Reinspect Date	Photo No.
Exterior	Eastern elevation, shed	Eaves	Fibre cement sheeting	Asbestos	57722-018-001	Positive	Non-friable	Low	Good	Low	15 m <sup>2</sup>	Label as containing asbestos and maintain in current condition if to remain in-situ. Remove under controlled non-friable asbestos removal conditions prior to refurbishment or demolition works by a Class B (non-friable) licensed asbestos removal contractor.	P4	Feb-23	1
Exterior	Eastern elevation, shed	Roof	Moulded fibre cement	Asbestos	57722-018-002	Positive	Non-friable	Low	Good	Low	15 m <sup>2</sup>	Label as containing asbestos and maintain in current condition if to remain in-situ. Remove under controlled non-friable asbestos removal conditions prior to refurbishment or demolition works by a Class B (non-friable) licensed asbestos removal contractor.	P4	Feb-23	2

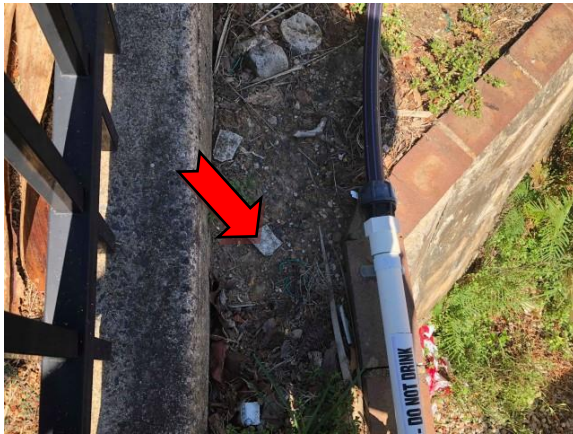
**Photo 3.** Exterior, south-eastern elevation, to ground surface – asbestos-containing fibre cement sheeting debris.

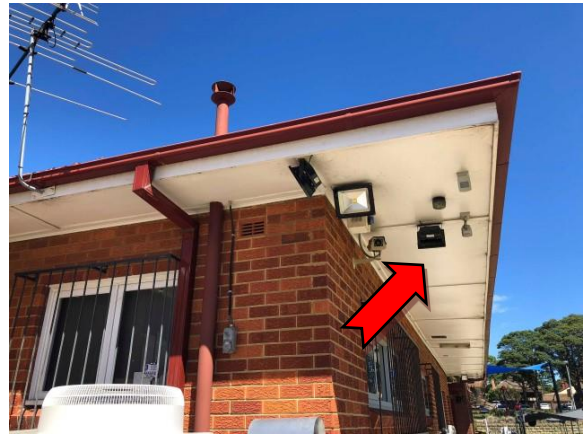
**Photo 4.** Exterior, main building, eaves – asbestos-containing fibre cement sheeting.

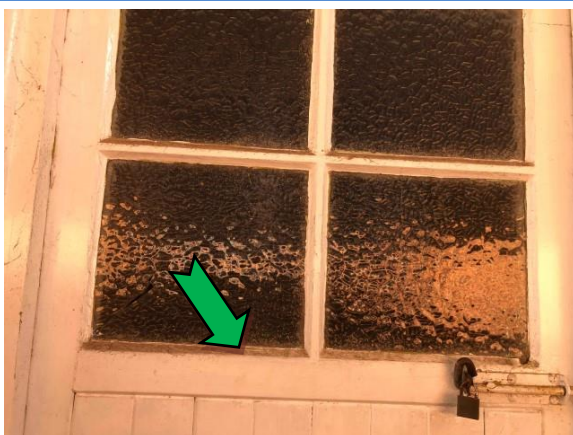
**Photo 5.** Exterior, east elevation, shed, door – non asbestos-containing window caulking.

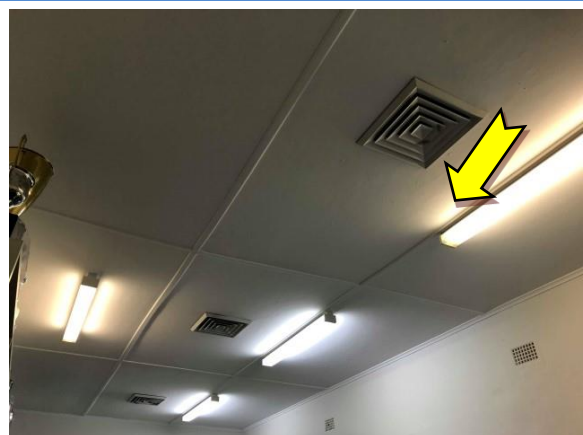
**Photo 6.** Interior, Canterbury soccer football office, main office, ceiling – asbestos-containing fibre cement sheeting.

Exterior	South-eastern elevation, to ground	Debris	Fibre cement sheeting	Asbestos	57722-018-003	Positive	Non-friable	Medium	Poor	Medium	1 m <sup>2</sup>	Restrict access and isolate area. Remove under controlled non-friable asbestos removal conditions prior to refurbishment or demolition works by a Class B (non-friable) licensed asbestos removal contractor.	P2	Feb-19	3
Exterior	Main building	Eaves	Fibre cement sheeting	Asbestos	57722-018-004	Positive	Non-friable	Low	Good	Low	60 m <sup>2</sup>	Label as containing asbestos and maintain in current condition if to remain in-situ. Remove under controlled non-friable asbestos removal conditions prior to refurbishment or demolition works by a Class B (non-friable) licensed asbestos removal contractor.	P4	Feb-23	4
Exterior	Eastern elevation, shed	Door	Window caulking	Asbestos	57722-018-005	Negative	-	-	-	-	-	-	-	-	5
Interior	Cantebury soccer football office, main office	Ceiling	Fibre cement sheeting	Asbestos	57722-018-006	Positive	Non-friable	Low	Good	Low	15 m <sup>2</sup>	Label as containing asbestos and maintain in current condition if to remain in-situ. Remove under controlled non-friable asbestos removal conditions prior to refurbishment or demolition works by a Class B (non-friable) licensed asbestos removal contractor.	P4	Feb-23	6

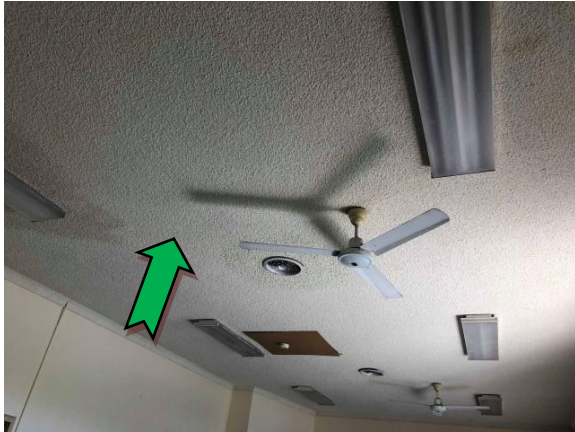
**Photo 7.** Interior, bar area, ceiling – non asbestos-containing vermiculite.

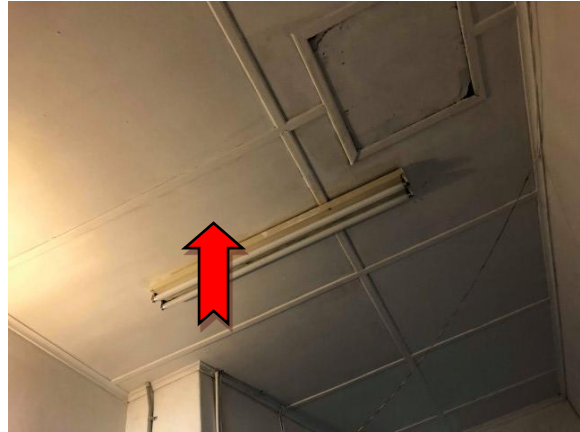
**Photo 8.** Interior, bar and kitchen toiler areas, ceiling – asbestos-containing fibre cement sheeting.

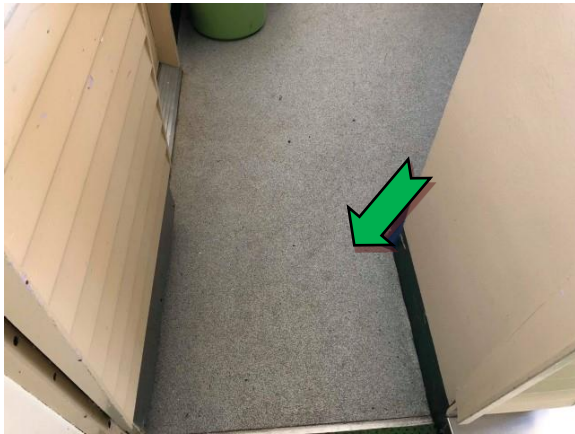
**Photo 9.** Interior, bar area, floor coverings – suspected non asbestos-containing sheet vinyl.

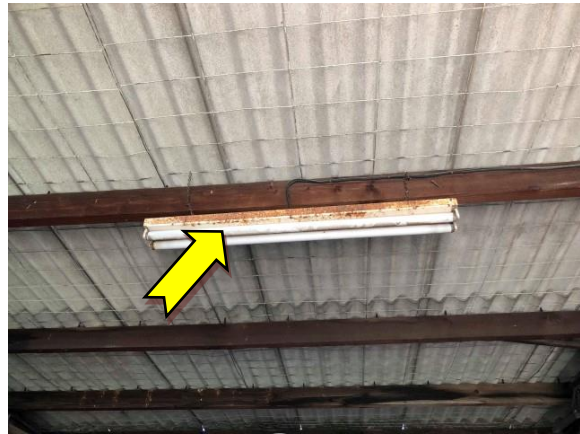
**Photo 10.** Interior, east elevation, shed, double tube fluorescent light fitting – suspected PCB-containing capacitor.

- Electrical fittings that contain or suspected to contain PCB oil-containing capacitors should be removed as hazardous/regulated waste under controlled working conditions prior to the demolition or refurbishment works in accordance with the *Polychlorinated Biphenyls Management Plan, Revised Edition April 2003*.

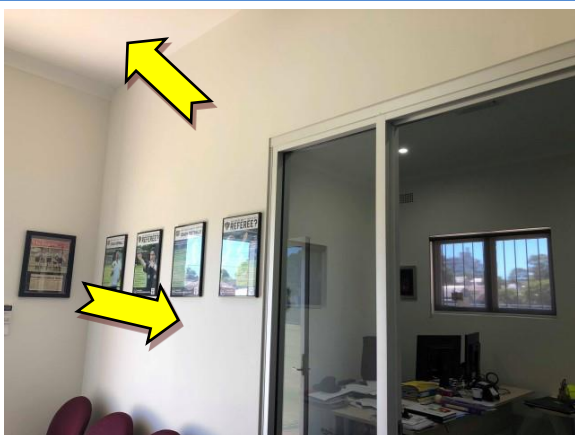
**Photo 11.** Interior, throughout, walls and ceiling – suspected lead-containing cream and white upper coloured paint systems.

Exterior	Throughout	Guttering	Red - upper coloured paint system	Lead Paint - Swab	-	Suspected Positive	-	Low	Good	Low	100 m <sup>2</sup>	Confirm status by quantitative test method, remove flaking sections and over paint with a lead-free paint. Remove under controlled conditions in accordance with AS 4361.2:2017 Guide to hazardous paint management prior to renovation or demolition works.	-	-	-
Interior	Throughout	Walls	Cream - upper coloured paint system	Lead Paint - Swab	-	Suspected Positive	-	Low	Good	Low	300 m <sup>2</sup>	Confirm status by quantitative test method, remove flaking sections and over paint with a lead-free paint. Remove under controlled conditions in accordance with AS 4361.2:2017 Guide to hazardous paint management prior to renovation or demolition works.	-	-	11
Interior	Throughout	Ceiling	White - upper coloured paint system	Lead Paint - Swab	-	Suspected Positive	-	Low	Good	Low	30 m <sup>2</sup>	Confirm status by quantitative test method, remove flaking sections and over paint with a lead-free paint. Remove under controlled conditions in accordance with AS 4361.2:2017 Guide to hazardous paint management prior to renovation or demolition works.	-	-	11

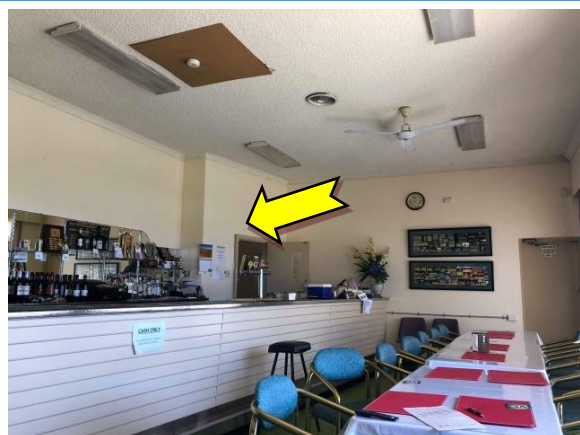
**Photo 12.** Interior, events room and bar area, walls – suspected lead-containing yellow upper paint system.

Interior	Events room & bar area	Walls	Yellow - upper coloured paint system	Lead Paint - Swab	-	Suspected Positive	-	Low	Good	Low	80 m <sup>2</sup>	Confirm status by quantitative test method, remove flaking sections and over paint with a lead-free paint. Remove under controlled conditions in accordance with AS 4361.2:2017 Guide to hazardous paint management prior to renovation or demolition works.	-	-	12
Exterior	Back of house	Air conditioning unit	Unknown refrigerant	Ozone Depleting Substances	-	Suspected Positive	-	-	-	-	1 unit	No data was visible at the time of the assessment due to worn out label. Confirm status of suspected ozone depleting substances identified in the assessment.	-	-	13
Interior	Canterbury soccer football office	Ceiling space	-	-	No access	-	-	-	-	-	-	No access at the time of the assessment.	-	-	-
Interior	Bar area, behind bar	Ceiling space	-	-	No access	-	-	-	-	-	-	No access at the time of the assessment.	-	-	-

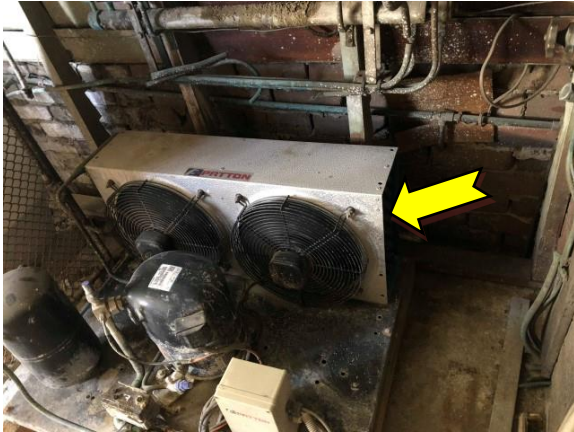
**Photo 13.** Exterior, back of house area, unknown refrigerant – suspected ODS-containing refrigerant gas.

- One suspected ODS-containing air conditioning unit was located to the exterior of the back of house area.

- If the ozone depleting substances identified on-site unit require removal they should be appropriately decanted and disposed of by a licensed contractor in accordance with the *Ozone Protection and Synthetic Greenhouse Gas Management Amendment Regulation 2017* as amended from time to time.
- In accordance with the Commonwealth Ozone Protection Legislation, Prensa recommends, in line with Australia's commitment to phase out ODS-containing substances that units which are required to be replaced due to their age, damage or functionality, have their ODS-containing refrigerants replaced with a non-ODS alternative such as R410A.
- It is important to note that, if a system which utilises ODS-refrigerants is in good working order, there is no need to transition to an alternative refrigerant/system (until 2029).
