Hazardous Building Materials Assessment Ashfield Park Bowling Club Orpington Street and Parramatta Road, Ashfield NSW 2131

Inner West Council
March 2018

Job No.: 57722-016

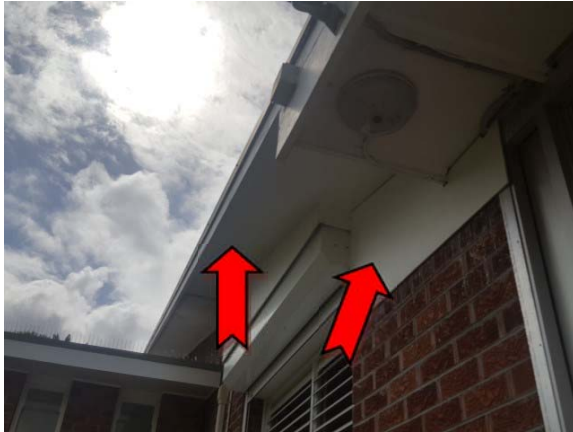
Photo 1. Exterior, throughout, eaves & fascia – suspected asbestos-containing fibre cement sheeting.

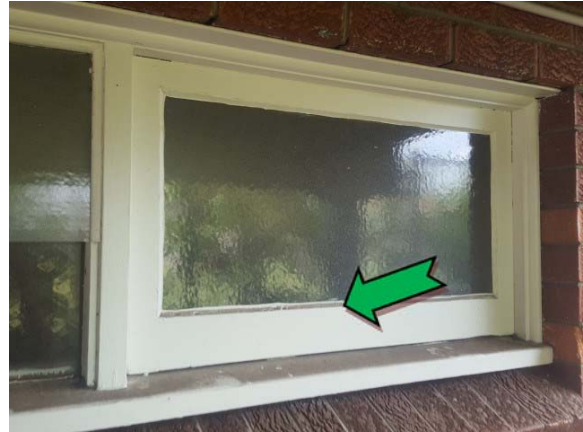
Photo 2. Exterior, throughout, window frames – non asbestos-containing window caulking.

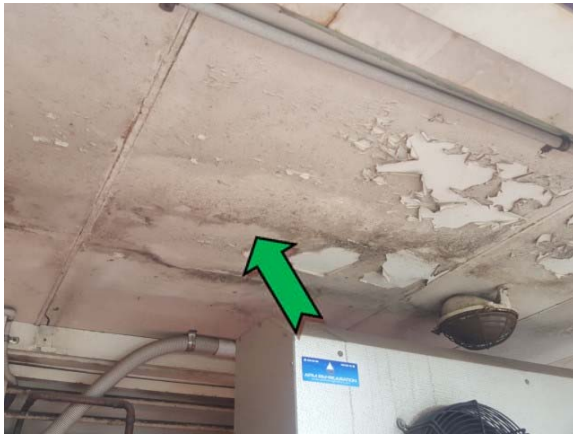
Photo 3. Exterior, north-west elevation, bin area, throughout, ceiling – non asbestos-containing fibre cement sheeting.

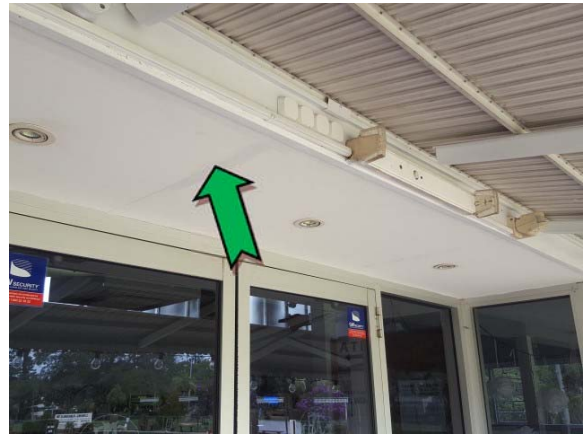
Photo 4. Exterior, main entrance, awning, throughout – non asbestos-containing fibre cement sheeting.

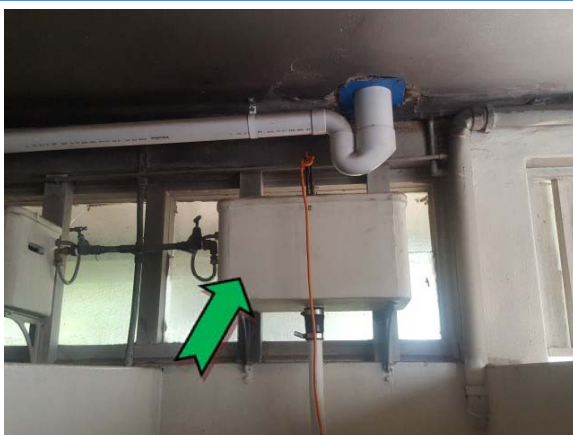
Photo 5. Interior, ground floor, toilet, cistern – non asbestos-containing moulded fibre cement.

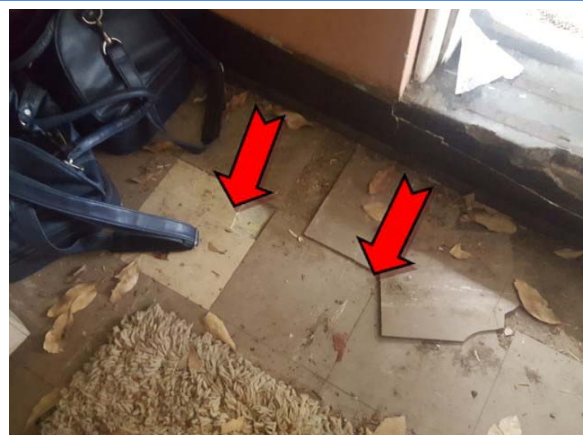
Photo 6. Interior, ground floor, bowls storage room, beige and white floor coverings – asbestos-containing vinyl floor tiles.

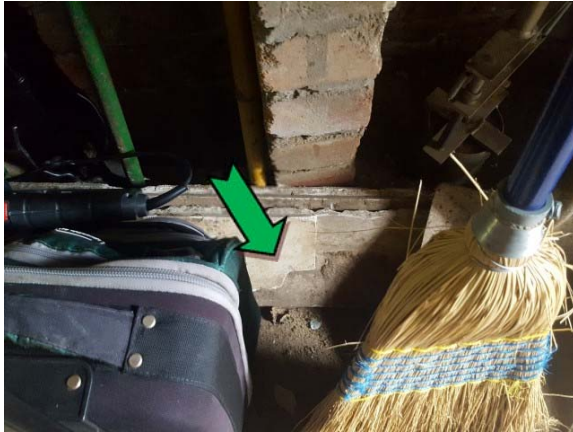
Photo 7. Interior, ground floor, storage area, redundant panels – non asbestos-containing fibre cement sheeting.

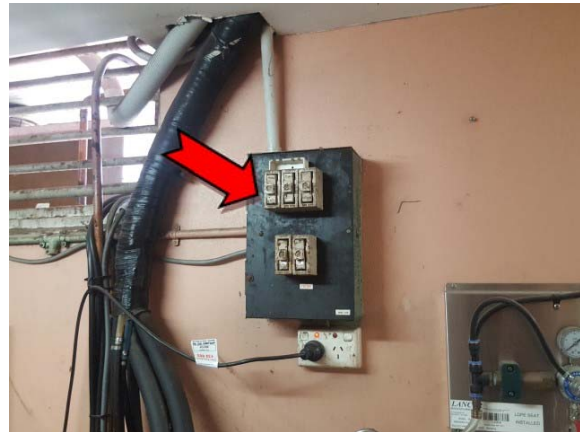
Photo 8. Interior, ground floor, rear storage area, electrical backing board – suspected asbestos-containing bituminous backing board.

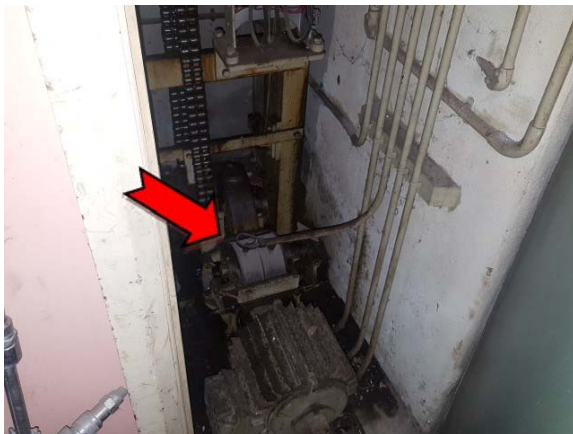
Photo 9. Interior, ground floor, lift motor – suspected asbestos-containing friction pads.

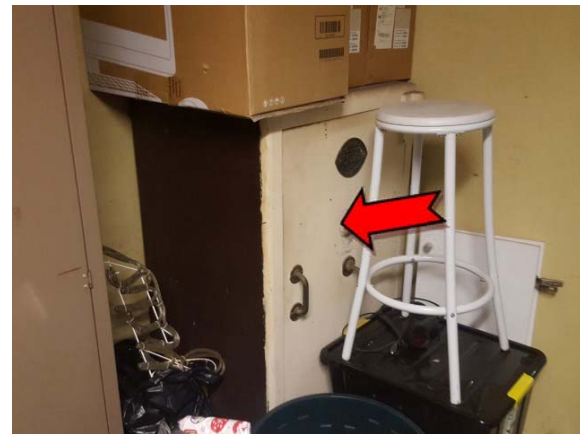
Photo 10. Interior, ground floor, rear storage area, safe – suspected asbestos-containing insulation material.

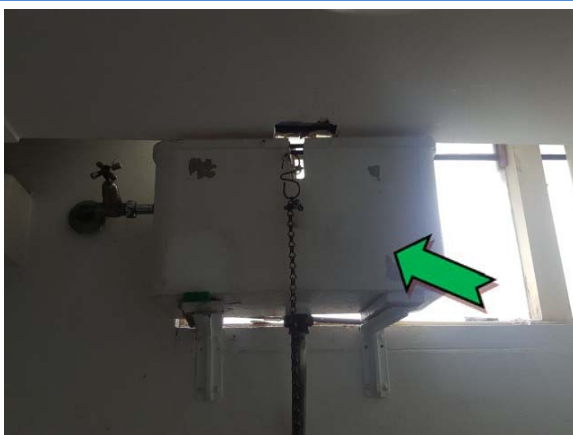
Photo 11. Interior, ground level, locker area, toilets, cistern – assumed non asbestos-containing moulded fibre cement.

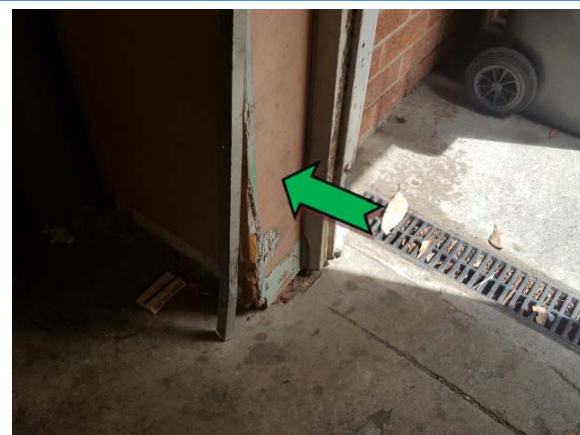
Photo 12. Interior, ground floor, doorway to exterior bin area, infill panels – non asbestos-containing fibre cement sheeting.

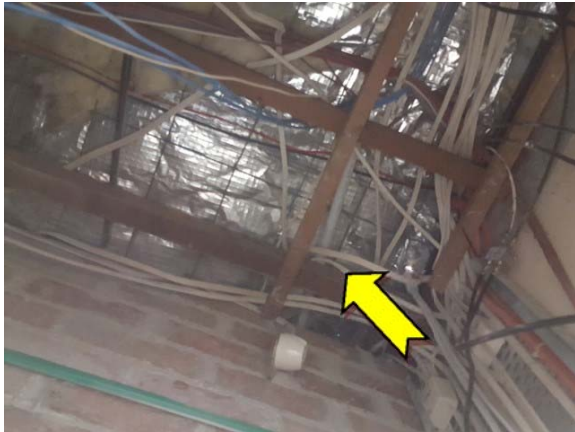
Photo 13. Interior, level one, throughout – suspected SMF sarking insulation.

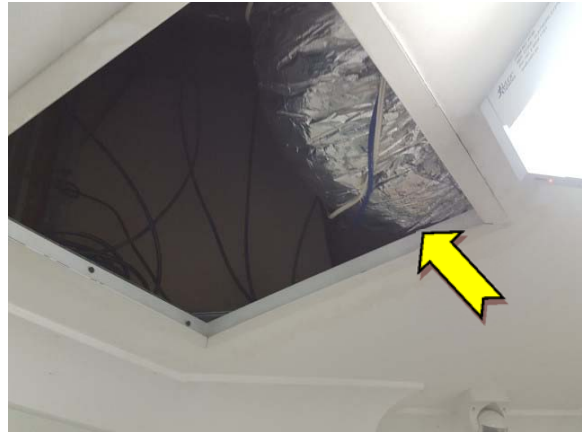
Photo 14. Interior, level one, throughout, flexible ductwork – suspected SMF internal insulation.

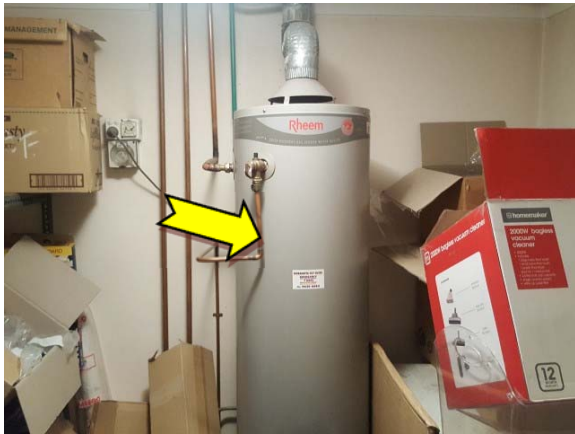
Photo 15. Interior, ground floor, east elevation, office, hot water heater – suspected SMF internal insulation.

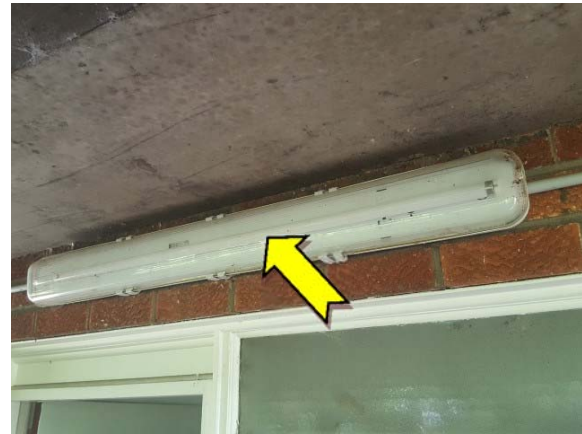
Photo 16. Exterior, throughout, single tube fluorescent light fitting – suspected PCB-containing capacitor.

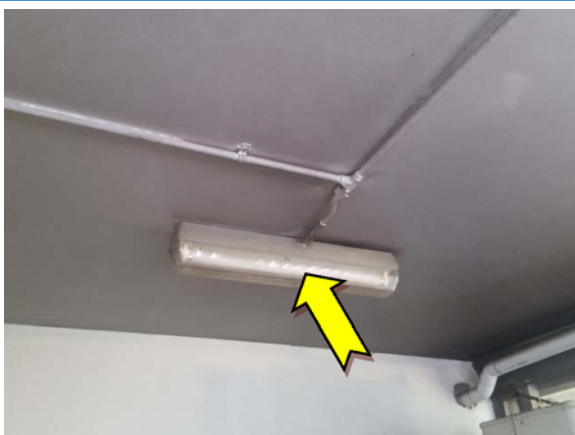
Photo 17. Interior, throughout, single tube fluorescent light fitting – suspected PCB-containing capacitor.

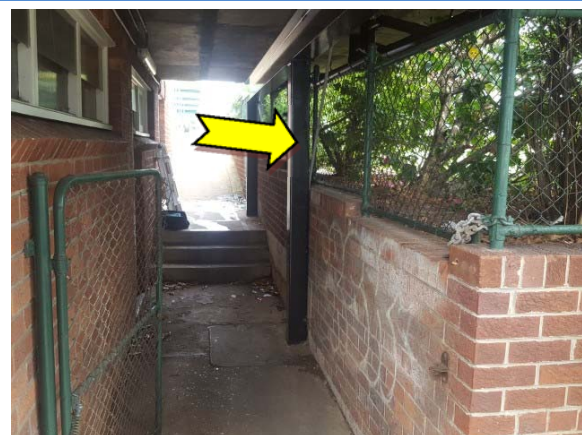
Photo 18. Exterior, throughout, features – suspected lead-containing green upper paint system.

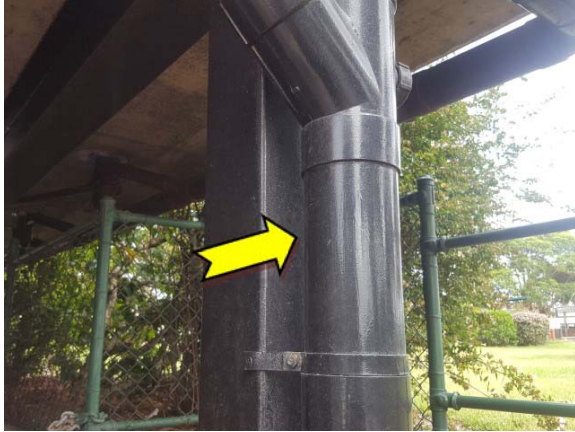
Photo 19. Exterior, throughout, features – suspected lead-containing black upper paint system.

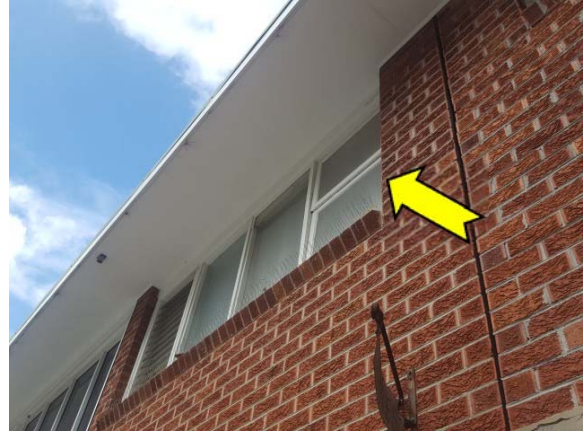
Photo 20. Exterior, throughout, eaves and window frames – suspected lead-containing white upper paint system.

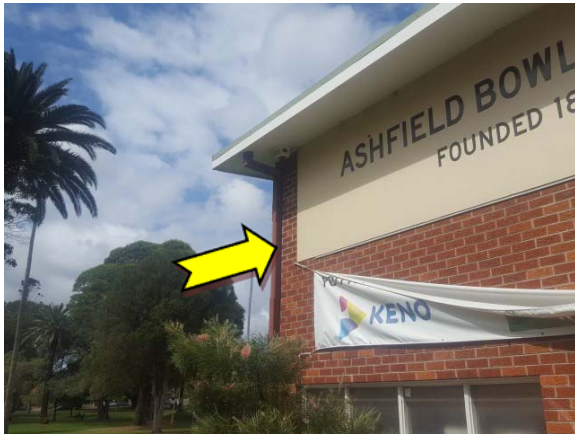
Photo 21. Exterior, throughout, pipework and guttering – suspected lead-containing red upper paint system.

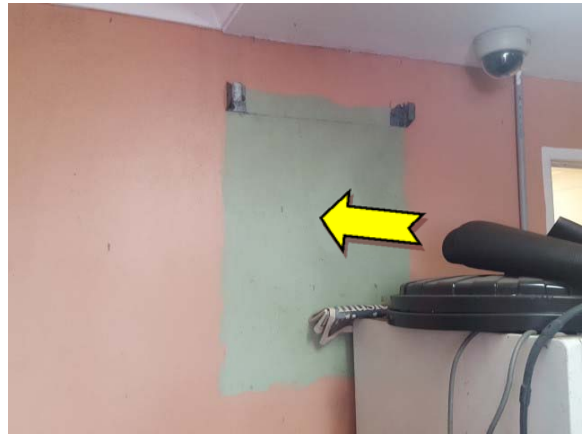
Photo 22. Interior, throughout, walls – suspected lead-containing lower green paint system.

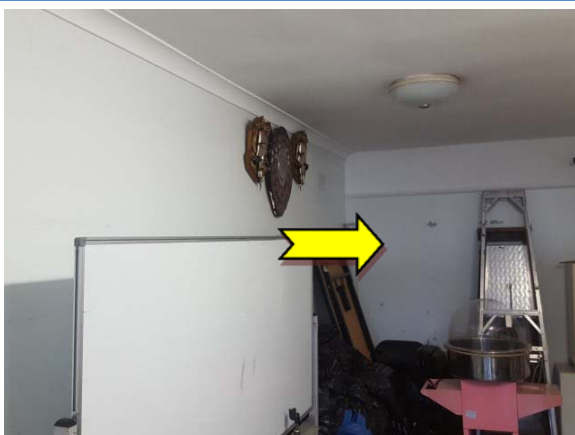
Photo 23. Interior, locker room, throughout, walls – suspected lead-containing blue upper paint system.

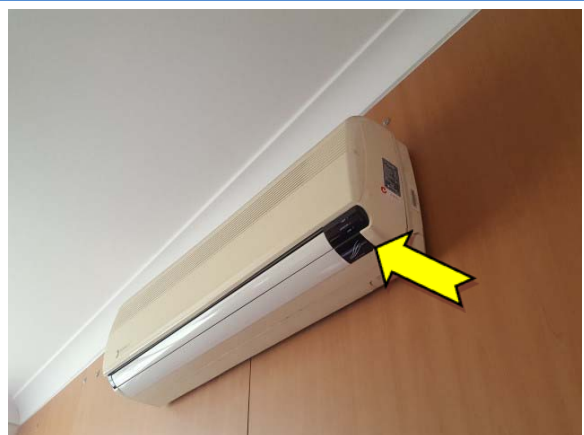
Photo 24. Interior, level 1, office, air conditioning unit, unknown refrigerant – suspected ozone depleting substance.

- One ODS-containing air conditioning unit was suspected to contain ODS refrigerant gas.

- If the ozone depleting substances identified on-site unit require removal they should be appropriately decanted and disposed of by a licensed contractor in accordance with the *Ozone Protection and Synthetic Greenhouse Gas Management Amendment Regulation 2017* as amended from time to time.
- In accordance with the Commonwealth Ozone Protection Legislation, Prensa recommends, in line with Australia's commitment to phase out ODS-containing substances that units which are required to be replaced due to their age, damage or functionality, have their ODS-containing refrigerants replaced with a non-ODS alternative such as R410A.
- It is important to note that, if a system which utilises ODS-refrigerants is in good working order, there is no need to transition to an alternative refrigerant/system (until 2029).
