Hazardous Building Materials Assessment

Jack Shanahan Reserve Toilets

Inner West Council
March 2018

Job No.: 57722-006

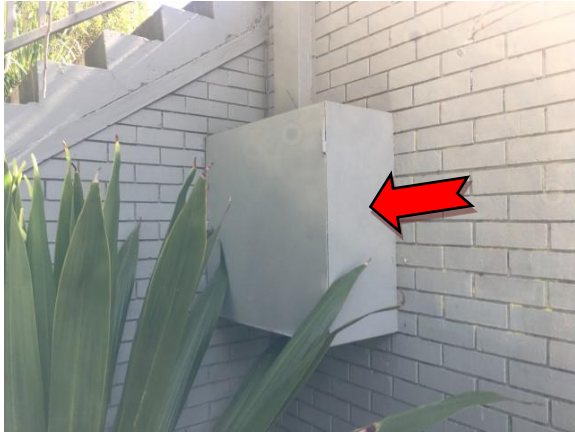
Photo 1. Ground level, exterior, western elevation – suspected asbestos containing bituminous electrical backing board.

- Non-friable asbestos was assumed in the form of a bituminous backing board within the electrical box located on the western elevation of the building.

- ACM that may be disturbed should be removed prior to the commencement of any works.
- When asbestos removal works are required, the person that commissions the works must ensure that this is undertaken by an appropriately licensed asbestos contractor. The asbestos removal works must be conducted under controlled asbestos removal working conditions.

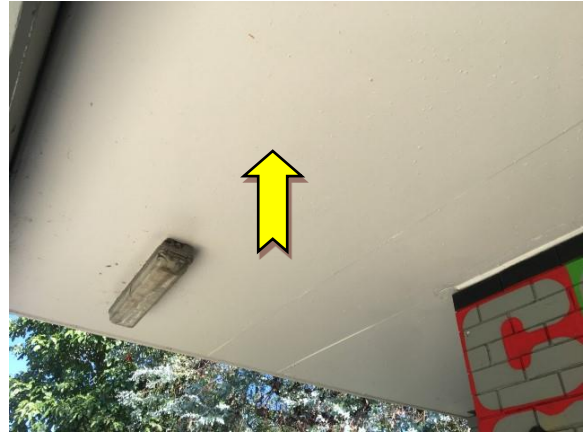
Photo 2. Exterior, throughout awning – suspected lead-containing white upper paint systems.

- LCP was suspected in the form of white upper paint systems located to interior walls and the exterior awning.
- LCP was also suspected in the form of grey upper and green lower paint systems to exterior wall.

- The *LeadCheck* paint swab method can detect lead in paint at concentrations of 0.5% and above, and may indicate lead in some paint films as low as 0.2%. As paint with a lead content greater than 0.1% by dry weight is now considered to be lead-containing, Prensa recommends confirming status of suspected LCP identified during the assessment by quantitative test method.

- The safest method of dealing with LCP is to replace or remove the items in their entirety that have LCP on them and replace them with new items that do not contain lead. This allows the items to be disposed of as regular building or demolition unsegregated waste in accordance with the NSW Environment Protection Authority (EPA) *Waste Classification Guidelines 2014 Part 1 – Classifying Waste*. The advantage of this method is the reduction in labour requirements to remove the lead paint and also this reduces the risk to workers from exposure to lead dust or fumes. If the removal of the LCP or coatings is the preferred or required option this may generate significant amounts of potential hazardous waste. This waste must be removed, collected and disposed of by an appropriately licensed contractor under controlled conditions that minimises the release to air, water and soil. Disposal of lead waste must be disposed of as hazardous waste at an approved waste facility.

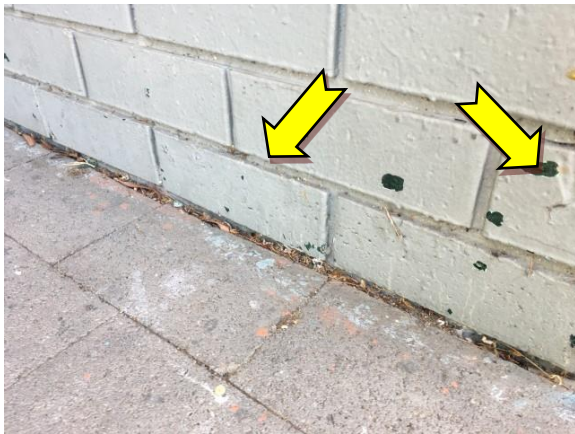
Photo 3. Exterior, throughout walls – suspected lead-containing grey upper and green lower paint systems.

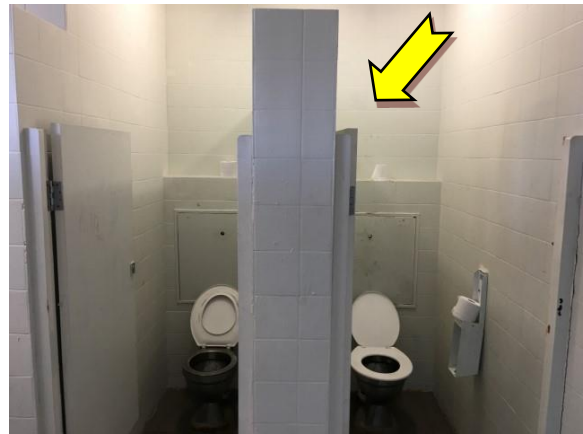
Photo 4. Interior, throughout walls– suspected lead-containing white upper paint systems.

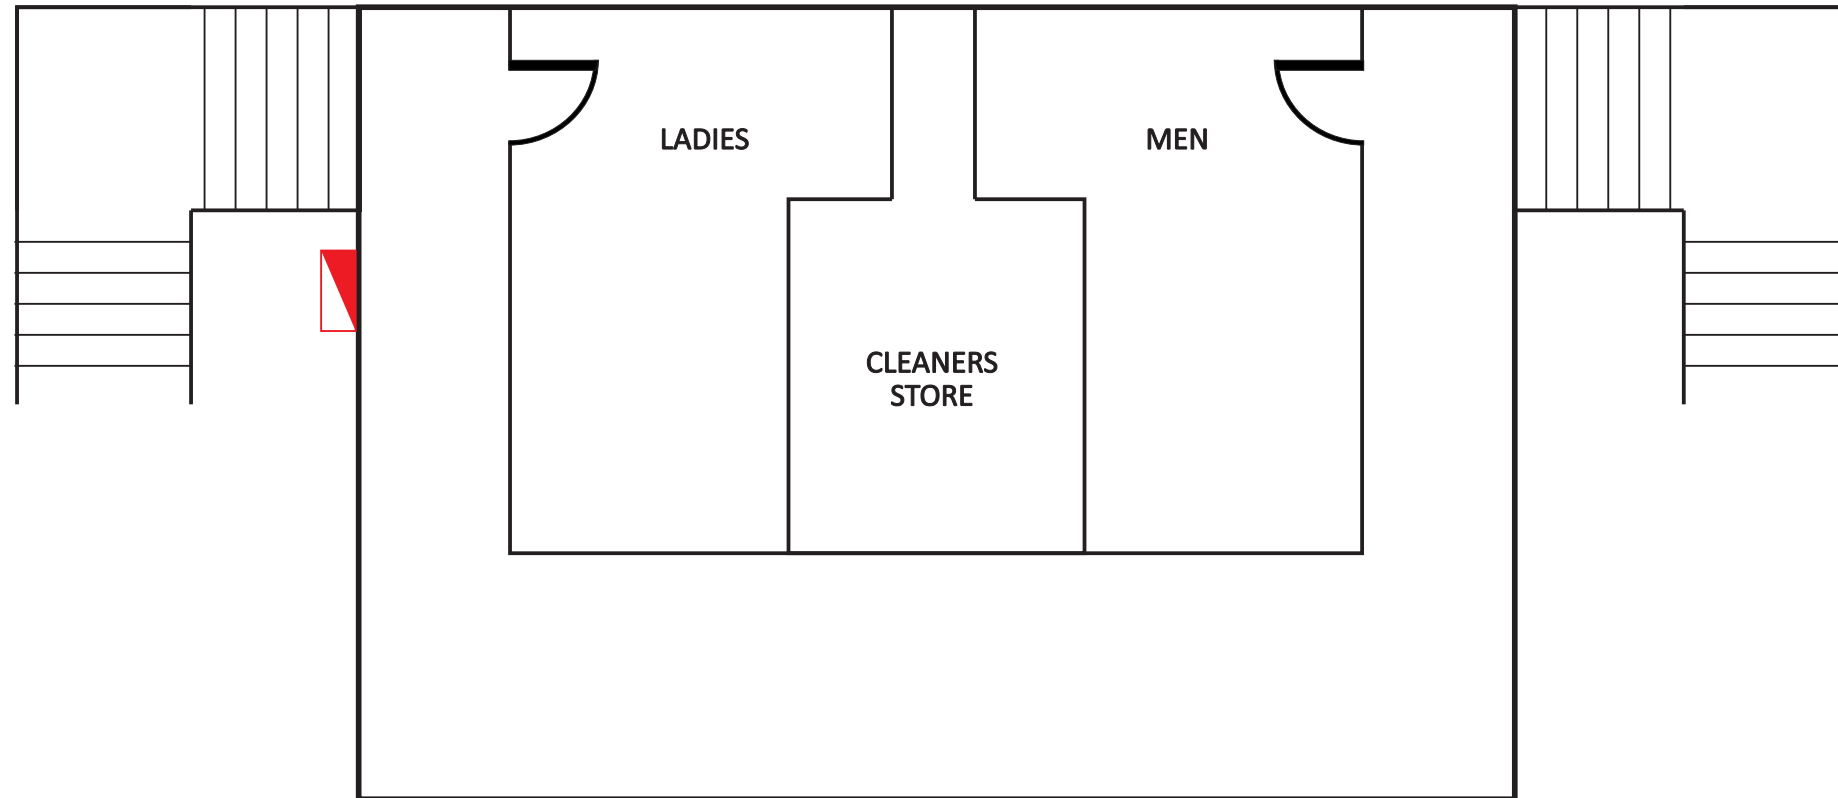
Jack Shanahan Reserve Toilets, Dulwich Hill - Ground Level

Electrical Backing Board
