Hazardous Building Materials Assessment

Deborah Little Early Learning Centre – Rear Building

1 MacArthur Parade
Dulwich Hill NSW 2203

Inner West Council
March 2018

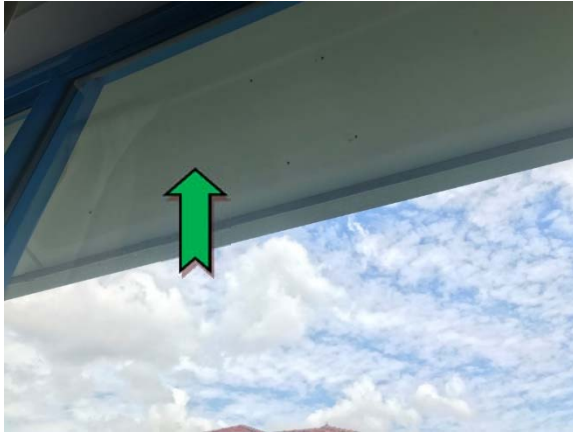
Photo 1. Exterior, level 1, north elevation, eaves – non asbestos-containing fibre cement sheeting.

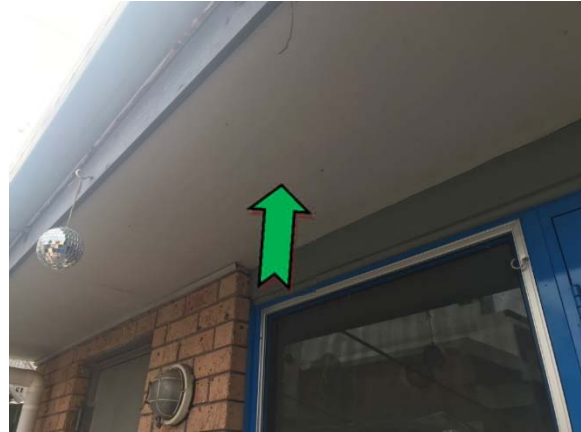
Photo 2. Exterior, ground level, north elevation, eaves – non asbestos-containing fibre cement sheeting.

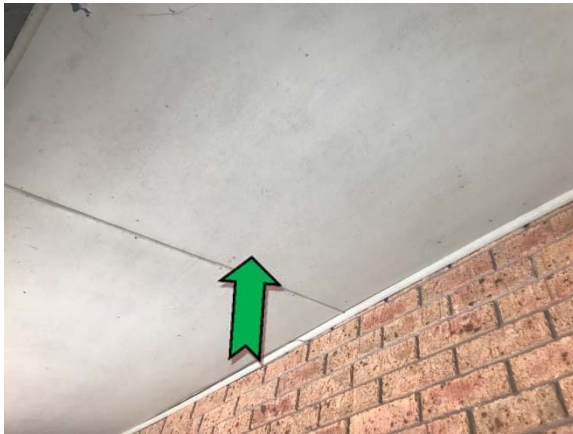
Photo 3. Exterior, ground level, south-east elevation, eaves – assumed non asbestos-containing fibre cement sheeting.

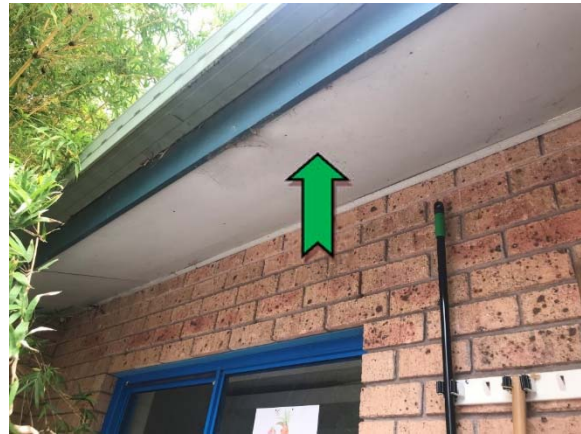
Photo 4. Exterior, ground level, south elevation, eaves – assumed non asbestos-containing fibre cement sheeting.

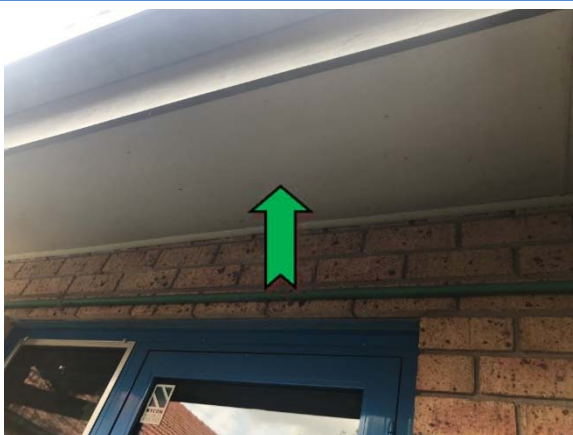
Photo 5. Exterior, ground level, south-west elevation, eaves – assumed non asbestos-containing fibre cement sheeting.

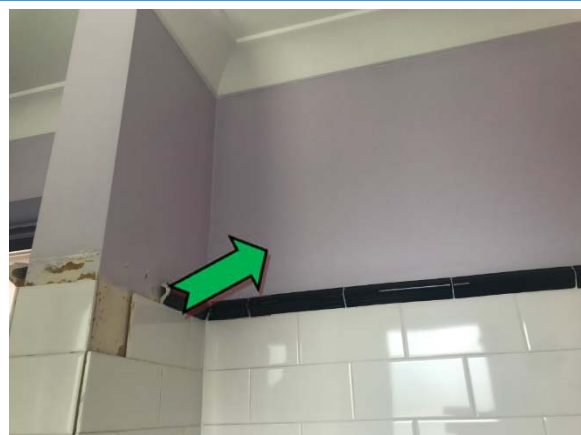
Photo 6. Interior, level 1, bathroom, walls – assumed non asbestos-containing fibre cement sheeting.

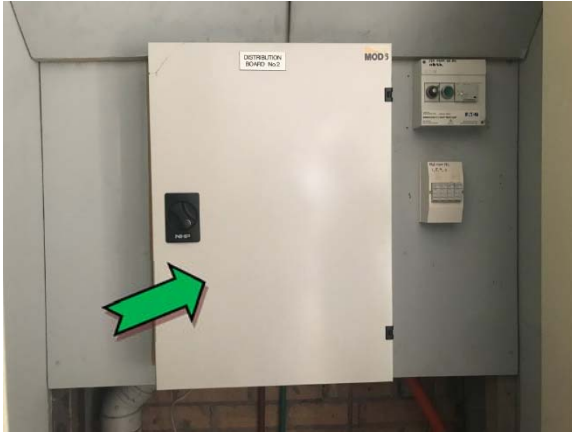
Photo 7. Interior, ground level, electrical cupboard – suspected non asbestos-containing bituminous backing board.

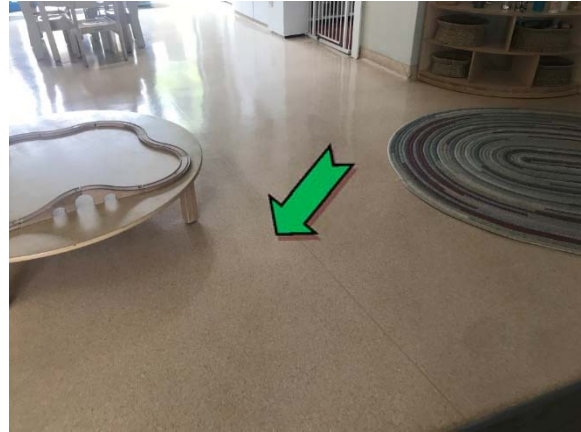
Photo 8. Interior, ground level, playroom, brown floor coverings – suspected non asbestos-containing sheet vinyl.

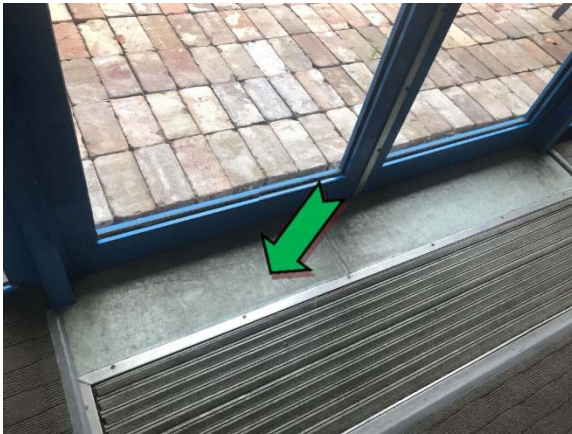
Photo 9. Interior, ground level, playroom, blue floor coverings – suspected non asbestos-containing sheet vinyl.

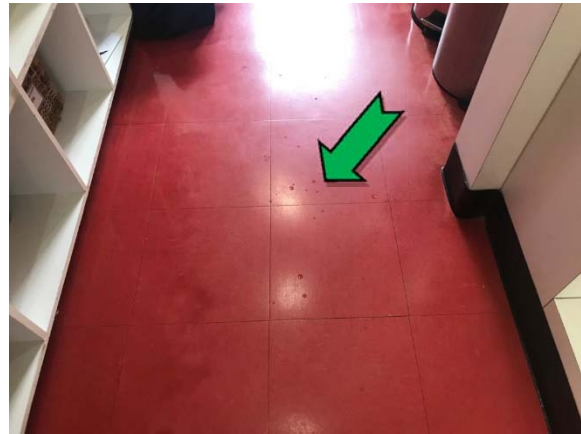
Photo 10. Interior, ground level, change room, red floor coverings – non asbestos-containing floor tiles.

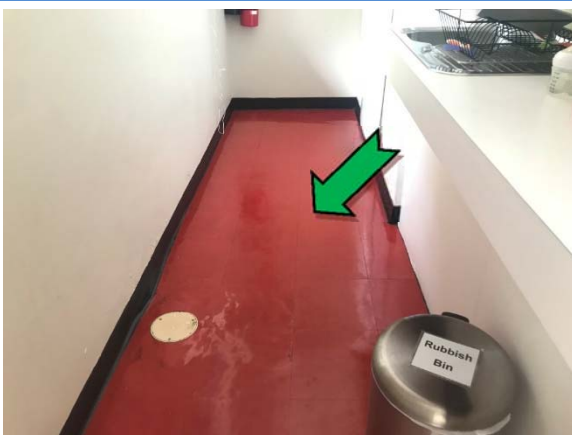
Photo 11. Interior, ground level, office, red floor coverings – assumed non asbestos-containing floor tiles.

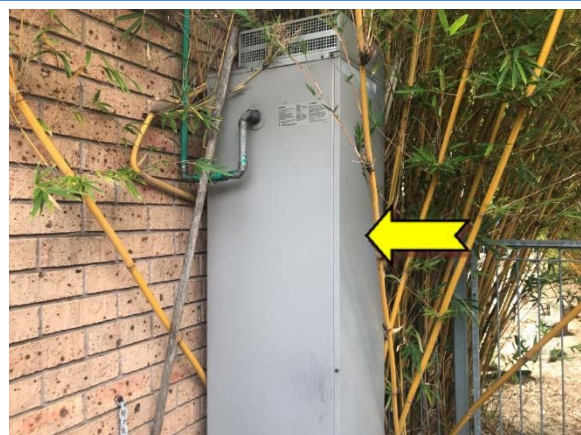
Photo 12. Exterior, south-west elevation, hot water heater – suspected SMF internal insulation.

- Suspected SMF internal insulation was suspected within the hot water heater to the south-west exterior of the building.
- Suspected SMF sarking insulation was observed within the roof space on level 1 and the ceiling space on the ground level.

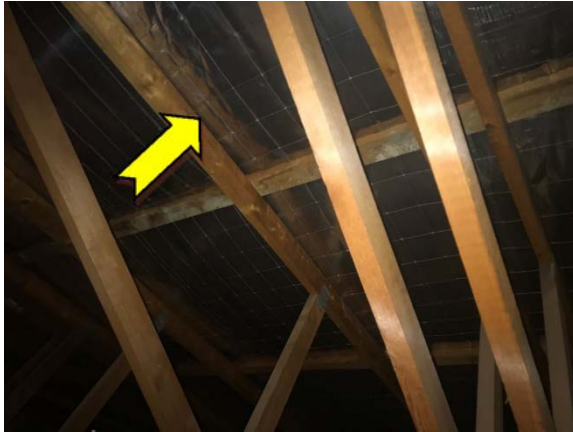
Interior, Level 1	Roof space	Insulation	Sarking insulation	SMF	-	Suspected Positive	Bonded	Low	Good	Low	60 m ²	Maintain in current condition if to remain in-situ. Remove under controlled SMF conditions as per the Code of Practice for the Safe Use of Synthetic Mineral Fibres [NOHSC: 2006 (1990)].	-	-	13

Photo 13. Interior, level 1, roof space – suspected SMF sarking insulation.

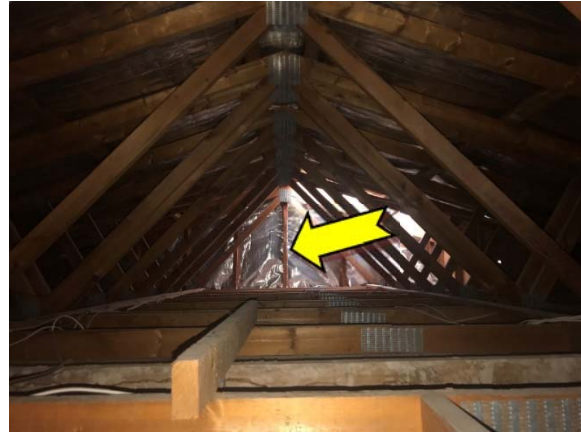
Photo 14. Interior, level 1, roof space, gable end – suspected SMF sarking insulation.

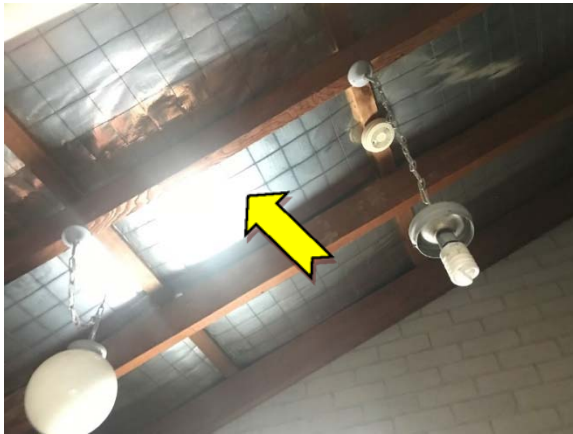
Photo 15. Interior, ground level, storeroom, ceiling space – suspected SMF sarking insulation

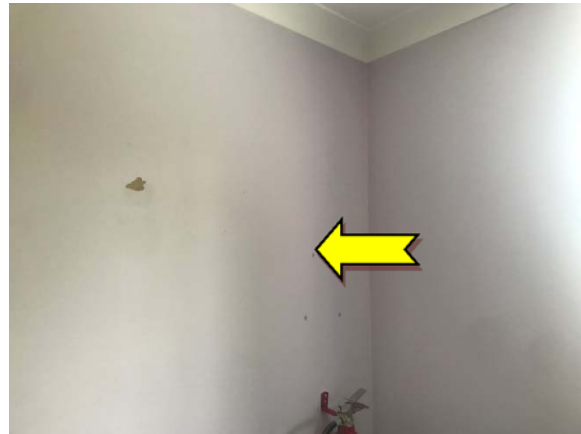
Photo 16. Interior, level 1, throughout, walls – suspected lead-containing purple upper paint system.

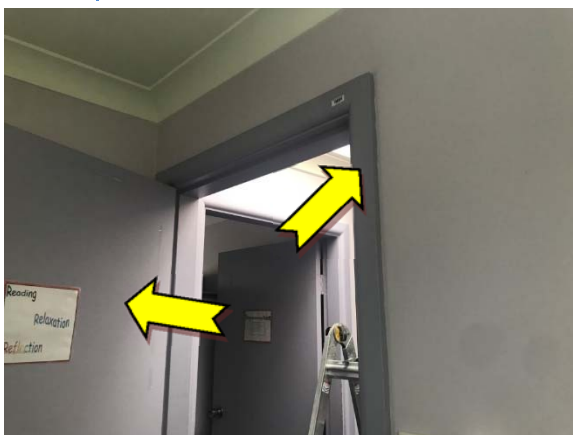
Photo 17. Interior, level 1, throughout, doors, window & door frames – suspected lead-containing dark purple upper paint system.

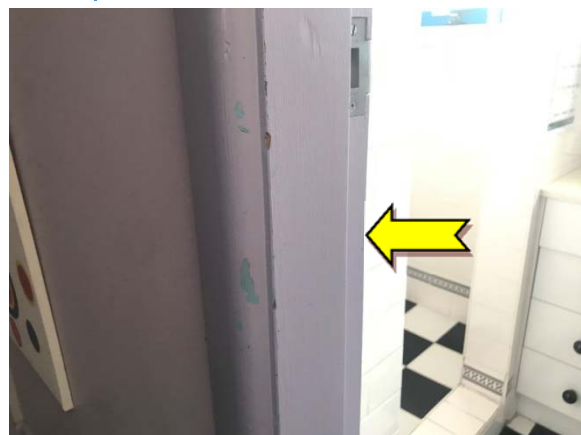
Interior, Level 1	Throughout	Walls	Purple (light) - upper coloured paint system	Lead Paint - Swab	-	Suspected Positive	-	Low	Good	Low	120 m ²	Confirm status by quantitative test method, maintain in current condition, over paint with a lead-free paint as part of ongoing maintenance. Remove under controlled conditions in accordance with AS 4361.2:2017 Guide to hazardous paint management prior to renovation or demolition works.	-	-	16
Interior, Level 1	Throughout	Windows & door frames	Purple (dark) - upper coloured paint system	Lead Paint - Swab	-	Suspected Positive	-	Low	Good	Low	20 m	Confirm status by quantitative test method, maintain in current condition, over paint with a lead-free paint as part of ongoing maintenance. Remove under controlled conditions in accordance with AS 4361.2:2017 Guide to hazardous paint management prior to renovation or demolition works.	-	-	17
Interior, Level 1	Throughout	Door frame	Blue - lower coloured paint system	Lead Paint - Swab	-	Suspected Positive	-	Low	Good	Low	20 m	Confirm status by quantitative test method, maintain in current condition, over paint with a lead-free paint as part of ongoing maintenance. Remove under controlled conditions in accordance with AS 4361.2:2017 Guide to hazardous paint management prior to renovation or demolition works.	-	-	18

Photo 18. Interior, level 1, throughout, door frames – suspected lead-containing blue lower paint system.

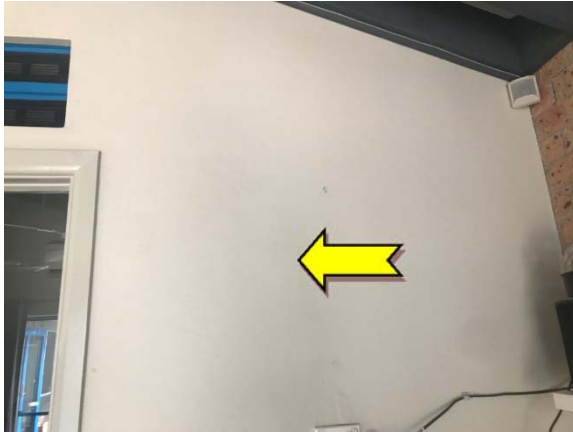
Photo 19. Interior, ground level, throughout, walls – suspected lead-containing light green paint system.

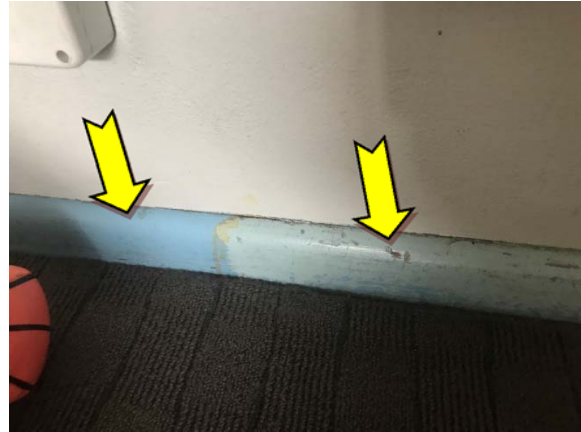
Interior, ground level	Throughout	Walls	Green (light) - upper coloured paint system	Lead Paint - Swab	-	Suspected Positive	-	Low	Good	Low	150 m ²	Confirm status by quantitative test method, maintain in current condition, over paint with a lead-free paint as part of ongoing maintenance. Remove under controlled conditions in accordance with AS 4361.2:2017 Guide to hazardous paint management prior to renovation or demolition works.	-	-	19
Interior, ground level	Throughout	Skirting board	Blue (dark) - upper coloured paint system	Lead Paint - Swab	-	Suspected Positive	-	Low	Good	Low	10 m	Confirm status by quantitative test method, maintain in current condition, over paint with a lead-free paint as part of ongoing maintenance. Remove under controlled conditions in accordance with AS 4361.2:2017 Guide to hazardous paint management prior to renovation or demolition works.	-	-	20
Interior, ground level	Throughout	Skirting board	Blue (light) - lower coloured paint system	Lead Paint - Swab	-	Suspected Positive	-	Low	Good	Low	10 m	Confirm status by quantitative test method, maintain in current condition, over paint with a lead-free paint as part of ongoing maintenance. Remove under controlled conditions in accordance with AS 4361.2:2017 Guide to hazardous paint management prior to renovation or demolition works.	-	-	20

Photo 20. Interior, ground level, throughout skirting board – suspected lead-containing light blue lower paint system & dark blue upper paint system.
