# Hazardous Building Materials Assessment

## Hoskins Park Toilets

531-565 Pigott Street  
Dulwich Hill NSW 2203

Inner West Council  
March 2018

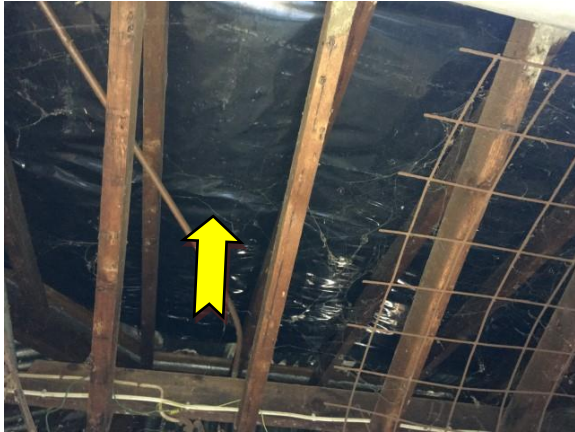
**Photo 1.** Interior, throughout, roof space – Suspected SMF sarking insulation.

- Suspected SMF sarking insulation was present throughout the roof.

- SMF materials that are likely to be disturbed during any proposed demolition/refurbishment works should be handled in accordance with the *Code of Practice for the Safe Use of Synthetic Mineral Fibres* [NOHSC:2006(1990)]. If these materials are impacted upon by accident or by pre-planned works, the Inner West Council must be informed via the contact detailed within Section 7: *Accidental Disturbance of Known or Suspected Hazardous Building Materials*. Following disturbance, inspection by a competent person should be undertaken.

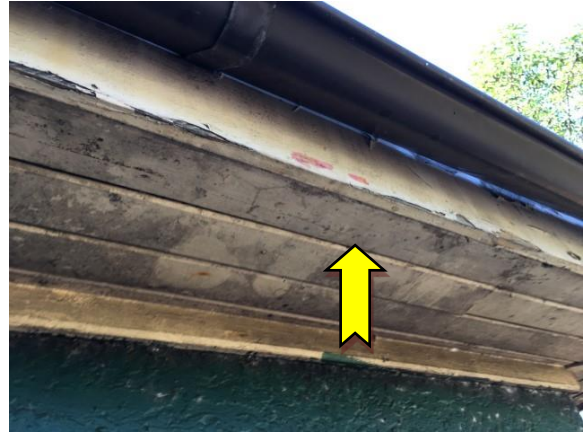
**Photo 2.** Exterior, throughout, eaves – positive lead-containing cream upper coloured paint systems.

- LCP was identified in cream upper paint systems to the eaves around the building.
- LCP was suspected in green upper coloured paint systems paint to the exterior walls of the building.

- Remove flaking lead containing paint to the eaves throughout the building in accordance with AS4361.2-2017 Guide to Hazardous Paint Management and relevant legislation.

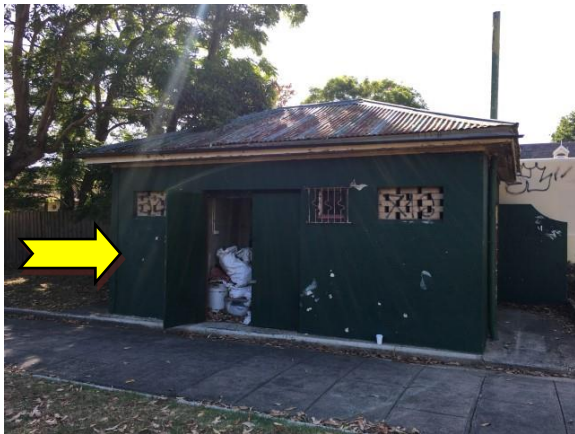
Exterior, ground level	Throughout	Walls	Green - upper coloured paint system	Lead Paint - Swab	-	Suspected Positive	-	Low	Fair	Low	80 m <sup>2</sup>	Confirm status by quantitative test method, maintain in current condition, over paint with a lead-free paint as part of ongoing maintenance. Remove under controlled conditions in accordance with AS 4361.2:2017 Guide to hazardous paint management prior to renovation or demolition works.	-	-	3
Throughout	-	-	-	Ozone Depleting Substances	-	-	-	-	-	-	-	No suspect ODS's identified at the time of the assessment.	-	-	-
Interior, ground level	Female toilet	-	-	-	-	-	-	-	-	-	-	No access at the time of the assessment.	-	-	-
Interior, ground level	Male toilet	-	-	-	-	-	-	-	-	-	-	No access at the time of the assessment.	-	-	-

**Photo 3.** Exterior, throughout, walls – suspected lead-containing green upper coloured paint systems.

- The *LeadCheck* paint swab method can detect lead in paint at concentrations of 0.5% and above, and may indicate lead in some paint films as low as 0.2%. As paint with a lead content greater than 0.1% by dry weight is now considered to be lead-containing, Prensa recommends confirming status of suspected LCP identified during the assessment by quantitative test method.
