# Hazardous Building Materials Assessment Arlington Recreational Reserve – Kiosk Williams Parade Dulwich Hill NSW 2203

Inner West Council  
March 2018

Job No.: 57722-045

Count ID: CID: 13

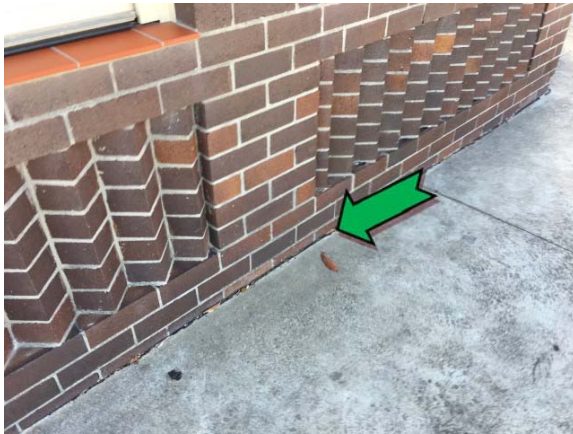
**Photo 1.** Exterior, throughout, ground, expansion joint – non asbestos-containing construction mastic.

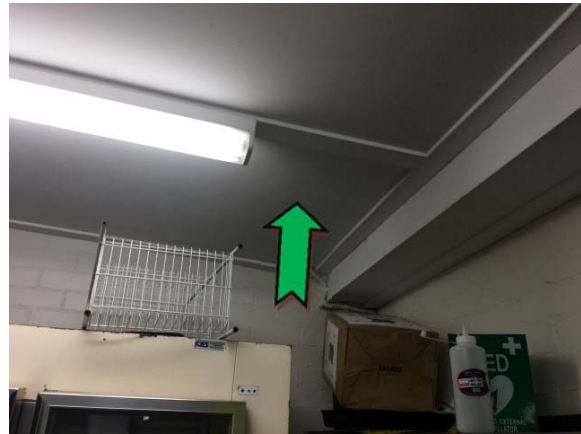
**Photo 2.** Interior, throughout, ceiling – non asbestos-containing fibre cement sheeting.

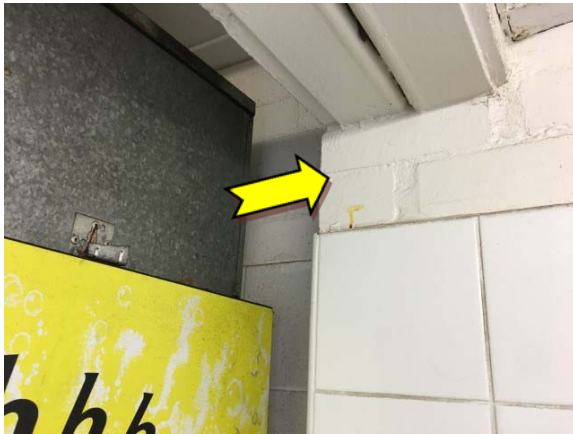
**Photo 3.** Interior, throughout, walls – suspected lead-containing cream upper paint system.

- LCP was suspected in the form of cream and white upper coloured paint systems to the internal walls and ceiling throughout the kiosk.

- The *LeadCheck* paint swab method can detect lead in paint at concentrations of 0.5% and above, and may indicate lead in some paint films as low as 0.2%. As paint with a lead content greater than 0.1% by dry weight is now considered to be lead-containing, Prensa recommends confirming status of suspected LCP identified during the Assessment by quantitative test method.

- The safest method of dealing with LCP is to replace or remove the items in their entirety that have LCP on them and replace them with new items that do not contain lead. This allows the items to be disposed of as regular building or demolition unsegregated waste in accordance with the NSW Environment Protection Authority (EPA) *Waste Classification Guidelines 2014 Part 1 – Classifying Waste*. The advantage of this method is the reduction in labour requirements to remove the lead paint and also this reduces the risk to workers from exposure to lead dust or fumes. If the removal of the LCP or coatings is the preferred or required option this may generate significant amounts of potential hazardous waste. This waste must be removed, collected and disposed of by an appropriately licensed contractor under controlled conditions that minimises the release to air, water and soil. Disposal of lead waste must be disposed of as hazardous waste at an approved waste facility.

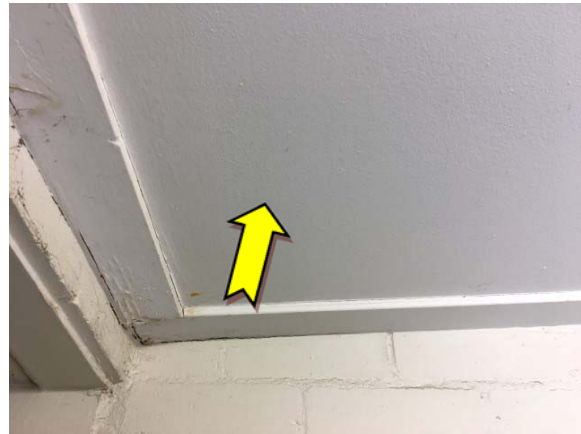
Interior	Throughout	Ceiling	White - upper coloured paint system	Lead Paint - Swab	-	Suspected Positive	-	Low	Good	Low	30 m <sup>2</sup>	Confirm status by quantitative test method, maintain in current condition, over paint with a lead-free paint as part of ongoing maintenance. Remove under controlled conditions in accordance with AS 4361.2:2017 Guide to hazardous paint management prior to renovation or demolition works.	-	-	4
Throughout	-	-	-	Ozone Depleting Substances	-	-	-	-	-	-	-	No suspect ODS's identified at the time of the assessment.	-	-	-
Roof Space	-	-	-	-	-	-	-	-	-	-	-	No access at the time of the assessment.	-	-	-

**Photo 4.** Interior, throughout, ceiling – suspected lead-containing white upper paint system.
