Hazardous Building Materials Assessment Arlington Recreational Reserve – Public Toilets Williams Parade Dulwich Hill NSW 2203

Inner West Council
March 2018

Job No.: 57722-043

Count ID: CID: 11

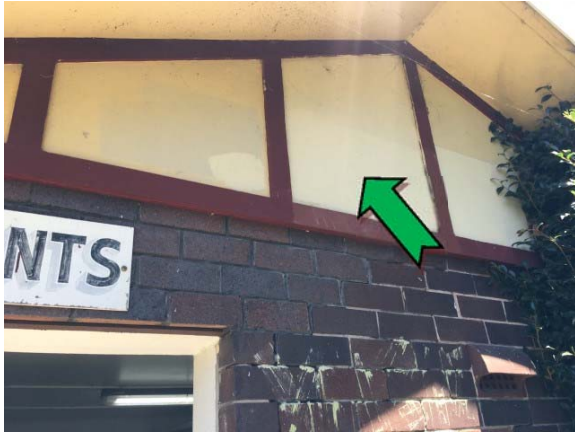
Photo 1. Exterior, male toilets, gable end – non asbestos-containing fibre cement sheeting.

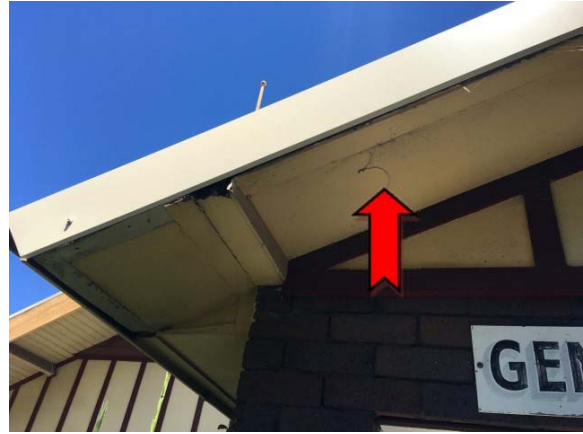
Photo 2. Exterior, male toilets, eaves – asbestos-containing fibre cement sheeting.

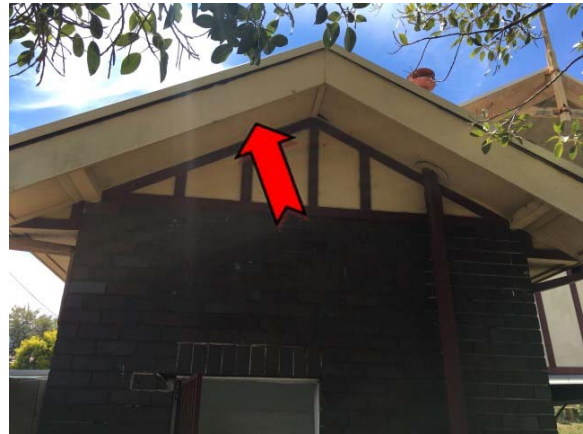
Photo 4. Exterior, ladies toilets, eaves – suspected asbestos-containing fibre cement sheeting.

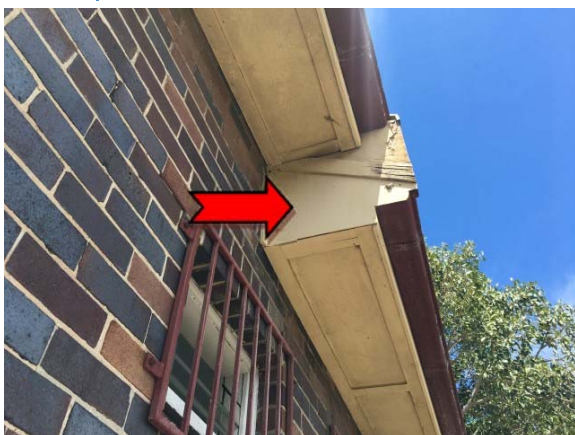
Photo 5. Exterior, ladies toilets, upstand panel – suspected asbestos-containing fibre cement sheeting.

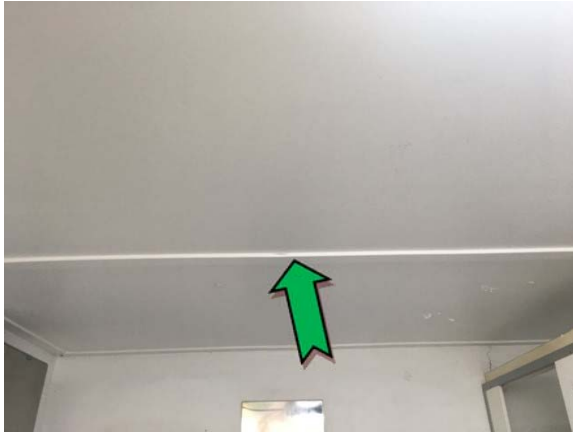
Interior	Ladies toilets	Ceiling	Fibre cement sheeting	Asbestos	57722-043-004	Negative	-	-	-	-	-	-	-	-	-	7
Throughout	-	-	-	SMF	-	-	-	-	-	-	-	No suspect SMF material identified at the time of the assessment.	-	-	-	-
Interior	Male toilets	Fluorescent light fitting - double tube	Capacitor	PCBs	Not sampled: Electrical hazard	Suspected Positive	-	-	-	-	1 unit	PCB-containing capacitors are suspected due to age & appearance of electrical fittings. Remove and dispose of in accordance with the Polychlorinated Biphenyls Management Plan, Revised Edition April 2003.	-	-	-	8
Interior	Female toilets	Fluorescent light fitting - double tube	Capacitor	PCBs	Not sampled: Electrical hazard	Suspected Positive	-	-	-	-	1 unit	PCB-containing capacitors are suspected due to age & appearance of electrical fittings. Remove and dispose of in accordance with the Polychlorinated Biphenyls Management Plan, Revised Edition April 2003.	-	-	-	8

Photo 7. Interior, ladies toilet, ceiling – non asbestos containing fibre cement sheeting.

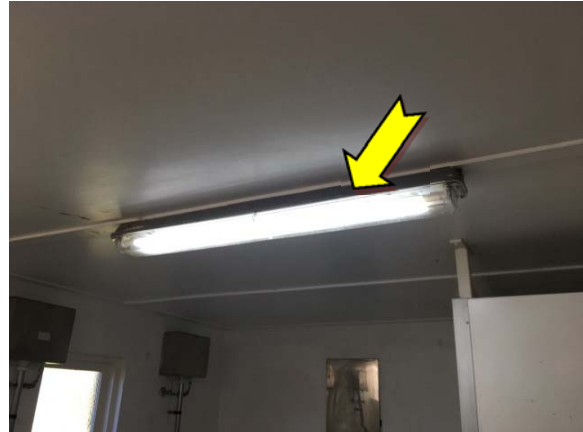
Photo 8. Interior, double tube fluorescent light fitting – suspected PCB-containing capacitor.

- Electrical fittings suspected of containing PCB oil capacitors should be treated as containing PCB oils until such time as evidence suggest otherwise e.g. further assessed.
- Electrical fittings that contain or suspected to contain PCB oil-containing capacitors should be removed as hazardous/regulated waste under controlled working conditions prior to the demolition or refurbishment works in accordance with the *Polychlorinated Biphenyls Management Plan, Revised Edition April 2003*.

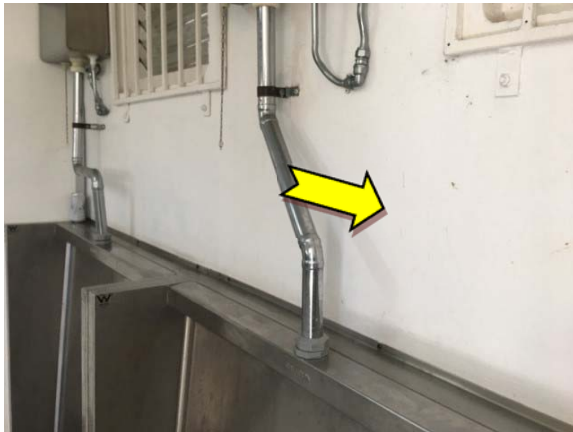
Photo 9. Interior, male toilets, walls – suspected lead-containing white upper paint systems.

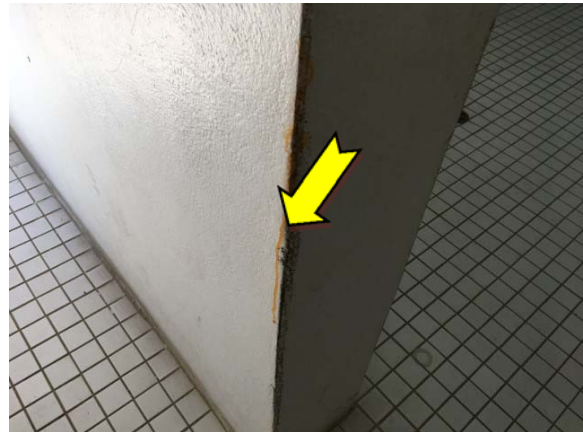
Exterior	Exterior	Throughout	Yellow - upper coloured paint system	Lead Paint - Swab	-	Suspected Positive	-	Low	Good	Low	100 m ²	Confirm status by quantitative test method, maintain in current condition, over paint with a lead-free paint as part of ongoing maintenance. Remove under controlled conditions in accordance with AS 4361.2:2017 Guide to hazardous paint management prior to renovation or demolition works.	-	-	-	-
Interior	Male toilets	Walls	White - upper coloured paint system	Lead Paint - Swab	-	Suspected Positive	-	Low	Good	Low	60 m ²	Confirm status by quantitative test method, maintain in current condition, over paint with a lead-free paint as part of ongoing maintenance. Remove under controlled conditions in accordance with AS 4361.2:2017 Guide to hazardous paint management prior to renovation or demolition works.	-	-	-	9
Interior	Male toilets	Walls	Yellow - lower coloured paint system	Lead Paint - Swab	-	Suspected Positive	-	Low	Good	Low	60 m ²	Confirm status by quantitative test method, maintain in current condition, over paint with a lead-free paint as part of ongoing maintenance. Remove under controlled conditions in accordance with AS 4361.2:2017 Guide to hazardous paint management prior to renovation or demolition works.	-	-	-	10

Photo 10. Interior, male toilets, walls – suspected lead-containing yellow lower paint systems.

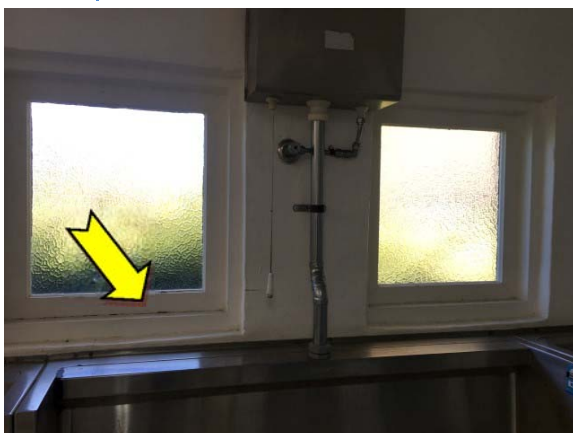
Photo 11. Interior, window frames – suspected lead-containing white upper paint systems.

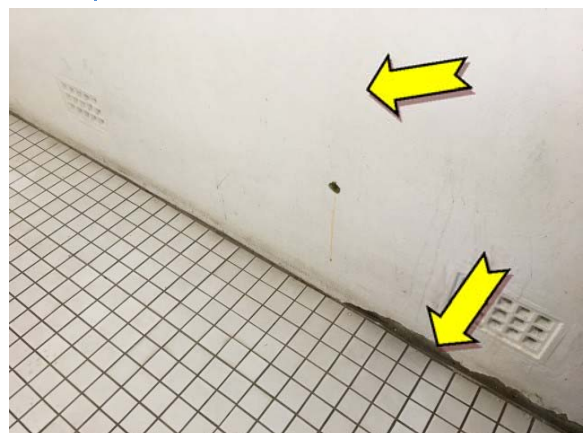
Photo 12. Interior, female toilets, walls – suspected lead-containing white upper and blue lower coloured paint systems.
