Hazardous Building Materials Assessment Fanny Durack Aquatic Centre – Plant Room Brighton and West Streets, Petersham NSW 2049

Inner West Council
March 2018

Job No.: 57722-026

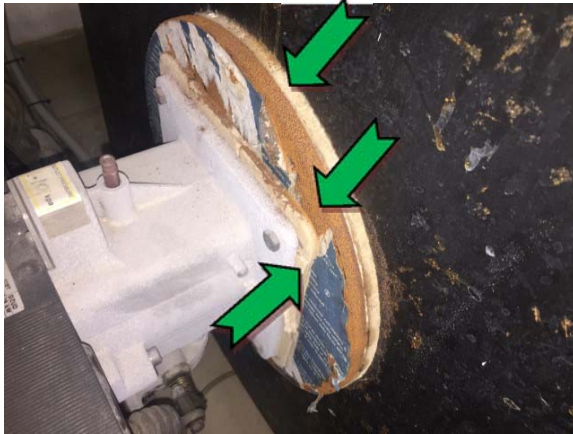
Photo 1. Pump plant room, west elevation, to boiler – non asbestos-containing packer, woven material and gasket.

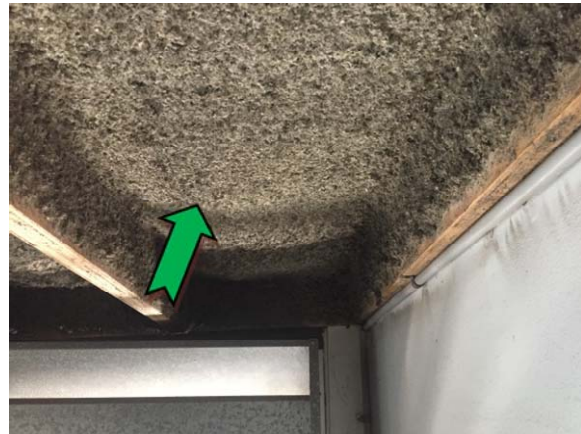
Photo 2. Interior, air conditioning plant room, ceiling – non asbestos-containing vermiculite.

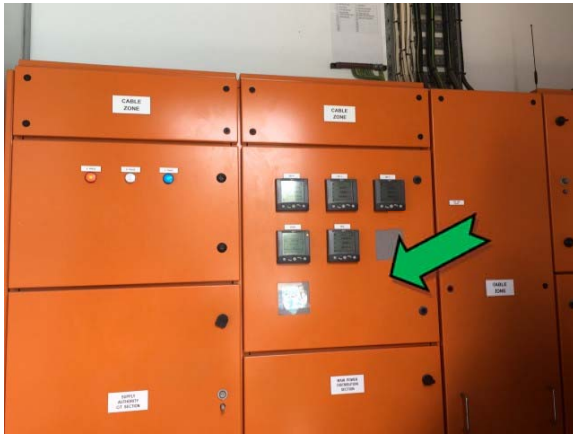
Photo 3. Interior, main switchboard room – suspected non asbestos-containing bituminous backing board.

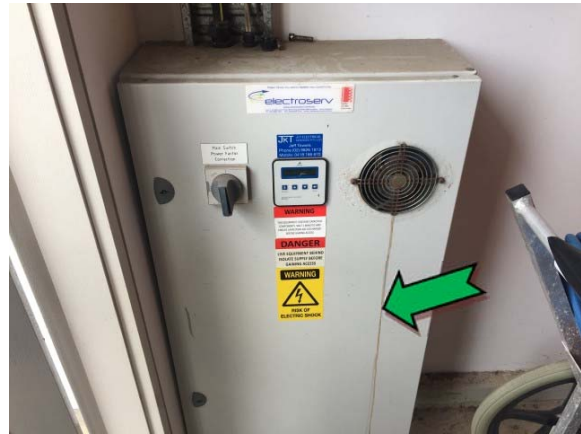
Interior	Main switchboard room, switch power factor corrector	Electrical backing board	Bituminous backing board	Asbestos	Not sampled: Electrical hazard	Suspected Negative	-	-	-	-	-	Suspected negative due to age and appearance.	-	-	4
Interior	Pump plant room, western corner, throughout	Pipe work	Insulation material - internal	SMF	-	Suspected Positive	Bonded	Low	Good	Low	15 m ²	Maintain in current condition if to remain in-situ. Remove under controlled SMF conditions as per the Code of Practice for the Safe Use of Synthetic Mineral Fibres [NOHSC: 2006 (1990)].	-	-	5
Interior	Throughout	Ceiling	Sarking insulation	SMF	-	Suspected Positive	Bonded	Low	Good	Low	30 m ²	Maintain in current condition if to remain in-situ. Remove under controlled SMF conditions as per the Code of Practice for the Safe Use of Synthetic Mineral Fibres [NOHSC: 2006 (1990)].	-	-	6
Throughout	-	-	-	PCBs	-	-	-	-	-	-	-	No suspect PCB-containing capacitors identified at the time of the assessment.	-	-	-

Photo 4. Interior, main switchboard room, switch power factor corrector – suspected non asbestos-containing bituminous backing board.

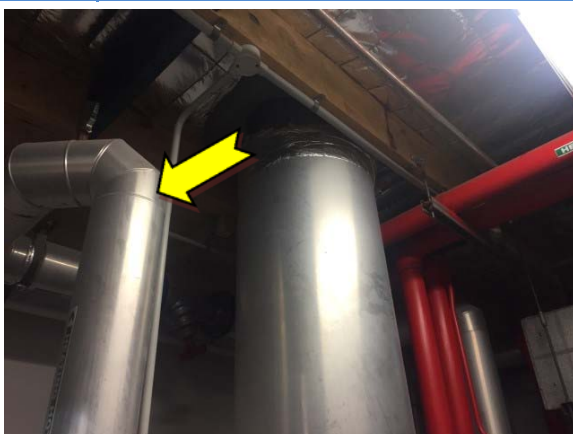
Photo 5. Interior, pump plant room, pipework – suspected internal SMF insulation.

- SMF internal insulation was suspected to pipework throughout the plant room.
- SMF sarking insulation was suspected to the ceiling throughout the plant room.

- SMF materials that are likely to be disturbed during any proposed demolition/refurbishment works should be handled in accordance with the *Code of Practice for the Safe Use of Synthetic Mineral Fibres* [NOHSC:2006(1990)]. If these materials are impacted upon by accident or by pre-planned works, the Inner West Council must be informed via the contact detailed within Section 7: *Accidental Disturbance of Known or Suspected Hazardous Building Materials*. Following disturbance, inspection by a competent person should be undertaken.

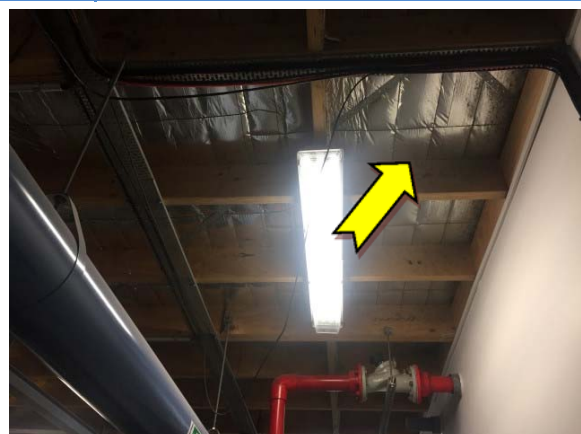
Photo 6. Interior, throughout, ceiling – suspected SMF sarking insulation.
