# Hazardous Building Materials Assessment Fanny Durack Aquatic Centre Brighton and West Streets, Petersham NSW 2049

Inner West Council  
March 2018

Job No.: 57722-025

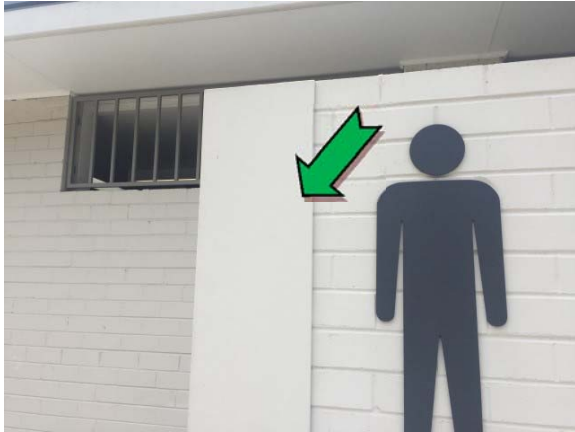
**Photo 1.** Exterior, toilet block, fascia – non asbestos-containing fibre cement sheeting.

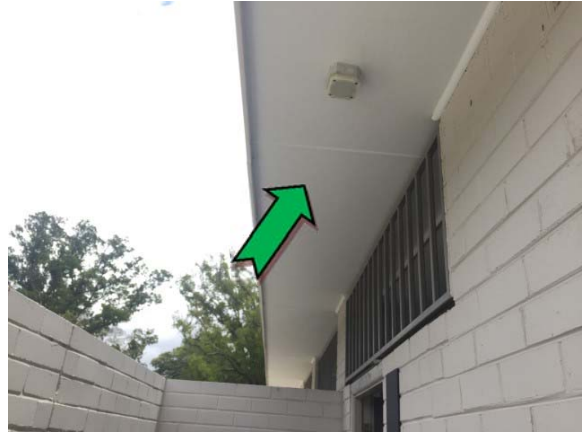
**Photo 2.** Exterior, throughout, eaves – non asbestos-containing fibre cement sheeting.

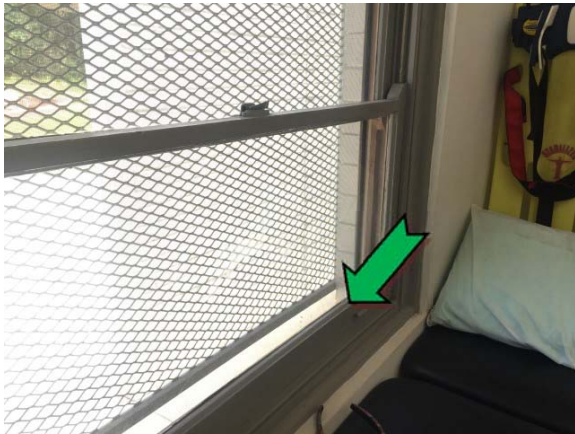
**Photo 3.** Exterior, first aid room, window frames – non asbestos-containing window caulking.

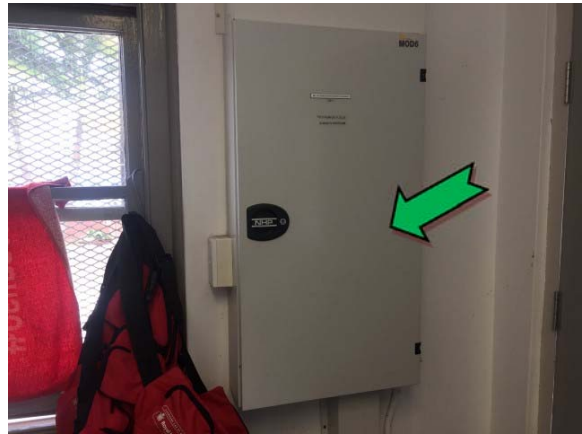
**Photo 4.** Interior, first aid room, electrical backing board – suspected non asbestos-containing bituminous backing board.

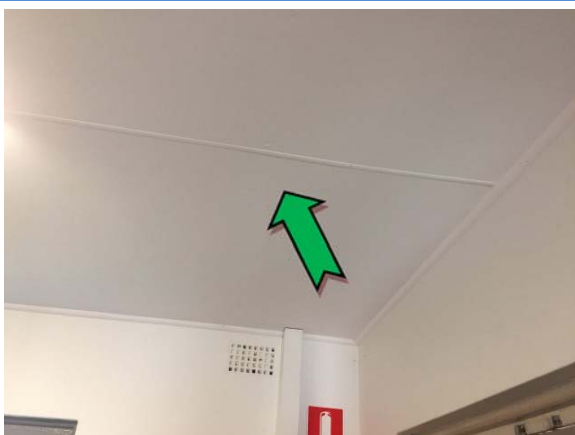
**Photo 5.** Interior, first aid room, ceiling – non asbestos-containing fibre cement sheeting.

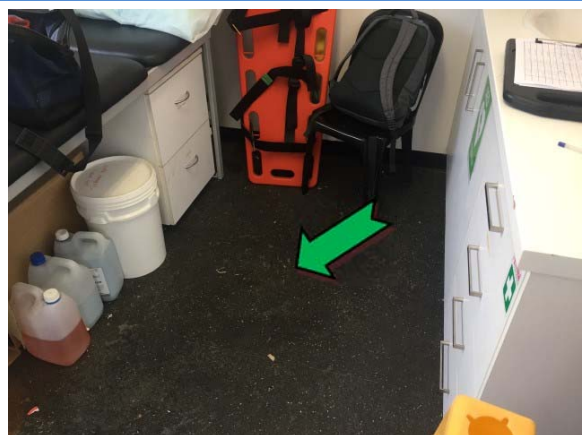
**Photo 6.** Interior, first aid room, black floor coverings – suspected non asbestos-containing sheet vinyl.

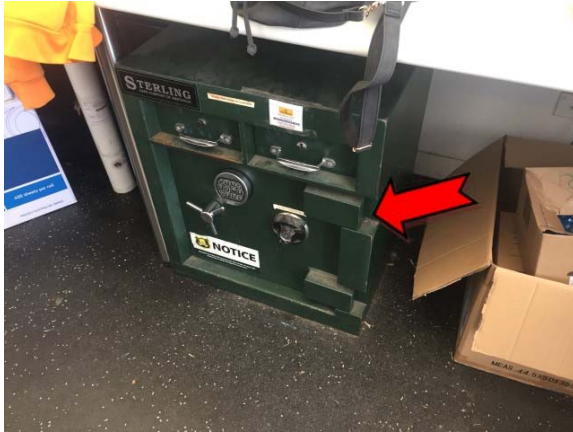
**Photo 7.** Interior, office, safe – suspected asbestos-containing internal insulation.

- Friable asbestos was suspected in the form of internal insulation within the safe located in the office.

Interior	Office	Safe	Insulation material - internal	Asbestos	Not sampled: Sealed unit	Suspected Positive	Friable	Low	Good	Low	1 unit	Confirm status, label as containing asbestos and maintain in current condition if to remain in-situ. Remove under controlled friable asbestos removal conditions prior to refurbishment or demolition works by a Class A (friable) licensed asbestos removal contractor.	P4	Feb-22	7
Exterior	North elevation	Hot water heater	Insulation material - internal	SMF	-	Suspected Positive	Bonded	Low	Good	Low	1 unit	Maintain in current condition if to remain in-situ. Remove under controlled SMF conditions as per the Code of Practice for the Safe Use of Synthetic Mineral Fibres [NOHSC: 2006 (1990)].	-	-	8
Interior	Reception and café	Ceiling space	Sarking insulation	SMF	-	Suspected Positive	Bonded	Low	Good	Low	1 unit	Maintain in current condition if to remain in-situ. Remove under controlled SMF conditions as per the Code of Practice for the Safe Use of Synthetic Mineral Fibres [NOHSC: 2006 (1990)].	-	-	9

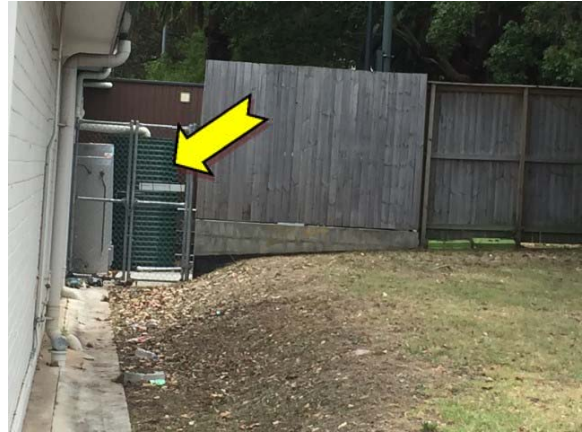
**Photo 8.** Exterior, north elevation, hot water heater – suspected SMF internal insulation.

- SMF internal insulation was suspected within the hot water heater to the exterior of the building.
- SMF sarking insulation was suspected throughout the ceiling space of the reception and café.

- SMF materials that are likely to be disturbed during any proposed demolition/refurbishment works should be handled in accordance with the *Code of Practice for the Safe Use of Synthetic Mineral Fibres* [NOHSC:2006(1990)]. If these materials are impacted upon by accident or by pre-planned works, the Inner West Council must be informed via the contact detailed within Section 7: *Accidental Disturbance of Known or Suspected Hazardous Building Materials*. Following disturbance, inspection by a competent person should be undertaken.

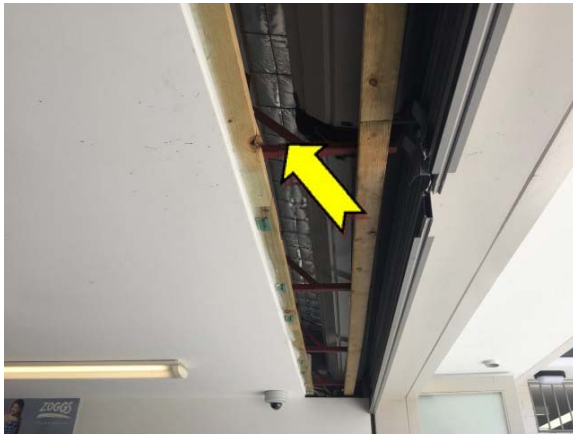
**Photo 9.** Interior, reception and café, ceiling space – suspected SMF sarking insulation.
