Hazardous Building Materials Assessment Petersham Park – Equipment Store Brighton and West Streets Petersham NSW 2049

Inner West Council
March 2018

Job No.: 57722-021

Count ID: CID: 290

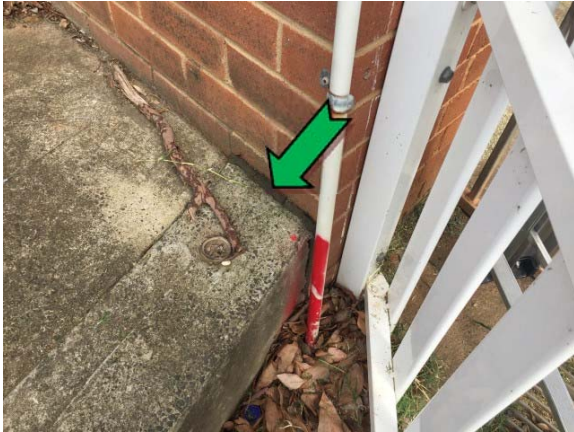
Photo 1. Exterior, southern wall, expansion joint – non asbestos-containing construction mastic.

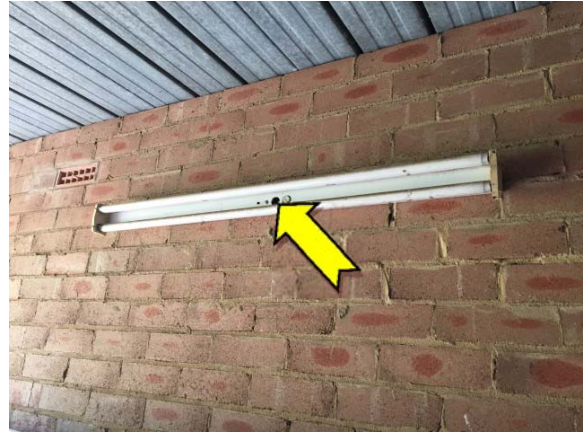
Photo 2. Interior, double tube fluorescent light fitting – suspected non PCB-containing capacitor.

- PCB-containing capacitors were suspected to double tube fluorescent light fittings throughout the site.

- Electrical fittings suspected of containing PCB oil capacitors should be treated as containing PCB oils until such time as evidence suggest otherwise e.g. further assessed.
- Electrical fittings that contain or suspected to contain PCB oil-containing capacitors should be removed as hazardous/regulated waste under controlled working conditions prior to the demolition or refurbishment works in accordance with the *Polychlorinated Biphenyls Management Plan, Revised Edition April 2003*.

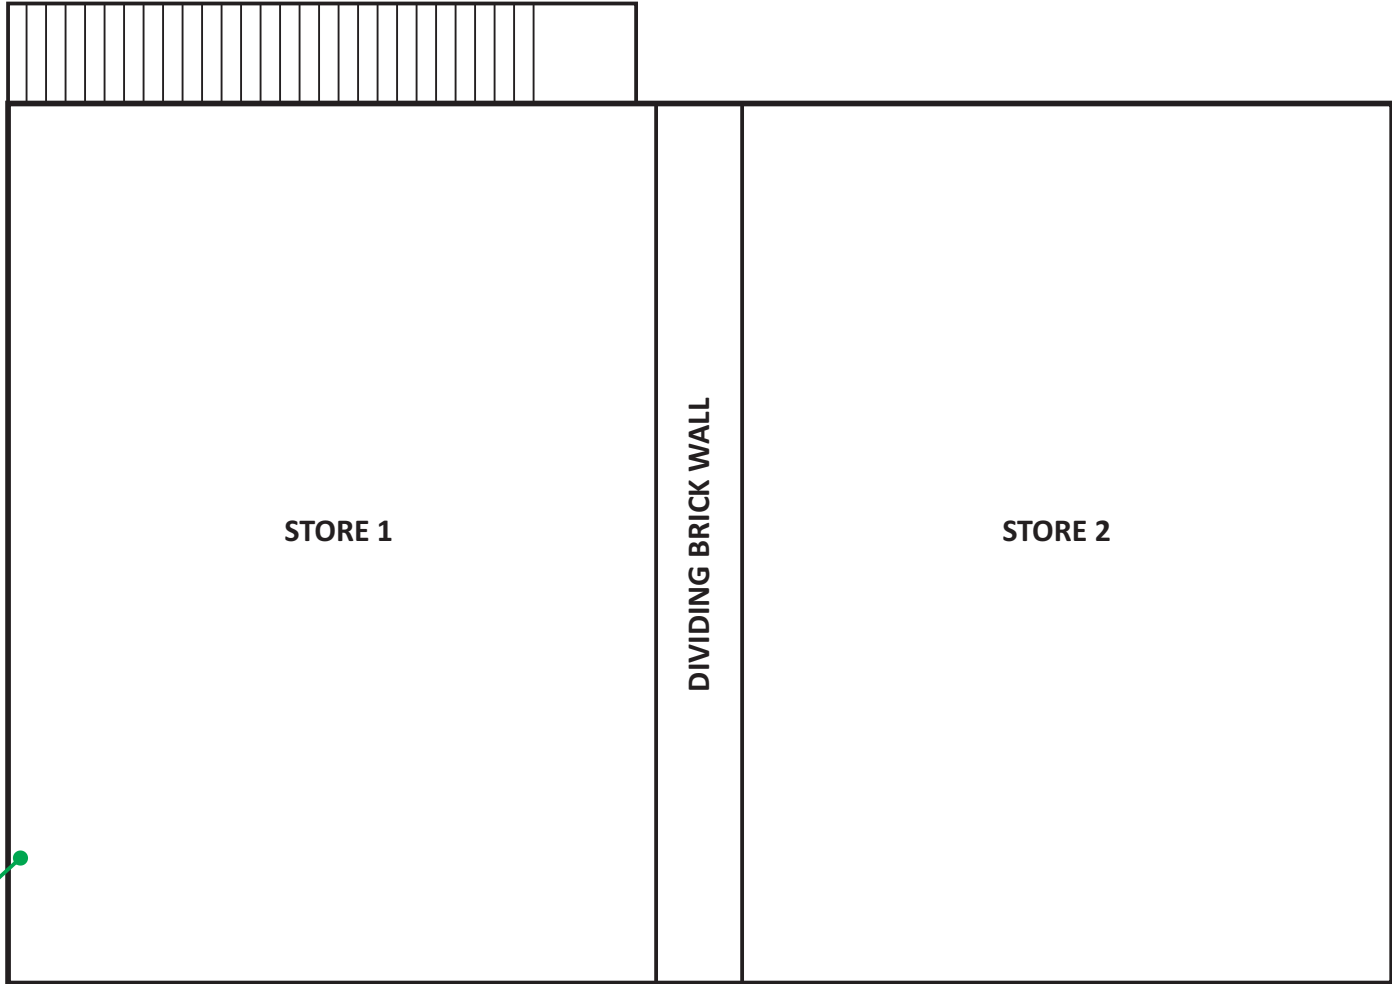
Petersham Park Equipment Store - Ground Level

57722-021-001
