# Hazardous Building Materials Assessment

## St Peters Depot – Building A

15-17 Unwins Bridge Road  
St Peters NSW 2044

Inner West Council  
March 2018

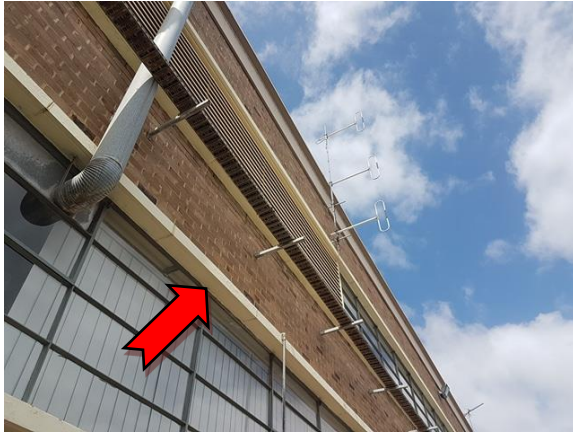
**Photo 1.** Exterior, throughout, eave lining – suspected asbestos containing fibre cement sheeting.

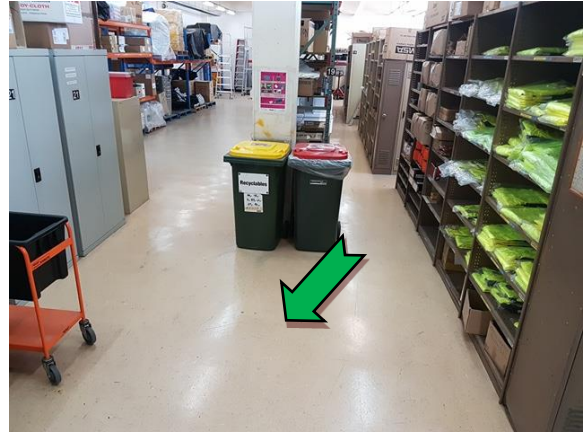
**Photo 2.** Interior, ground level, throughout, floor – non asbestos-containing vinyl floor tiles.

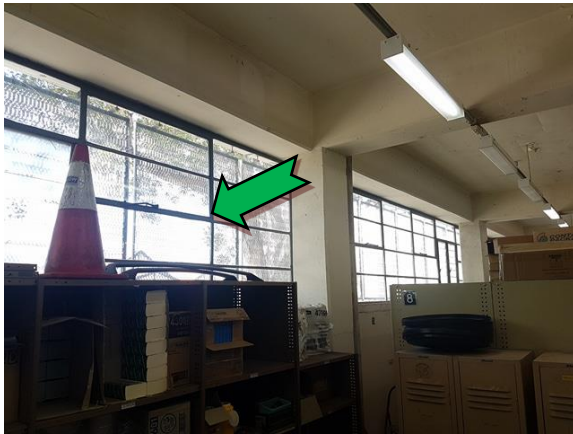
**Photo 3.** Interior, ground level, throughout, window frames – non asbestos-containing caulking.

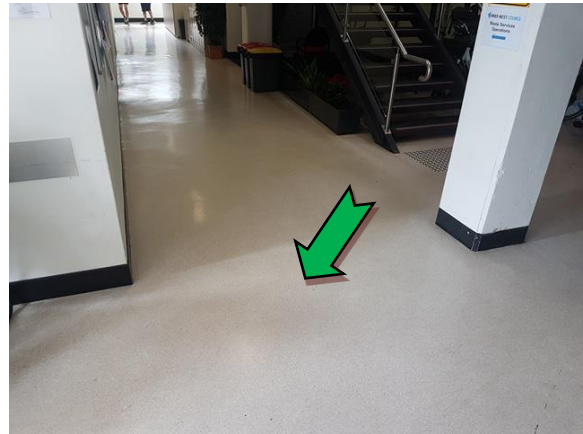
**Photo 4.** Interior, ground level, northern elevation, throughout, floor – suspected non asbestos-containing sheet vinyl.

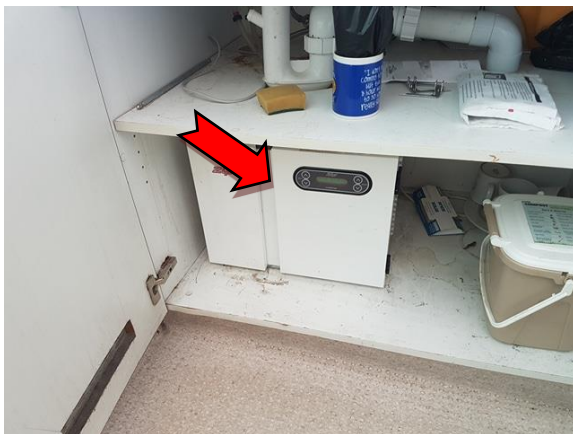
**Photo 5.** Interior, level 1, kitchen, hot water heater beneath sink – suspected SMF-containing internal insulation.

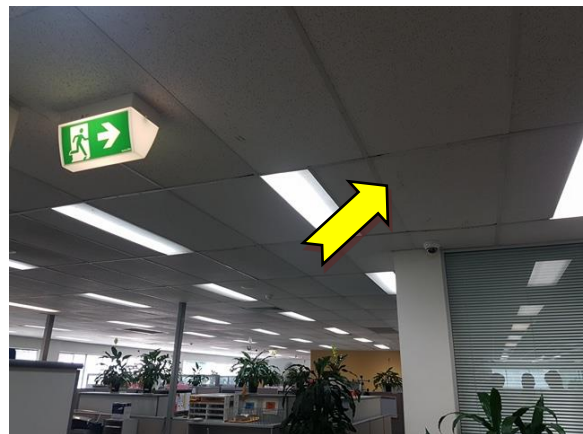
**Photo 6.** Interior, level 1, northern elevation, throughout, ceiling – suspected SMF-containing compressed ceiling tiles.

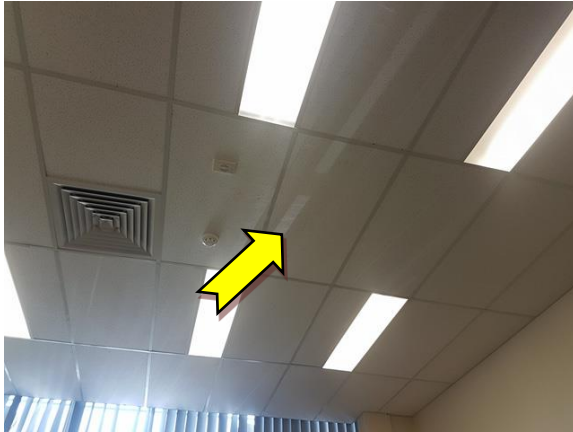
**Photo 7.** Interior, ground level, stores office, ceiling – suspected SMF-containing compressed ceiling tiles.

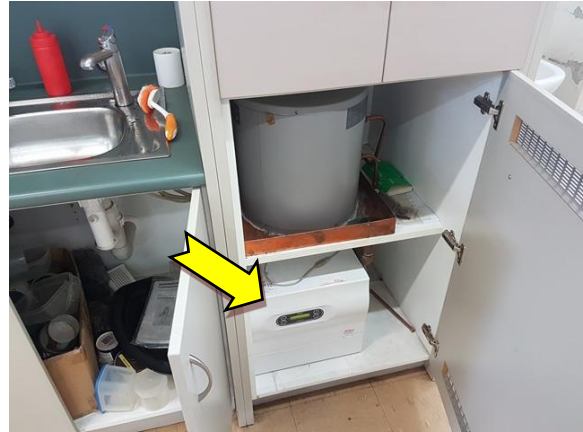
**Photo 8.** Interior, ground level, store kitchenette, hot water heater under sink – suspected SMF-containing internal insulation.

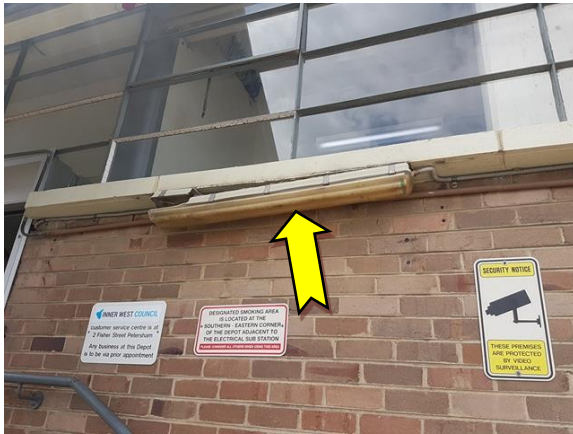
**Photo 9.** Exterior, throughout, single tube fluorescent light fittings – suspected PCB-containing capacitors.

- Electrical fittings suspected of containing PCB oil capacitors should be treated as containing PCB oils until such time as evidence suggest otherwise e.g. further assessed.
- Electrical fittings that contain or suspected to contain PCB oil-containing capacitors should be removed as hazardous/regulated waste under controlled working conditions prior to the demolition or refurbishment works in accordance with the *Polychlorinated Biphenyls Management Plan, Revised Edition April 2003*.

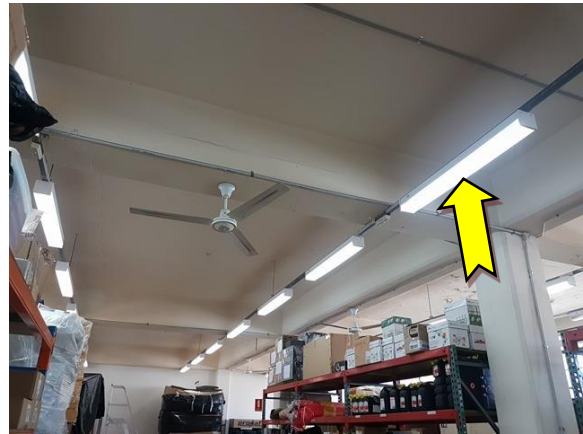
**Photo 10.** Interior, throughout, double tube fluorescent light fittings – suspected non PCB-containing capacitors.

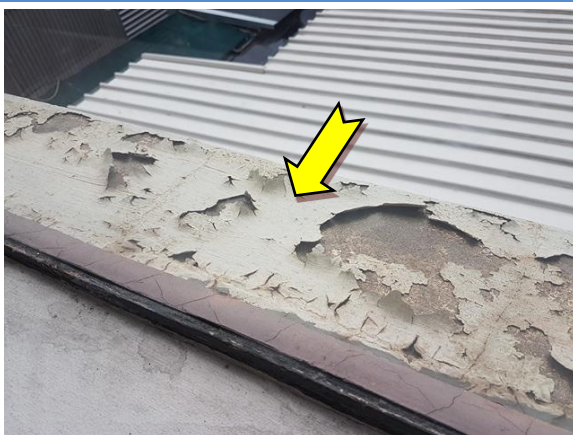
**Photo 11.** Exterior, throughout, window frames – suspected lead containing upper white coloured paint system.

- Remove flaking lead containing paint to window surrounds throughout the property in accordance with AS4361.2-2017 Guide to Hazardous Paint Management and relevant legislation.

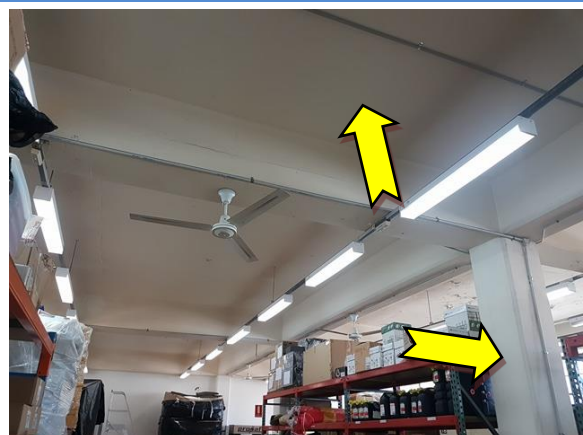
**Photo 12.** Interior, throughout, ceiling and walls – suspected lead containing upper white coloured paint system.
