# Hazardous Building Materials Assessment

## St Peters Depot – Building B

### 15-17 Unwins Bridge Road

Inner West Council  
March 2018

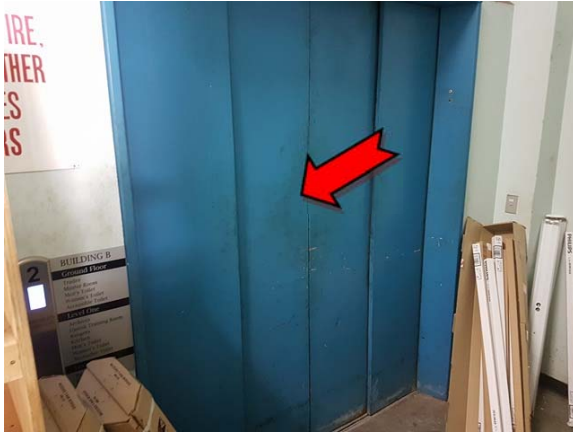
**Photo 1.** Interior, level 2, lift door – suspected asbestos containing door core.

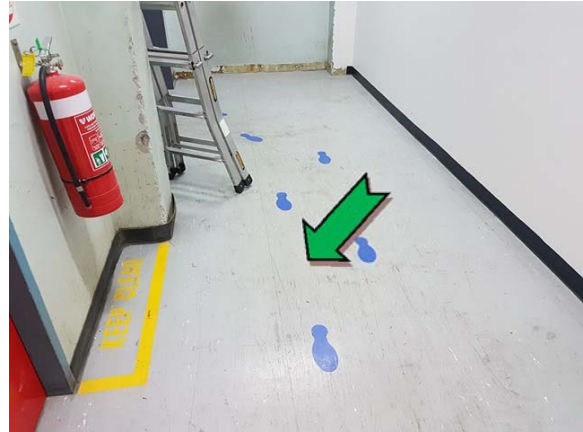
**Photo 2.** Interior, level 1, throughout, floor – non asbestos-containing vinyl floor sheeting.

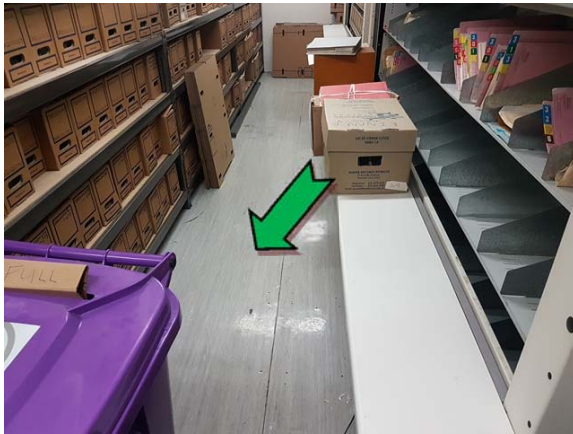
**Photo 3.** Interior, level 1, throughout, floor – non asbestos-containing vinyl floor sheeting.

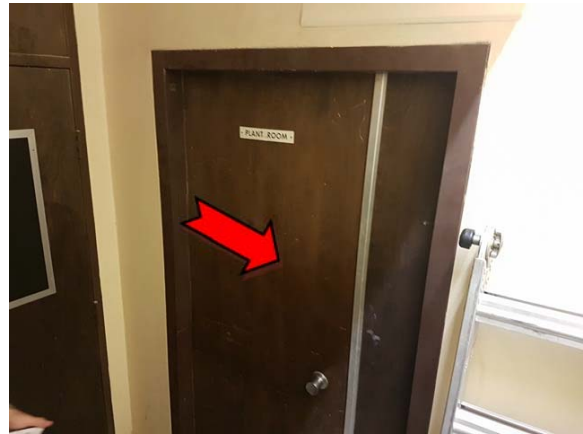
**Photo 4.** Interior, level 1, plant room, entrance door – asbestos-containing core.

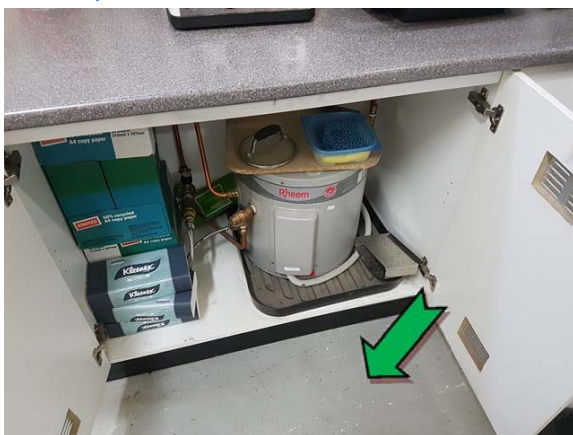
**Photo 5.** Interior, ground level, throughout, floor – non asbestos-containing vinyl sheeting.

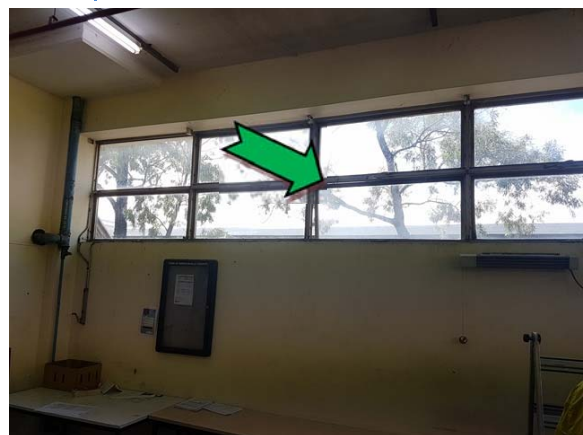
**Photo 6.** Interior, ground level, throughout, window frames – non asbestos-containing caulking.

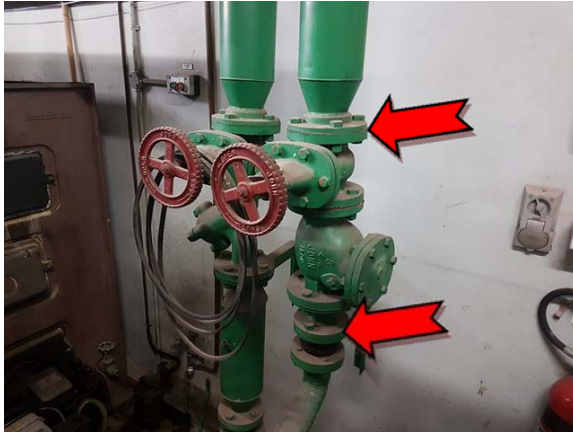
**Photo 7.** Interior, ground floor, southern store, throughout, pipework – asbestos containing gaskets.

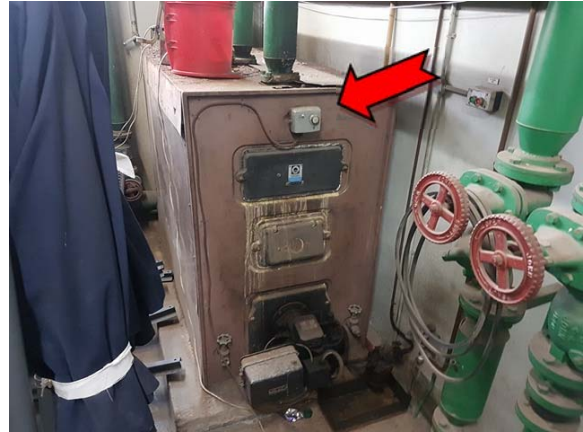
**Photo 8.** Interior, ground floor, southern store, throughout, boiler internal – asbestos containing gaskets.

- The boiler located in the ground level southern store room containing friable gasket material should be removed under controlled friable asbestos removal conditions prior to refurbishment or demolition works by a Class A (friable) license asbestos removal contractor.

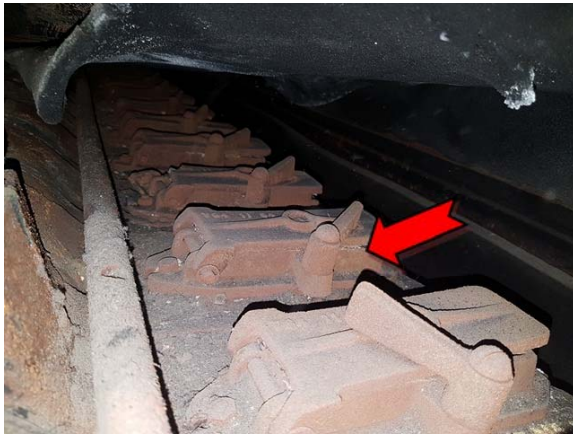
**Photo 9.** Interior, ground floor, southern store, throughout, boiler internal – asbestos containing gaskets.

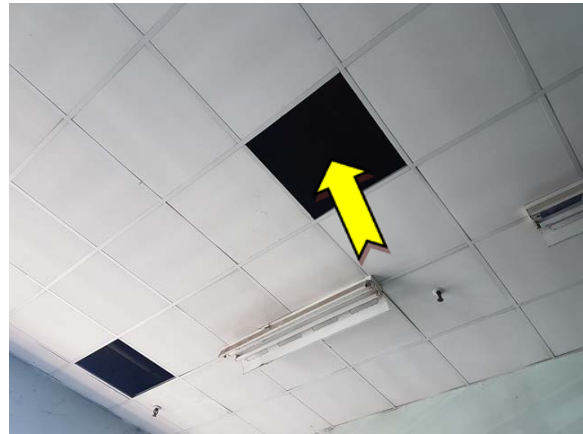
**Photo 10.** Interior, level 2, store, ceiling space – suspected SMF containing sarking.

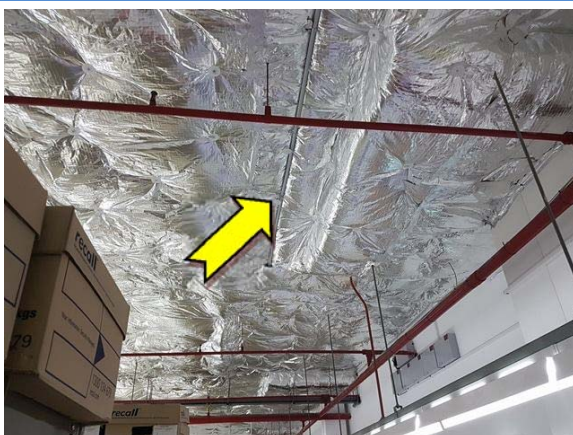
**Photo 11.** Interior, level 1, archives room, ceiling – suspected SMF containing sarking insulation.

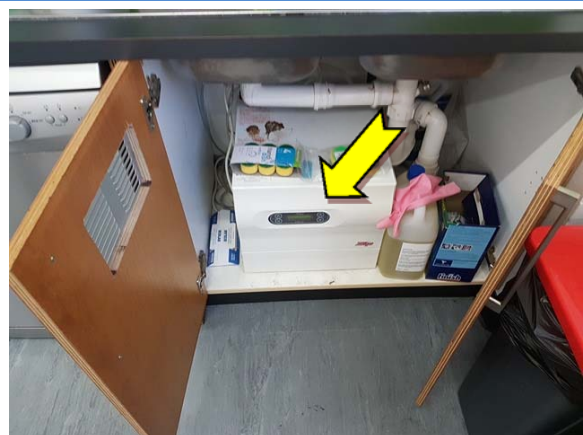
**Photo 12.** Interior, level 1, staff room, hot water heater – suspected SMF-containing internal insulation.

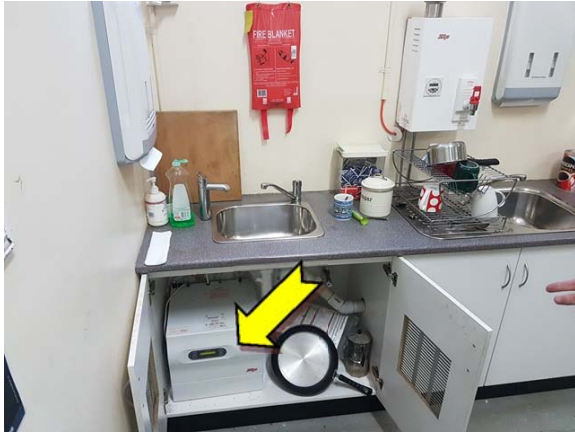
**Photo 13.** Interior, ground level, lunch room, hot water heater – suspected SMF-containing internal insulation.

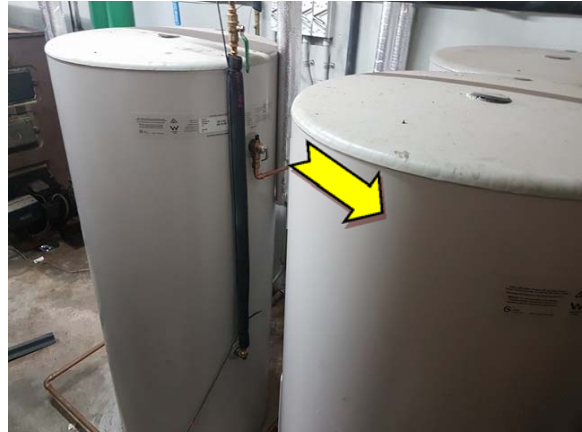
**Photo 14.** Interior, ground floor, southern store, hot water heaters – suspected SMF-containing internal insulation.

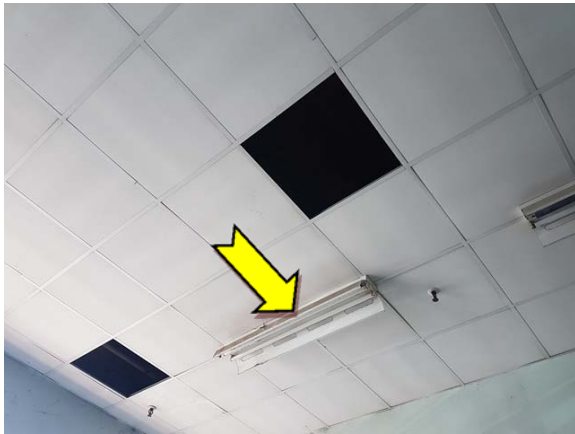
**Photo 15.** Interior, throughout, fluorescent light fittings – suspected PCB-containing capacitors.

- Electrical fittings suspected of containing PCB oil capacitors should be treated as containing PCB oils until such time as evidence suggest otherwise e.g. further assessed.
- Electrical fittings that contain or suspected to contain PCB oil-containing capacitors should be removed as hazardous/regulated waste under controlled working conditions prior to the demolition or refurbishment works in accordance with the *Polychlorinated Biphenyls Management Plan, Revised Edition April 2003*.

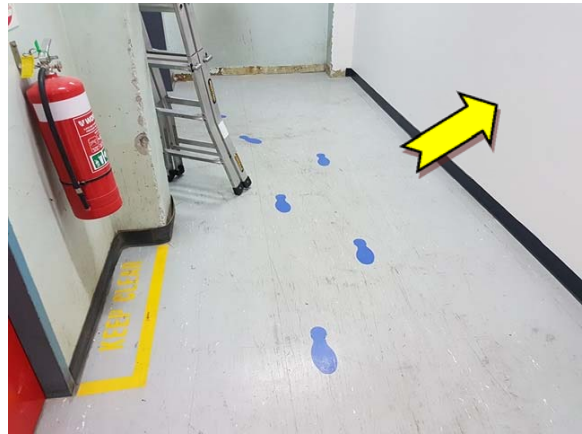
**Photo 16.** Interior, level 2, throughout, walls – suspected lead upper coloured blue paint system.

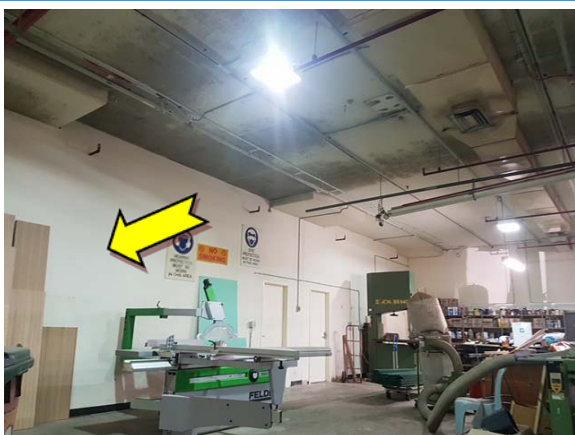
**Photo 17.** Interior, ground level, throughout, walls – suspected lead upper coloured white and cream paint systems.
