Hazardous Building Materials Assessment

St Peters Depot Building C

15-17 Unwins Bridge Road,
St Peters NSW 2044

Inner West Council
April 2018

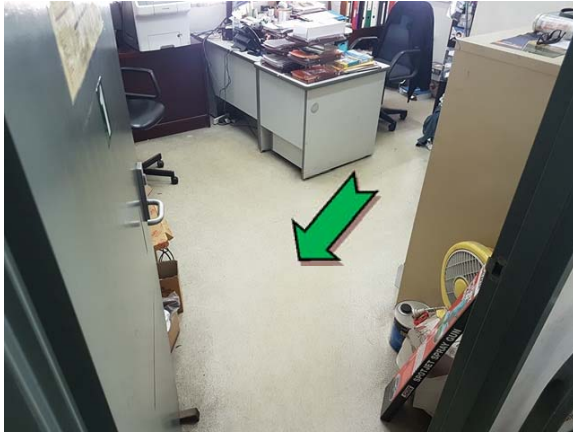
Photo 1. Interior, mezzanine level, western office, floor coverings – non asbestos-containing vinyl floor tiles.

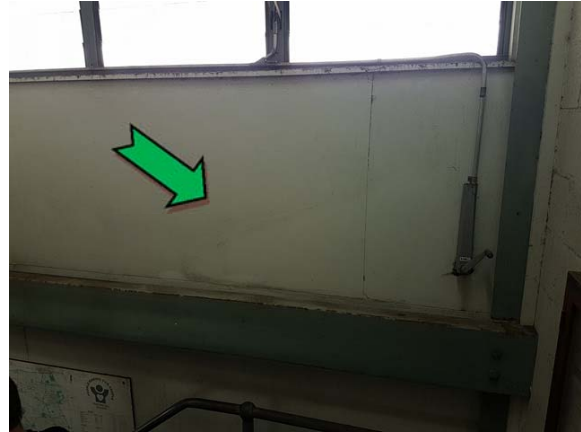
Photo 2. Interior, stairwell, walls – non asbestos-containing fibre cement sheeting.

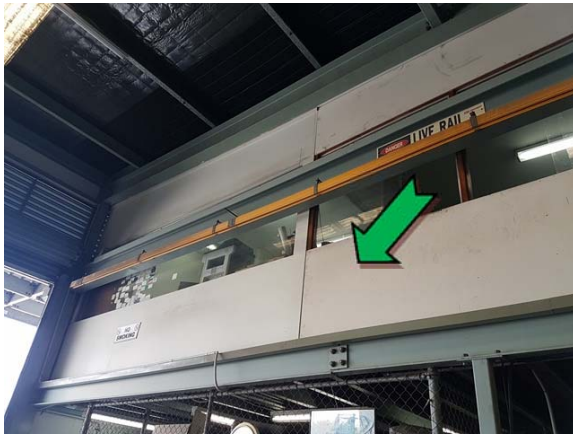
Photo 3. Interior, above kitchen, southern wall – assumed non asbestos-containing fibre cement sheeting.

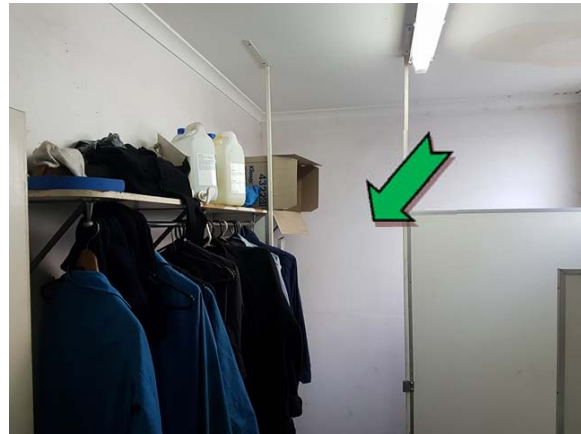
Photo 4. Interior, ground level, bathroom, walls – non asbestos-containing fibre cement sheeting.

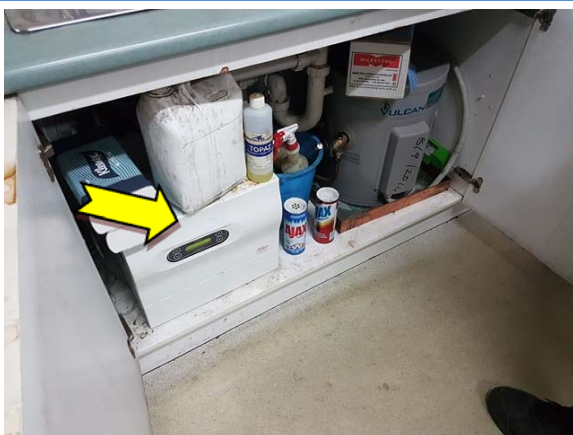
Interior, mezzanine	Kitchen	Hot water heater	Insulation material - internal	SMF	-	Suspected Positive	-	Low	Good	Low	1 unit	Maintain in current condition if to remain in-situ. Remove under controlled SMF conditions as per the Code of Practice for the Safe Use of Synthetic Mineral Fibres [NOHSC: 2006 (1990)].	-	-	5
Interior, ground level	Throughout	Ceiling	Sarking insulation	SMF	-	Suspected Positive	-	Low	Good	Low	400 m ²	Maintain in current condition if to remain in-situ. Remove under controlled SMF conditions as per the Code of Practice for the Safe Use of Synthetic Mineral Fibres [NOHSC: 2006 (1990)].	-	-	6
Throughout	-	-	-	PCBs	-	-	-	-	-	-	-	No suspect PCB-containing capacitors identified at the time of the assessment.	-	-	-
Interior, stairwell	Throughout	Paint systems	White - upper coloured paint system	Lead Paint - Swab	-	Suspected Positive	-	Low	Good	Low	50 m ²	Confirm status by quantitative test method, maintain in current condition, over paint with a lead-free paint as part of ongoing maintenance. Remove under controlled conditions in accordance with AS 4361.2:2017 Guide to hazardous paint management prior to renovation or demolition works.	-	-	-

Photo 5. Interior, mezzanine level, kitchen, hot water heater – suspected SMF internal insulation material.

- SMF internal insulation material was suspected within the hot water heater.
- SMF sarking insulation material was suspected to the ceiling.

- SMF materials that are likely to be disturbed during any proposed demolition/refurbishment works should be handled in accordance with the *Code of Practice for the Safe Use of Synthetic Mineral Fibres* [NOHSC:2006(1990)]. If these materials are impacted upon by accident or by pre-planned works, the Inner West Council must be informed via the contact detailed within Section 7: *Accidental Disturbance of Known or Suspected Hazardous Building Materials*. Following disturbance, inspection by a competent person should be undertaken.

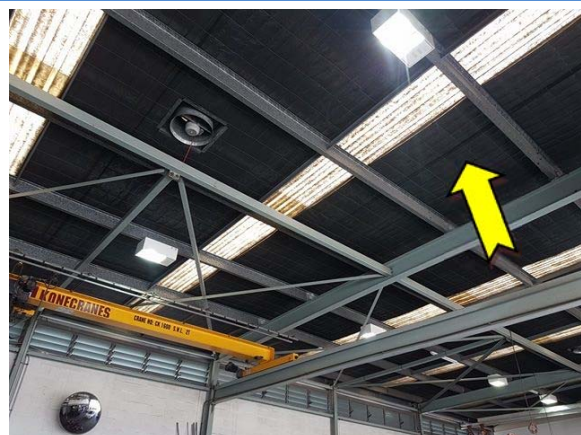
Photo 6. Interior, throughout, ceiling – suspected SMF sarking insulation material.
