# Hazardous Building Materials Assessment Cavendish Early Learning Centre 142 Cavendish Street, Stanmore NSW 2048

Inner West Council  
March 2018

Job No.: 57722-007

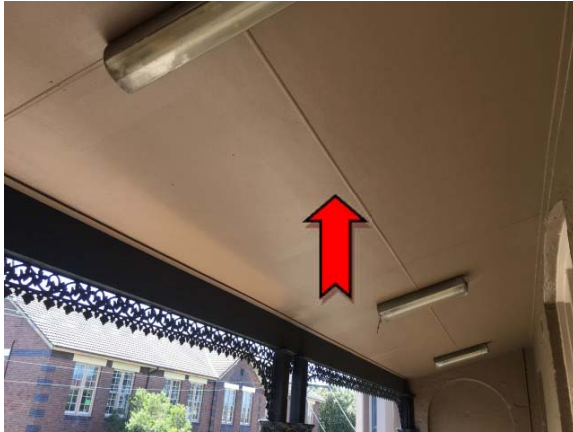
**Photo 1.** Exterior, level one, verandah, awning – suspected asbestos-containing fibre cement sheeting.

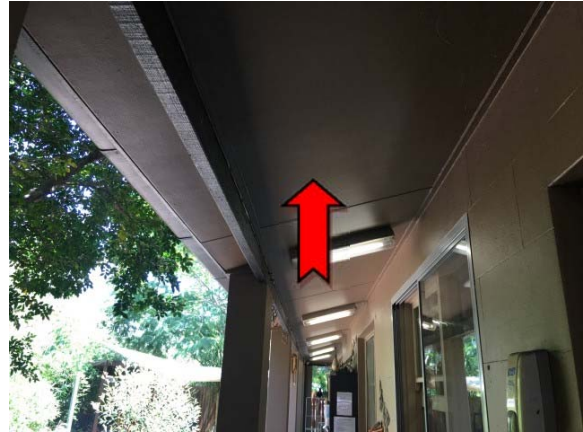
**Photo 2.** Exterior, ground level, south side of building, west end, awning – asbestos-containing fibre cement sheeting.

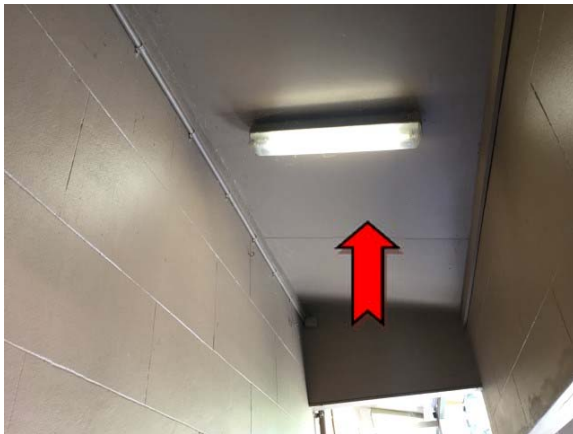
**Photo 3.** Exterior, ground level, east side of building, awning – suspected asbestos-containing fibre cement sheeting.

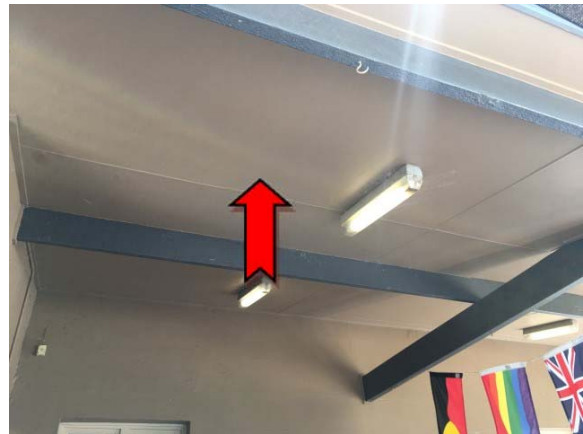
**Photo 4.** Exterior, ground level, east verandah, awning – suspected asbestos-containing fibre cement sheeting.

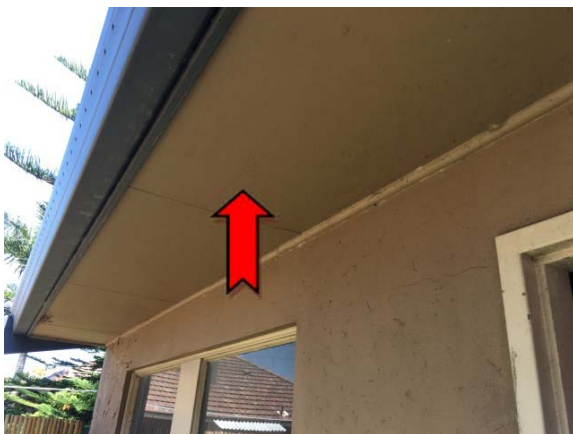
**Photo 5.** Exterior, ground level, toy store, east side, eaves – suspected asbestos-containing fibre cement sheeting.

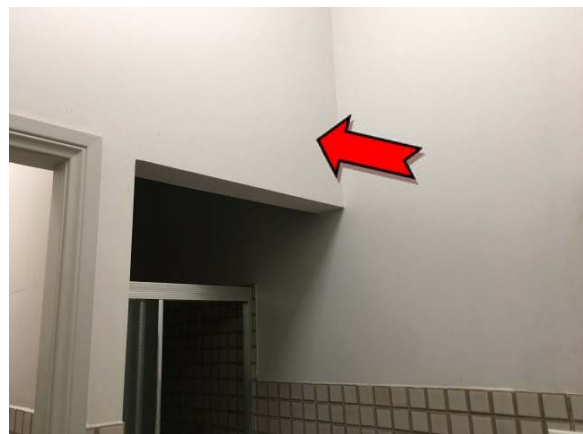
**Photo 6.** Interior, level one, staff room, toilet, east, south & dividing walls – asbestos-containing fibre cement sheeting.

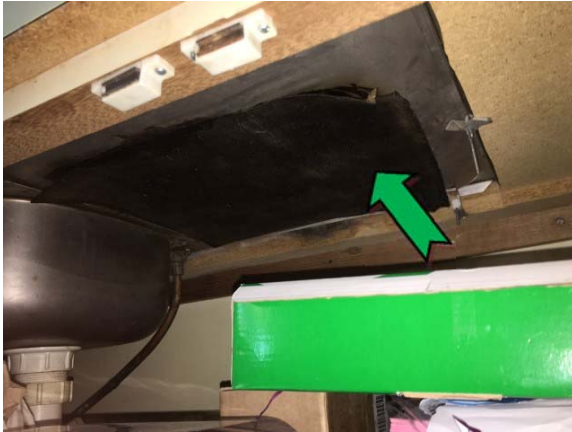
**Photo 7.** Interior, level one, art room, beneath sink, sink pad – non asbestos-containing bituminous membrane.

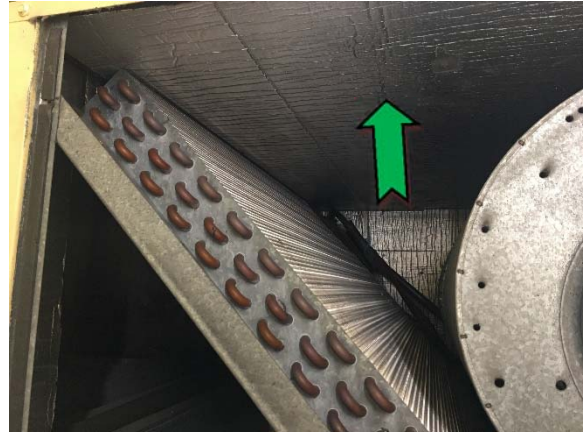
**Photo 8.** Interior, ground level, store, heater bank – non asbestos-containing internal insulation material.

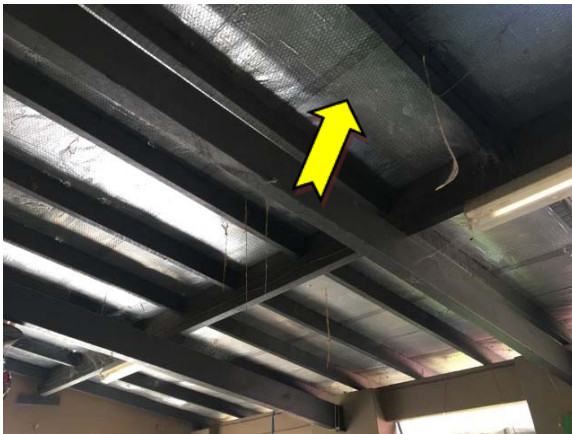
**Photo 9.** Exterior, ground level, play area, insulation – suspected SMF sarking insulation material.

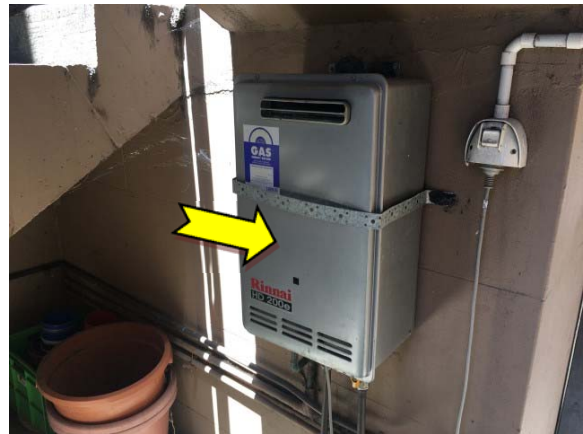
**Photo 10.** Exterior, ground level, west alleyway, hot water heater – suspected SMF internal insulation material.

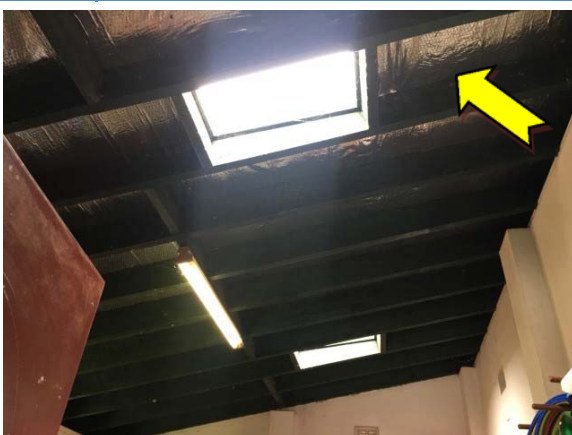
**Photo 11.** Exterior, ground level, toy store, under side of roof – suspected SMF sarking insulation material.

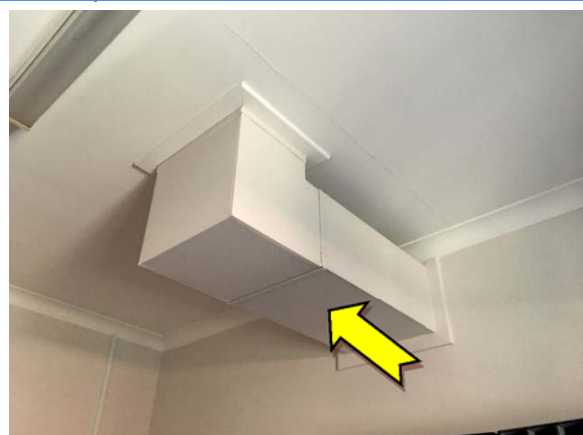
**Photo 12.** Interior, level one, office, air handling ductwork – suspected SMF internal insulation material.

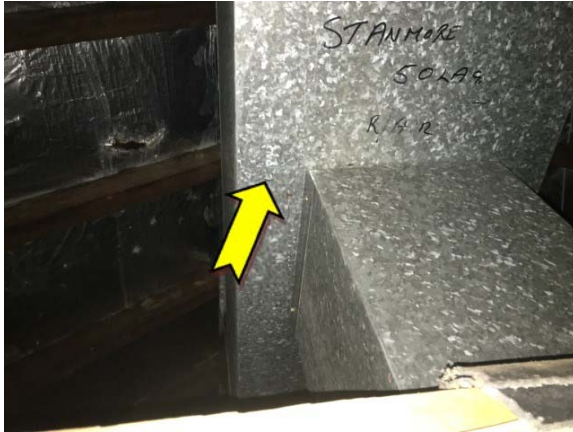
**Photo 13.** Interior, art room, roof space, air handling ductwork – suspected SMF internal insulation material.

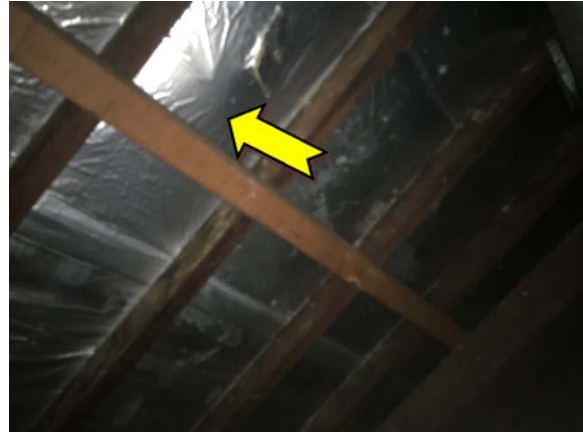
**Photo 14.** Interior, art room, roof space, under side of roof – suspected SMF sarking insulation material.

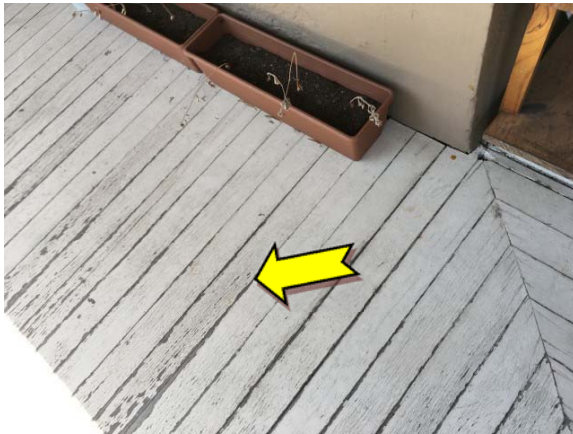
**Photo 15.** Exterior, level one, verandah, floor – suspected lead-containing blue upper paint systems.

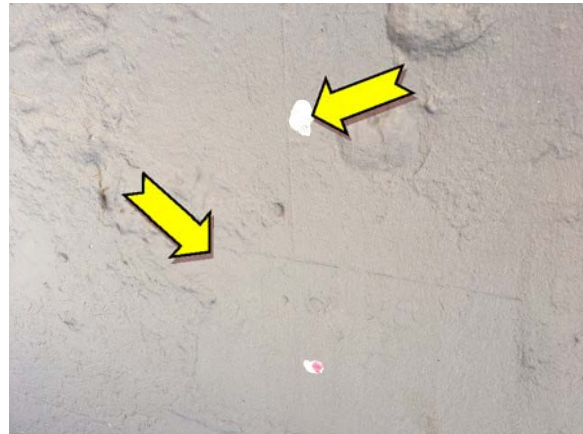
**Photo 16.** Exterior, level one, walls – lead-containing cream lower and brown upper coloured paint systems.

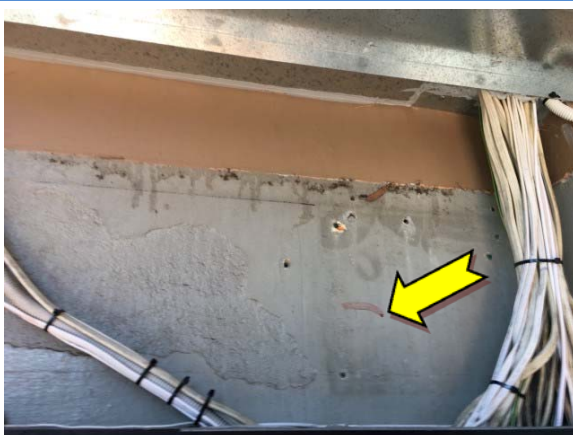
**Photo 17.** Exterior, ground level, inside electrical cabinet, wall – lead-containing grey upper paint systems.

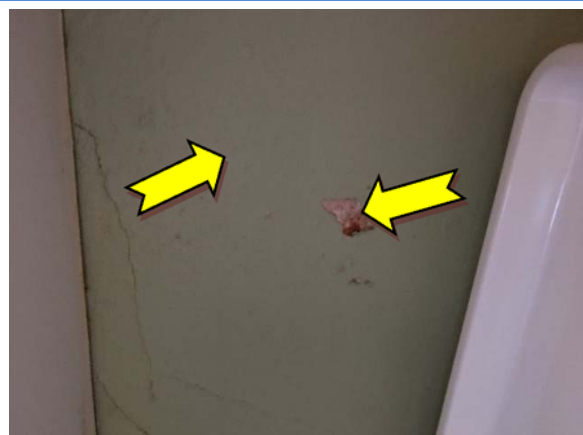
**Photo 18.** Interior, level one, art room, throughout, wall – lead-containing cream lower and green upper coloured paint systems.
