Hazardous Building Materials Assessment Stanmore Branch Library Stanmore Reserve, Douglas Street, Stanmore NSW 2048

Inner West Council
March 2018

Executive Summary

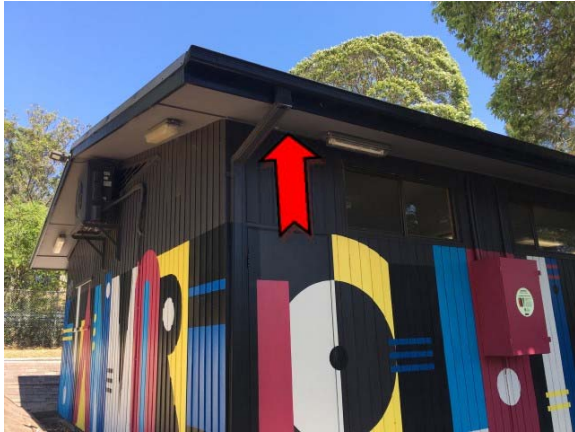
Photo 1. Exterior, throughout, eaves – suspected asbestos-containing fibre cement sheeting.

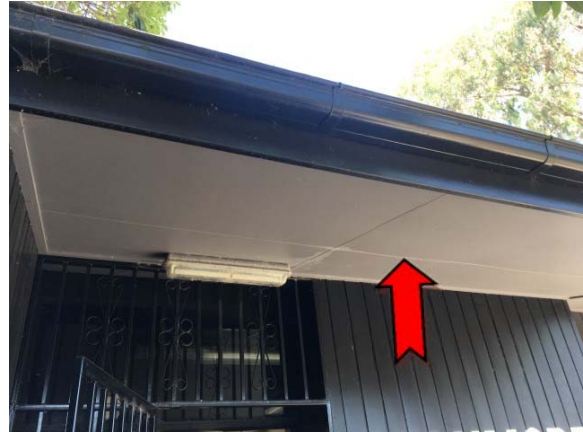
Photo 2. Exterior, main entrance, awning – suspected asbestos-containing fibre cement sheeting.

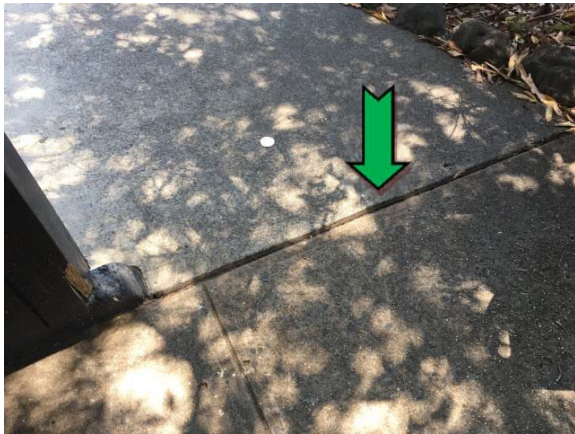
Photo 3. Exterior, north elevation, throughout pavement, expansion joint – non asbestos-containing construction mastic.

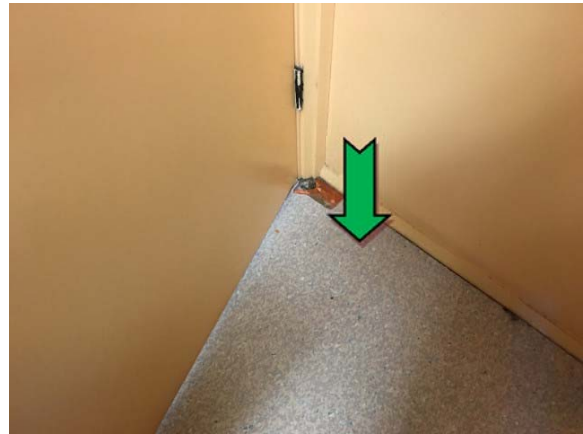
Photo 4. Interior, work room, light blue floor coverings – non asbestos-containing vinyl sheet.

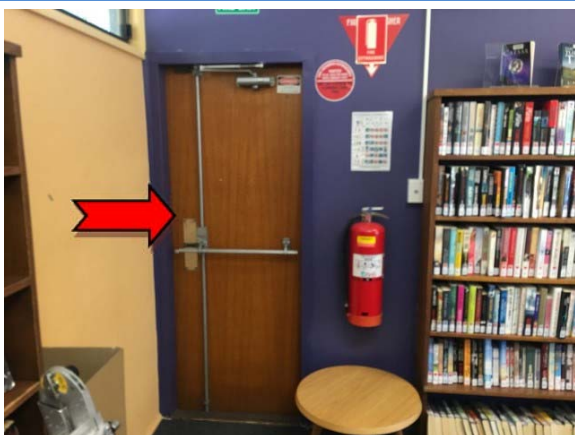
Photo 5. Interior, throughout, fire doors – suspected asbestos-containing fire door core.

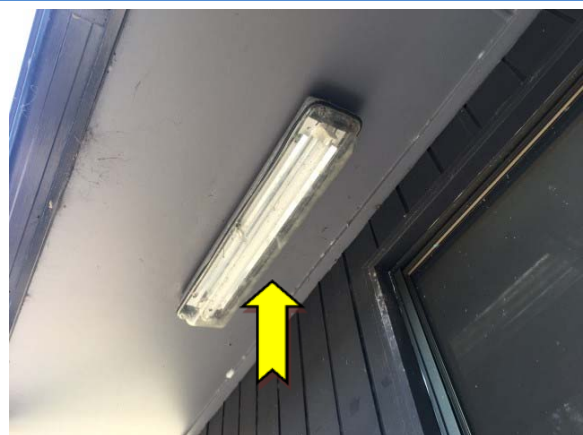
Photo 6. Exterior, throughout, single tube fluorescent light fitting – suspected PCB-containing capacitor.

- Electrical fittings suspected of containing PCB oil capacitors should be treated as containing PCB oils until such time as evidence suggest otherwise e.g. further assessed.
- Electrical fittings that contain or suspected to contain PCB oil-containing capacitors should be removed as hazardous/regulated waste under controlled working conditions prior to the demolition or refurbishment works in accordance with the *Polychlorinated Biphenyls Management Plan, Revised Edition April 2003*.

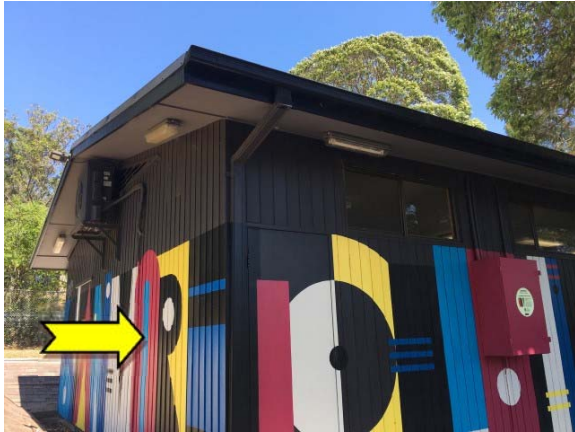
Exterior, ground level	Throughout	Walls	Various - upper coloured paint systems	Lead Paint - Swab	-	Suspected Positive	-	Low	Good	Low	20 m ²	Confirm status by quantitative test method, maintain in current condition, over paint with a lead-free paint as part of ongoing maintenance. Remove under controlled conditions in accordance with AS 4361.2:2017 Guide to hazardous paint management prior to renovation or demolition works.	-	-	7
Exterior, ground level	Throughout	Awning	White - upper coloured paint system	Lead Paint - Swab	-	Suspected Positive	-	Low	Good	Low	5 m ²	Confirm status by quantitative test method, maintain in current condition, over paint with a lead-free paint as part of ongoing maintenance. Remove under controlled conditions in accordance with AS 4361.2:2017 Guide to hazardous paint management prior to renovation or demolition works.	-	-	8

Photo 7. Exterior, throughout, walls – suspected lead-containing various coloured upper paint systems.

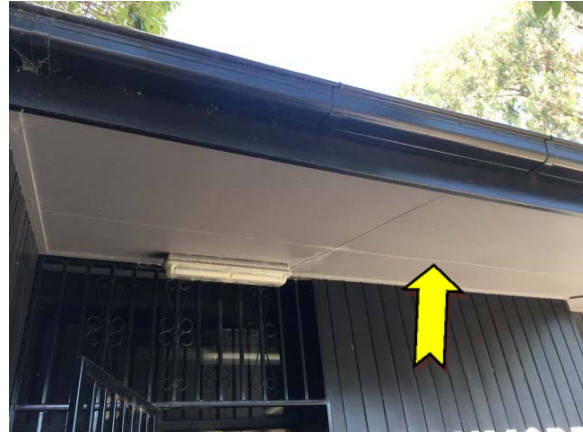
Photo 8. Exterior, throughout, awning – suspected lead-containing white upper paint systems.

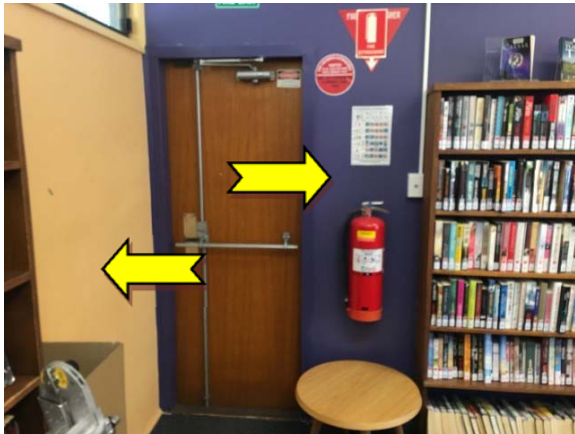
Area / Level	Room & Location	Feature	Item Description	Hazard Type	Sample No.	Sample Status	Friability	Disturb. Potential	Condition	Risk Status	Approx. Quantity	Recommendations & Comments	Control Priority	Reinspect Date	Photo No.
Interior, ground level	Throughout	Walls	Orange - upper coloured paint system	Lead Paint - Swab	-	Suspected Positive	-	Low	Good	Low	50 m ²	Confirm status by quantitative test method, maintain in current condition, over paint with a lead-free paint as part of ongoing maintenance. Remove under controlled conditions in accordance with AS 4361.2:2017 Guide to hazardous paint management prior to renovation or demolition works.	-	-	9
Interior, ground level	Throughout	Walls	Purple - upper coloured paint system	Lead Paint - Swab	-	Suspected Positive	-	Low	Good	Low	50 m ²	Confirm status by quantitative test method, maintain in current condition, over paint with a lead-free paint as part of ongoing maintenance. Remove under controlled conditions in accordance with AS 4361.2:2017 Guide to hazardous paint management prior to renovation or demolition works.	-	-	9

Photo 9. Interior, throughout, walls – suspected lead-containing orange and purple upper paint systems.
