Hazardous Building Materials Assessment Annandale Town Hall & Community Centre 77-79 Johnston Street Annandale NSW 2038

Inner West Council
April 2018

Job No.: 57722-011

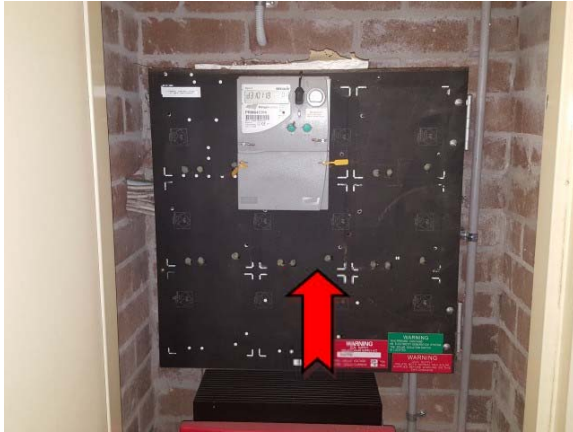
| Area / Level | Room & Location | Feature | Item Description | Hazard Type | Sample No. | Sample Status | Friability | Disturb. Potential | Condition | Risk Status | Approx. Quantity | Recommendations & Comments | Control Priority | Reinspect Date | Photo No. |
|---|---|---|---|---|--|---|---|---|---|---|---|--|---|---|---|
| Interior, ground level | Storeroom | Electrical backing board | Bituminous backing board | Asbestos | Not Sampled: Electrical hazard | Suspected Positive | Non-friable | Low | Good | Low | 1 unit | Confirm status, label as containing asbestos and maintain in current condition if to remain in-situ. Remove under controlled non-friable asbestos removal conditions prior to refurbishment or demolition works by a Class B (non-friable) licensed asbestos removal contractor. | P4 | Feb-23 | 1 |

Photo 1. Interior, ground level, store room, electrical board – suspected asbestos-containing bituminous backing board.

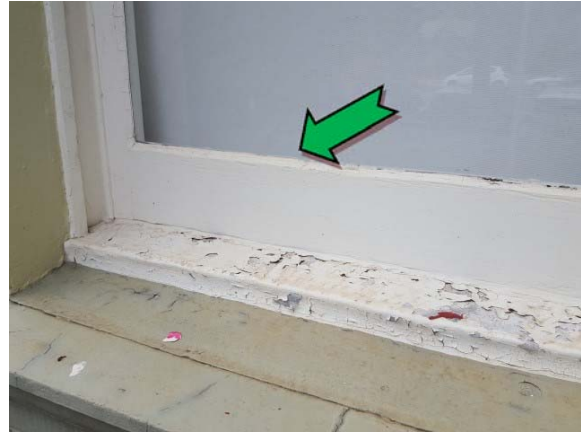
Photo 2. Exterior, throughout, window frames – non asbestos-containing window caulking.

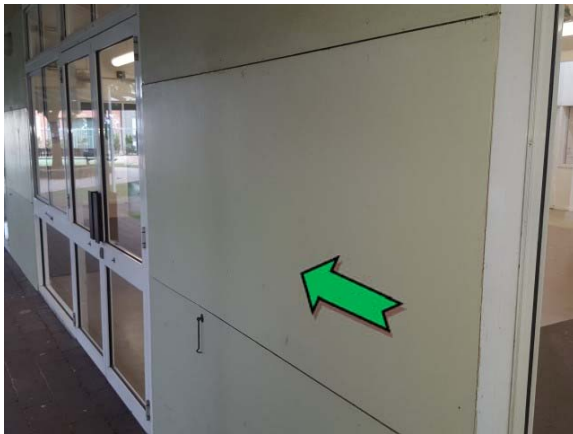
Photo 3. Exterior, throughout, walls – non asbestos-containing fibre cement sheeting.

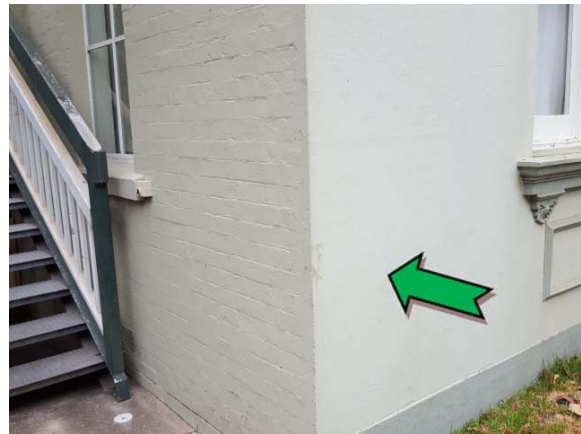
Photo 4. Exterior, throughout, walls – non asbestos-containing textured coating.

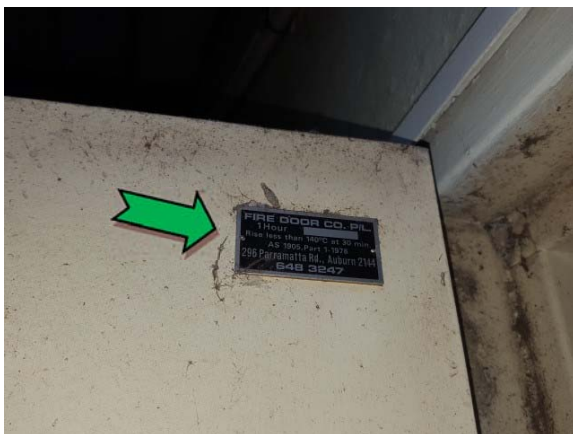
Photo 5. Exterior, main switch board, fire door – non asbestos-containing door core.

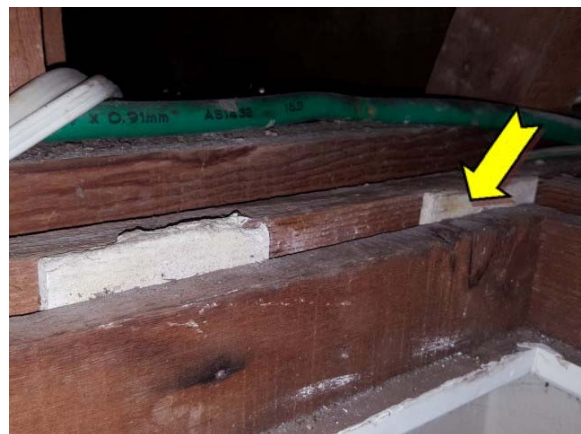
Photo 6. Interior, toilets, packers above ceiling void – non asbestos-containing fibre cement sheeting.

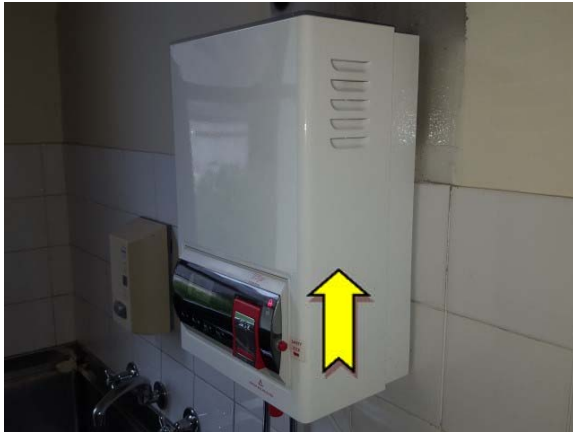
| Area / Level | Room & Location | Feature | Item Description | Hazard Type | Sample No. | Sample Status | Friability | Disturb. Potential | Condition | Risk Status | Approx. Quantity | Recommendations & Comments | Control Priority | Reinspect Date | Photo No. |
|---|---|---|---|---|---|---|---|---|---|---|---|--|---|---|---|
| Interior, level 1 | Kitchen | Hot Water Heater | Insulation material - internal | SMF | - | Suspected Positive | Bonded | Low | Good | Low | 1 unit | Maintain in current condition if to remain in-situ. Remove under controlled SMF conditions as per the Code of Practice for the Safe Use of Synthetic Mineral Fibres [NOHSC: 2006 (1990)]. | - | - | 7 |

Photo 7. Interior, ground level, kitchen, hot water heater – suspected SMF internal insulation.

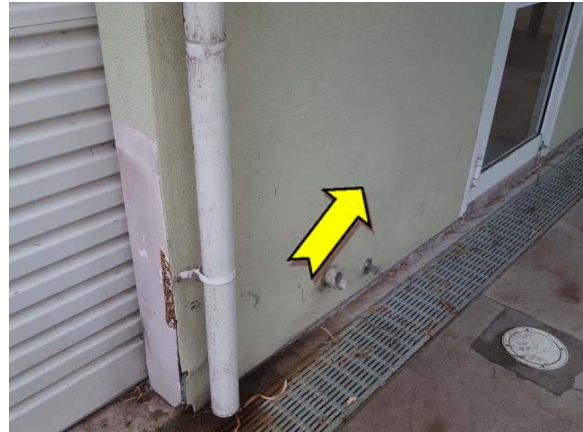
| Area / Level | Room & Location | Feature | Item Description | Hazard Type | Sample No. | Sample Status | Friability | Disturb. Potential | Condition | Risk Status | Approx. Quantity | Recommendations & Comments | Control Priority | Reinspect Date | Photo No. |
|---|---|---|---|---|---|---|---|---|---|---|---|--|---|---|---|
| Exterior | Throughout | Walls | Green (light) - upper coloured paint system | Lead Paint - Swab | - | Suspected Positive | - | Low | Good | Low | 400 m ² | Confirm status by quantitative test method, maintain in current condition, over paint with a lead-free paint as part of ongoing maintenance. Remove under controlled conditions in accordance with AS 4361.2:2017 Guide to hazardous paint management prior to renovation or demolition works. | - | - | 8 |

Photo 8. Exterior, throughout, walls – suspected lead-containing light green upper paint system.

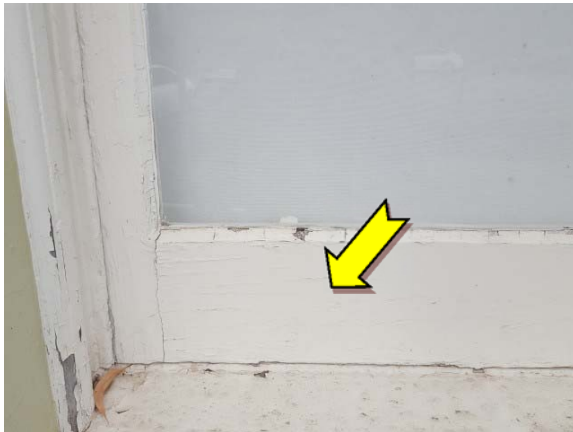
| Area / Level | Room & Location | Feature | Item Description | Hazard Type | Sample No. | Sample Status | Friability | Disturb. Potential | Condition | Risk Status | Approx. Quantity | Recommendations & Comments | Control Priority | Reinspect Date | Photo No. |
|---|---|---|---|---|---|---|---|---|---|---|---|--|---|---|---|
| Exterior | Throughout | Window frames | White - upper coloured paint system | Lead Paint - Swab | - | Suspected Positive | - | Low | Poor | Medium | 30 m ² | Confirm status by quantitative test method, maintain in current condition, over paint with a lead-free paint as part of ongoing maintenance. Remove under controlled conditions in accordance with AS 4361.2:2017 Guide to hazardous paint management prior to renovation or demolition works. | - | - | 9 |

Photo 9. Exterior, throughout, window frames – suspected lead-containing white upper paint system.

- Remove flaking lead containing paint to window surrounds and walls throughout the property in accordance with AS4361.2-2017 Guide to Hazardous Paint Management and relevant legislation.
