Hazardous Building Materials Assessment

Balmain Town Hall

370 Darling Street,
Balmain NSW 2041

Inner West Council
April 2018

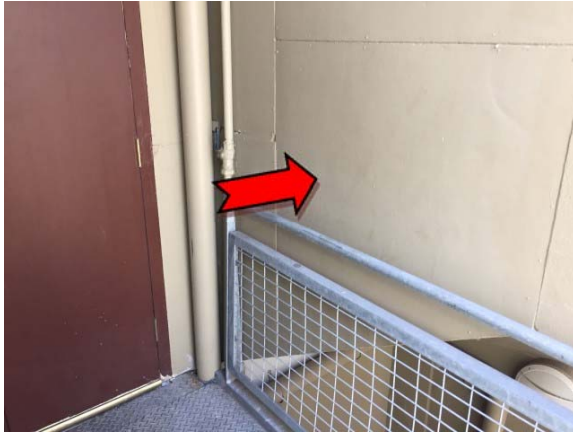
Photo 1. Exterior, level one, fire escape, wall – asbestos-containing fibre cement sheeting.

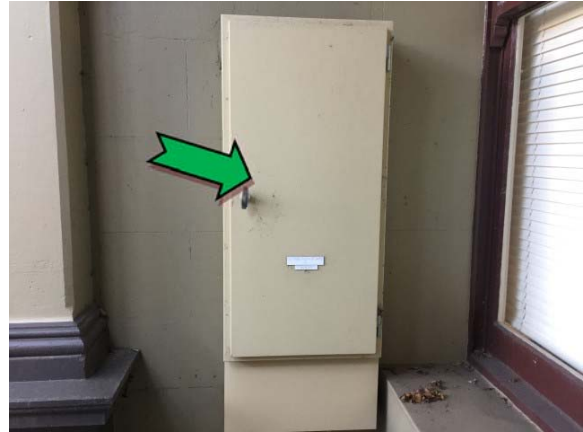
Photo 2. Exterior, west elevation, electrical backing board – suspected non asbestos-containing bituminous backing board.

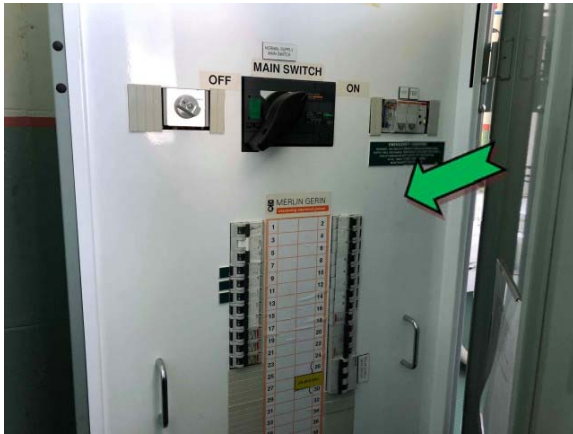
Photo 3. Interior, level one, west elevation, corridor, electrical backing board – suspected non asbestos-containing bituminous backing board.

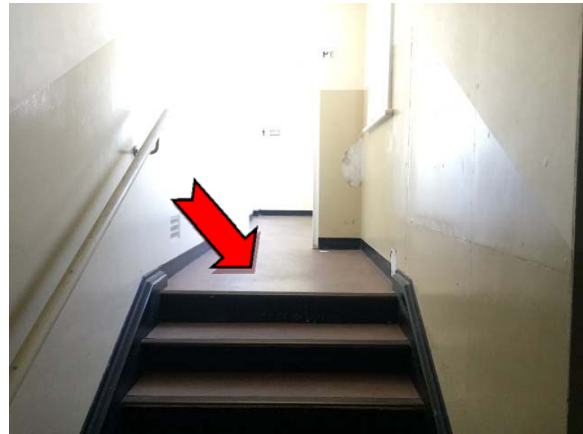
Photo 4. Interior, level one, floor coverings – assumed asbestos-containing sheet vinyl.

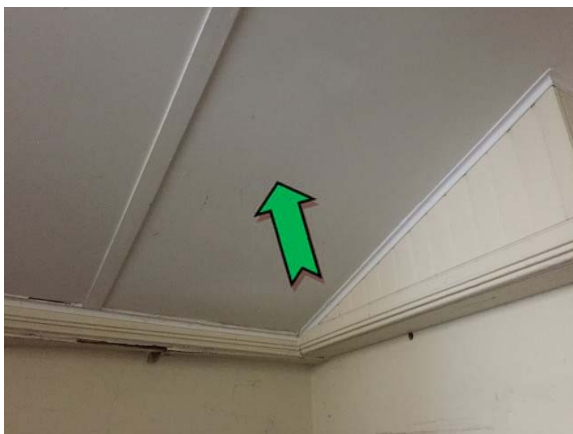
Photo 5. Interior, level one, corridor, adjacent disabled toilets, ceiling – suspected non asbestos-containing fibre cement sheeting.

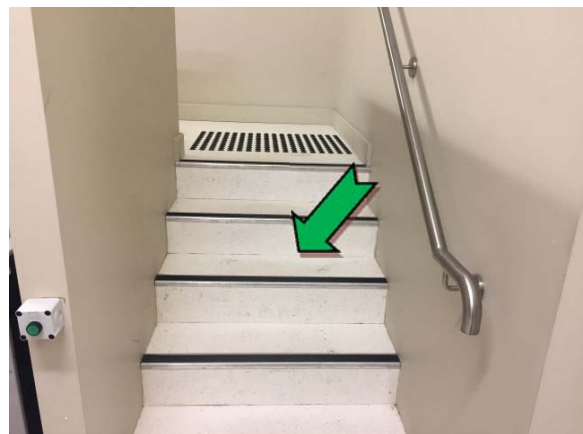
Photo 6. Interior, level one, hall adjacent audio/visual room, floor coverings – suspected non asbestos-containing sheet vinyl.

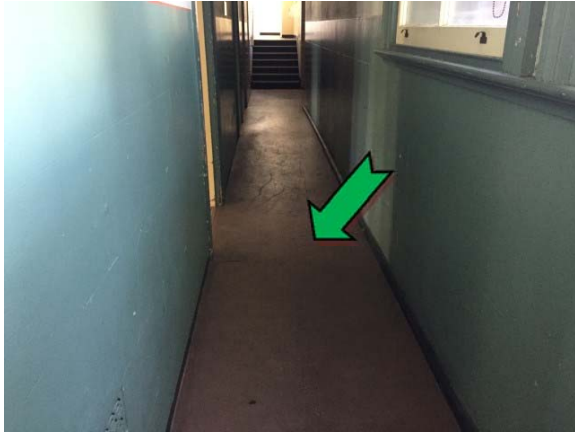
Photo 7. Interior, level one, west corridor, floor coverings – non asbestos-containing sheet vinyl.

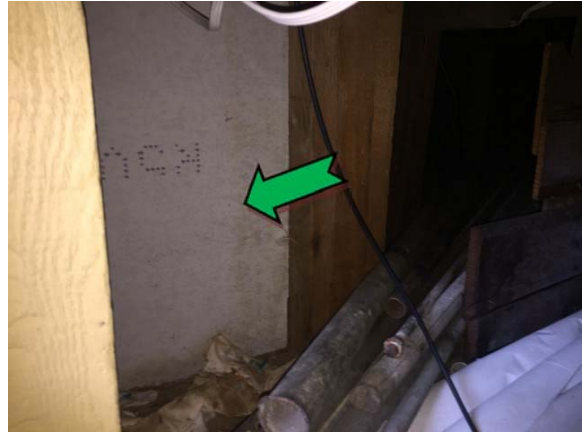
Photo 8. Interior, level one, main hall, beneath stage, wall – non asbestos-containing fibre cement sheeting.

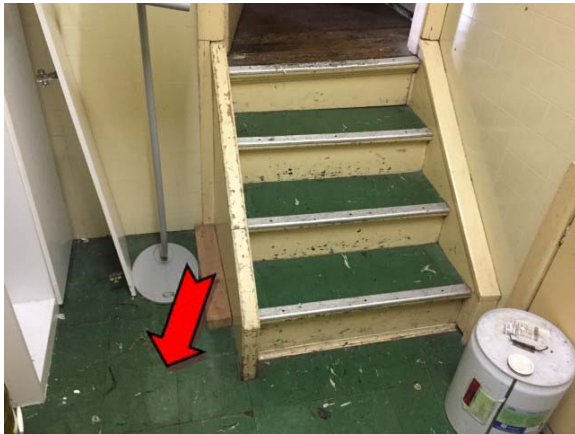
Photo 9. Interior, level one, storeroom, floor coverings – asbestos-containing vinyl floor tiles.

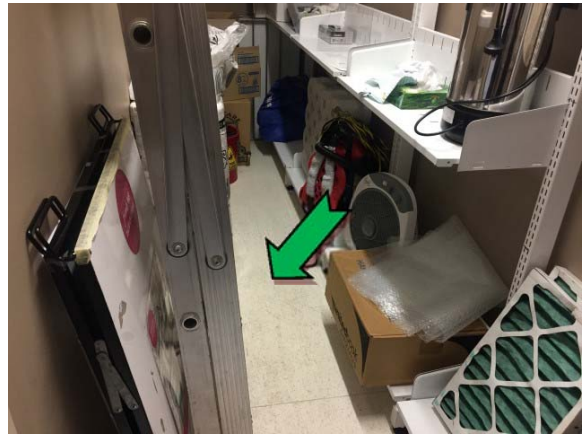
Photo 10. Interior, ground level, meeting room, storage, floor coverings – suspected non asbestos-containing sheet vinyl.

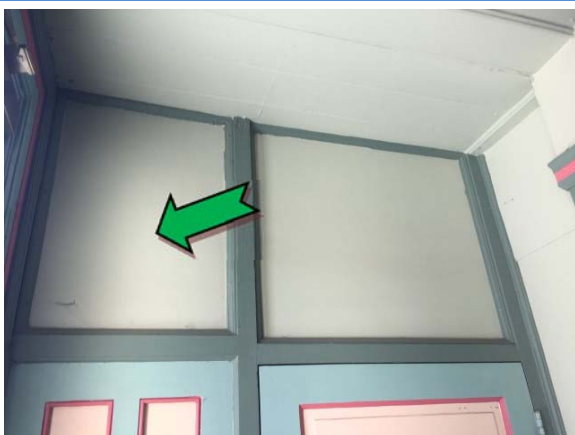
Photo 11. Interior, ground level, north-east elevation, above cupboard, infill panel – non asbestos-containing fibre cement sheeting.

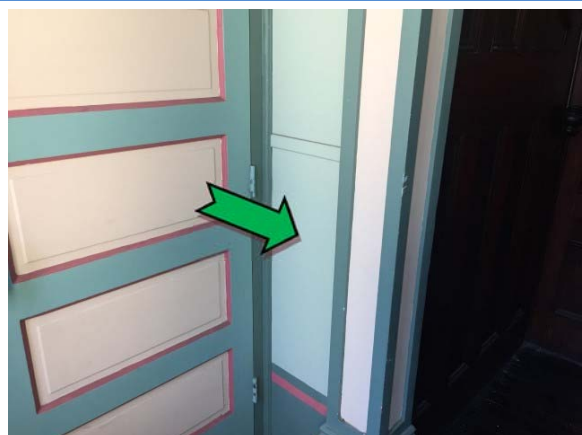
Photo 12. Interior, ground level, north-east elevation, wall – assumed non asbestos-containing fibre cement sheeting.

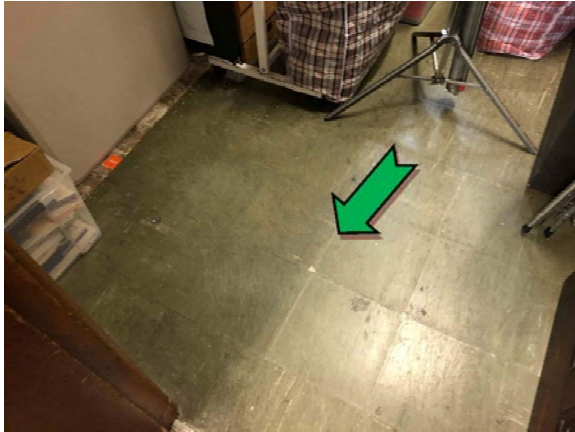
Photo 13. Interior, ground level, floor coverings – non asbestos-containing vinyl floor tiles.

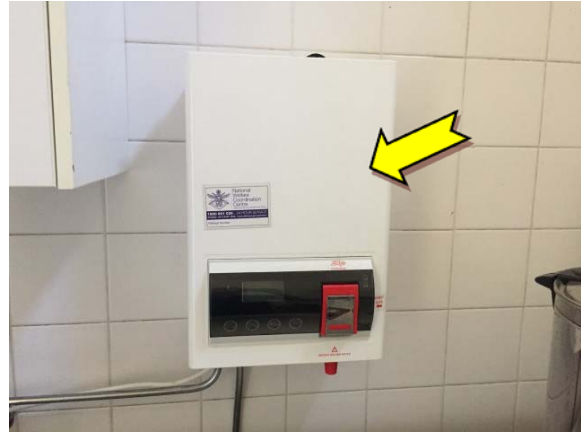
Photo 14. Interior, level one, kitchen, hot water boiler – suspected SMF internal insulation material.

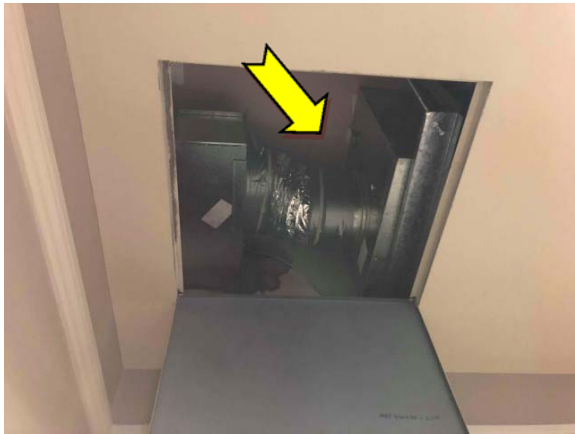
Photo 15. Interior, ground level, ceiling space, throughout, ductwork – suspected SMF internal insulation material.

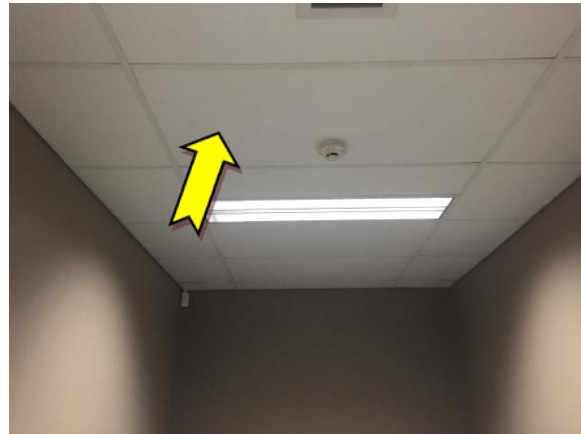
Photo 16. Interior, ground level, toilet, ceiling – suspected SMF compressed ceiling tiles.

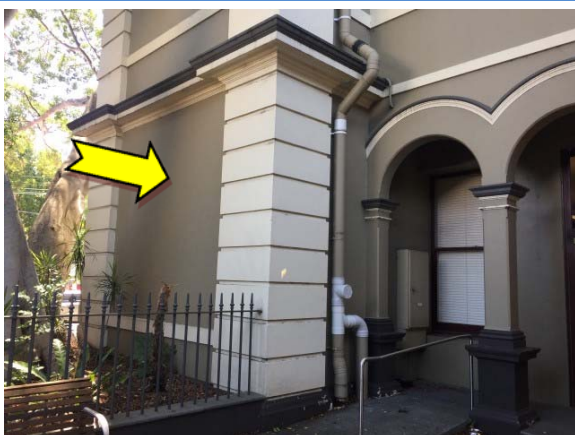
Exterior	Throughout	Walls	White - lower coloured paint system	Lead Paint - Swab	-	Positive	-	Low	Fair	Low	600 m ²	Remove flaking sections and over paint with a lead-free paint. Remove under controlled conditions in accordance with AS 4361.2:2017 Guide to hazardous paint management prior to renovation or demolition works.	-	-	17
Exterior	Throughout	Windows & door frames	Red (dark) - upper coloured paint system	Lead Paint - Swab	-	Suspected Positive	-	Low	Good	Low	50 m ²	Confirm status by quantitative test method, maintain in current condition, over paint with a lead-free paint as part of ongoing maintenance. Remove under controlled conditions in accordance with AS 4361.2:2017 Guide to hazardous paint management prior to renovation or demolition works.	-	-	
Exterior	Throughout	Walls	Green - upper coloured paint system	Lead Paint - Swab	-	Suspected Positive	-	Low	Good	Low	550 m ²	Confirm status by quantitative test method, maintain in current condition, over paint with a lead-free paint as part of ongoing maintenance. Remove under controlled conditions in accordance with AS 4361.2:2017 Guide to hazardous paint management prior to renovation or demolition works.	-	-	17

Photo 17. Exterior, throughout, walls – lead-containing white lower paint systems and suspected lead-containing green upper paint systems.

- Remove flaking lead containing paint to walls throughout the property and walls within the ceiling space in accordance with AS4361.2-2017 Guide to Hazardous Paint Management and relevant legislation.

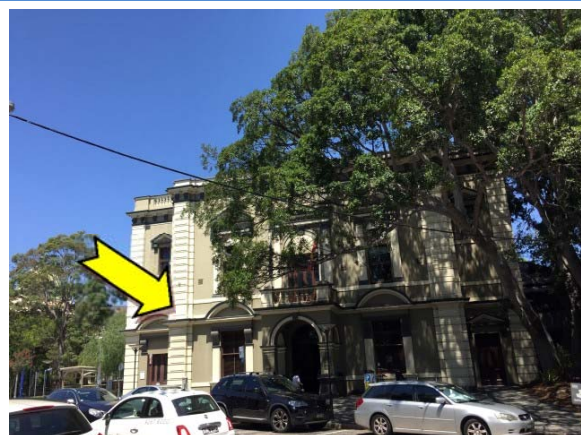
Photo 18. Exterior, throughout, features – suspected lead-containing cream upper paint systems.

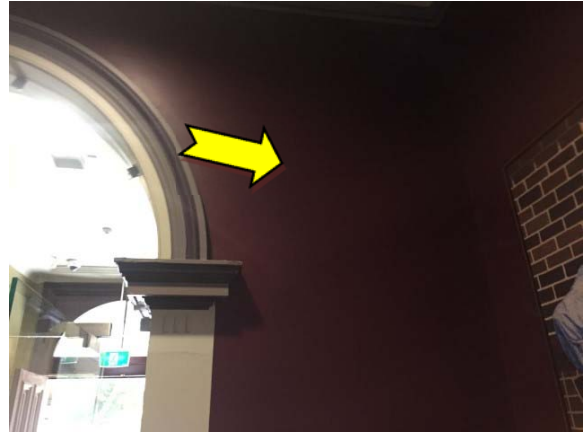
Photo 20. Interior, ground level, entrance, walls – suspected lead-containing red and light green upper paint systems.

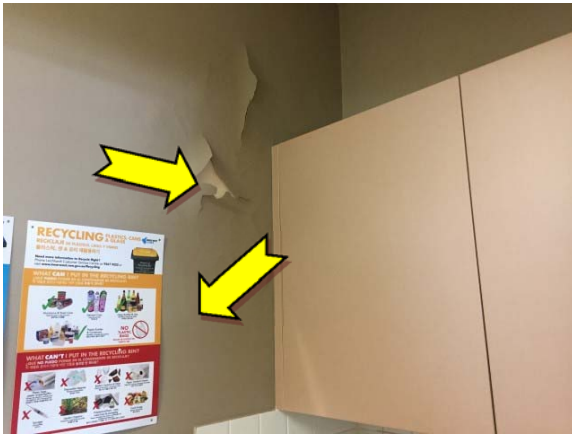
Photo 21. Interior, ground level, throughout, walls – lead-containing white lower and suspected lead-containing green upper coloured paint systems.
