Hazardous Building Materials Assessment Gladstone Park Toilet Block Darling Street, Balmain NSW 2041

Inner West Council
April 2018

Job No.: 57722-072

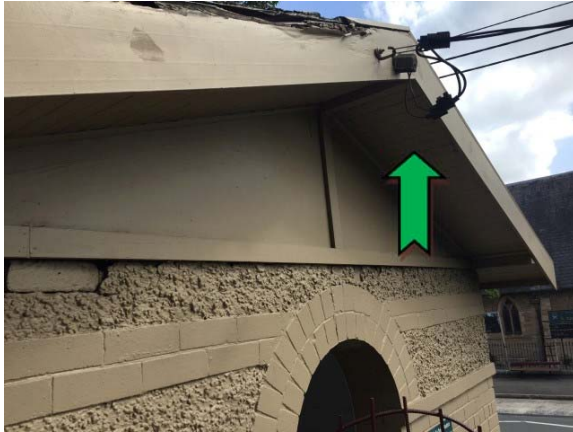
Photo 1. Exterior, east and west elevation, gable – non asbestos-containing fibre cement sheeting.

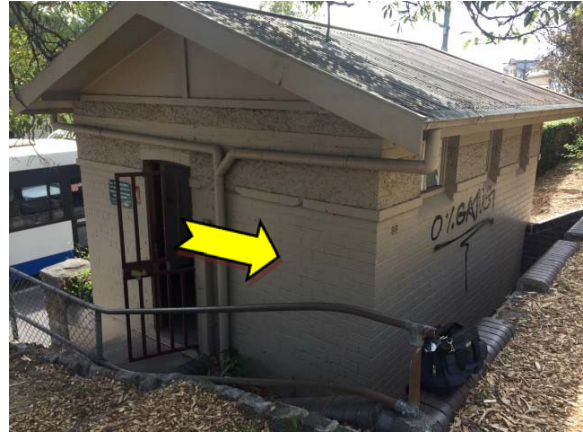
Photo 2. Exterior, throughout, walls – suspected lead-containing beige upper paint systems.

- LCP was suspected in the form of beige upper and white lower coloured paint systems to the exterior of the building.
- LCP was suspected in the form of white and red upper coloured paint systems throughout the interior of the building.

- The *LeadCheck* paint swab method can detect lead in paint at concentrations of 0.5% and above, and may indicate lead in some paint films as low as 0.2%. As paint with a lead content greater than 0.1% by dry weight is now considered to be lead-containing, Prensa recommends confirming status of suspected LCP identified during the Assessment by quantitative test method.

- The safest method of dealing with LCP is to replace or remove the items in their entirety that have LCP on them and replace them with new items that do not contain lead. This allows the items to be disposed of as regular building or demolition unsegregated waste in accordance with the NSW Environment Protection Authority (EPA) *Waste Classification Guidelines 2014 Part 1 – Classifying Waste*. The advantage of this method is the reduction in labour requirements to remove the lead paint and also this reduces the risk to workers from exposure to lead dust or fumes. If the removal of the LCP or coatings is the preferred or required option this may generate significant amounts of potential hazardous waste. This waste must be removed, collected and disposed of by an appropriately licensed contractor under controlled conditions that minimises the release to air, water and soil. Disposal of lead waste must be disposed of as hazardous waste at an approved waste facility.

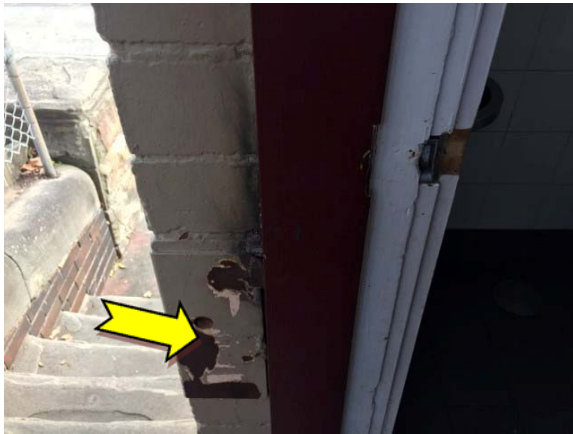
Exterior	Throughout	Walls - External	White - lower coloured paint system	Lead Paint - Swab	-	Suspected Positive	-	Low	Good	Low	100 m ²	Confirm status by quantitative test method, maintain in current condition, over paint with a lead-free paint as part of ongoing maintenance. Remove under controlled conditions in accordance with AS 4361.2:2017 Guide to hazardous paint management prior to renovation or demolition works.	-	-	3
Interior	Throughout	Ceiling	White - upper coloured paint system	Lead Paint - Swab	-	Suspected Positive	-	Low	Good	Low	25 m ²	Confirm status by quantitative test method, maintain in current condition, over paint with a lead-free paint as part of ongoing maintenance. Remove under controlled conditions in accordance with AS 4361.2:2017 Guide to hazardous paint management prior to renovation or demolition works.	-	-	4
Interior	Throughout	Windows & door frames	White - upper coloured paint system	Lead Paint - Swab	-	Suspected Positive	-	Low	Fair	Low	6 m ²	Confirm status by quantitative test method, maintain in current condition, over paint with a lead-free paint as part of ongoing maintenance. Remove under controlled conditions in accordance with AS 4361.2:2017 Guide to hazardous paint management prior to renovation or demolition works.	-	-	-

Photo 3. Exterior, throughout, walls – suspected lead-containing white lower paint system.

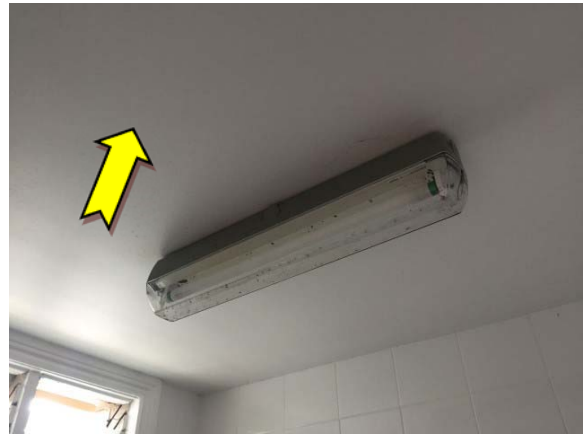
Photo 4. Interior, throughout ceiling – suspected lead-containing white upper paint system.
