Hazardous Building Materials Assessment Gladstone Park Bowling Clubhouse Darvall Street, Balmain NSW 2041

Inner West Council
April 2018

Job No.: 57722-157

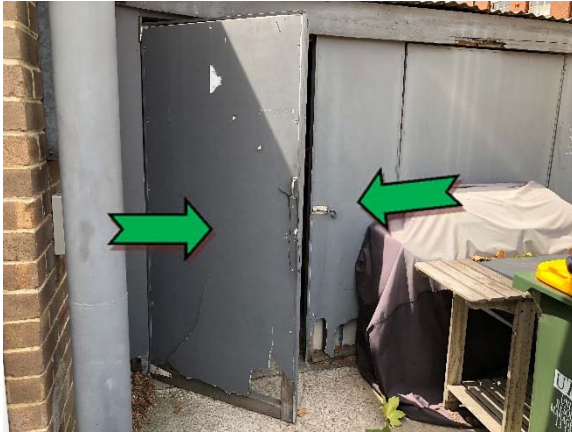
Photo 1. Exterior, shed, external walls and door – non asbestos-containing fibre cement sheeting.

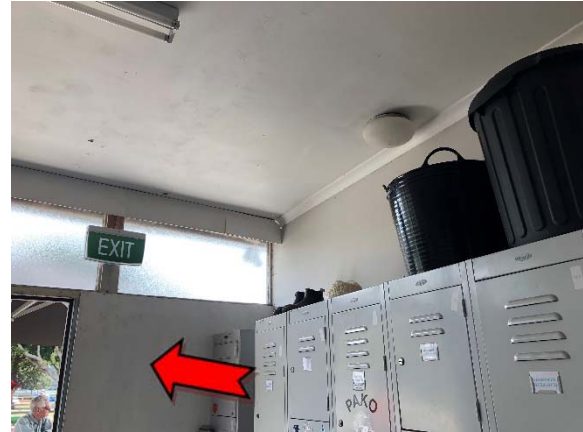
Photo 2. Exterior/interior, locker room, west elevation, walls – asbestos-containing fibre cement sheeting.

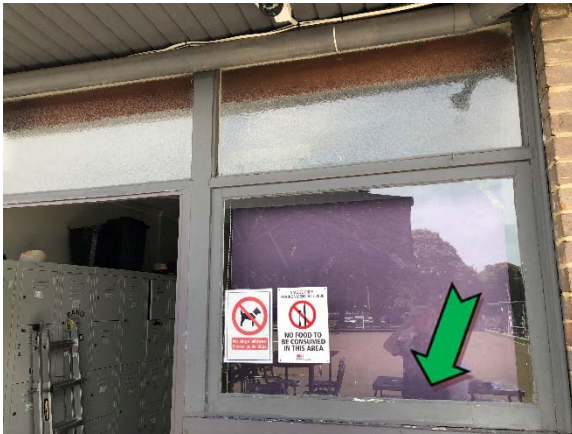
Photo 3. Exterior, locker room, window frames – non asbestos-containing window caulking.

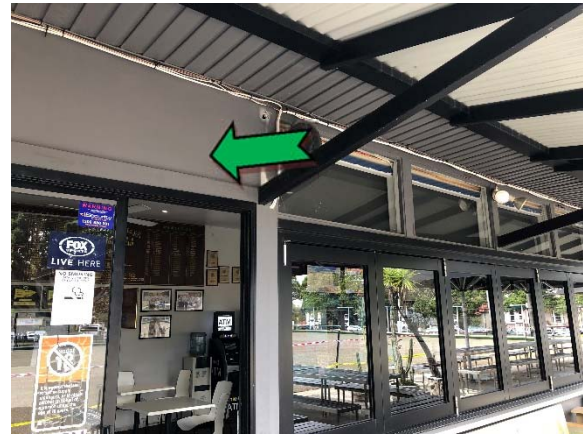
Photo 4. Exterior, north elevation, wall – non asbestos-containing fibre cement sheeting.

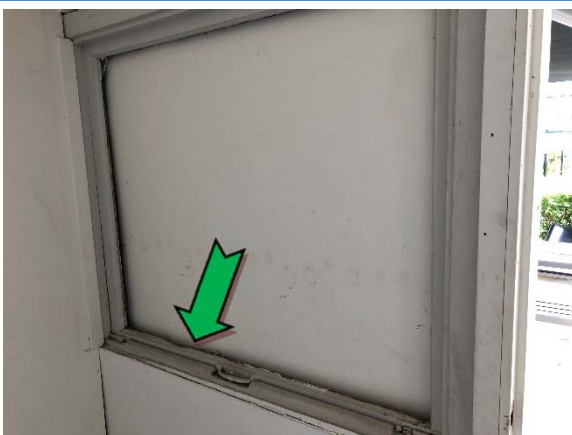
Photo 5. Exterior, north elevation, adjacent toilets, window frames – non asbestos-containing window caulking.

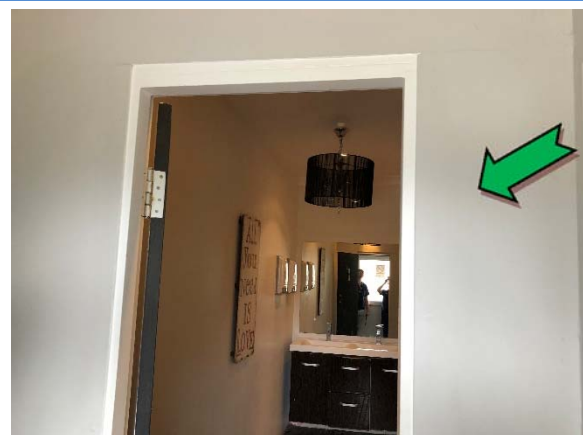
Photo 6. Exterior, female toilets, north and west elevations, walls – non asbestos-containing fibre cement sheeting.

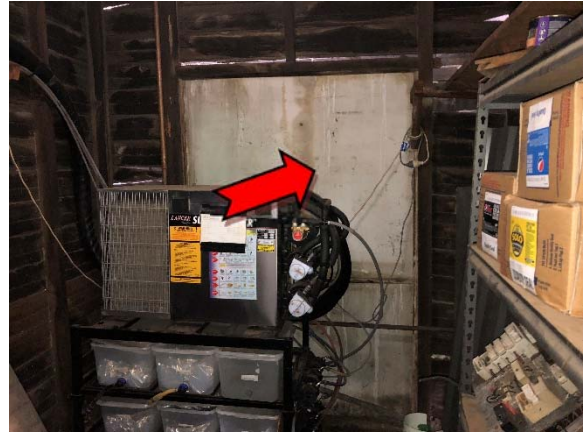
Photo 8. Interior, shed, south-east elevation, infill panels – asbestos-containing fibre cement sheeting.

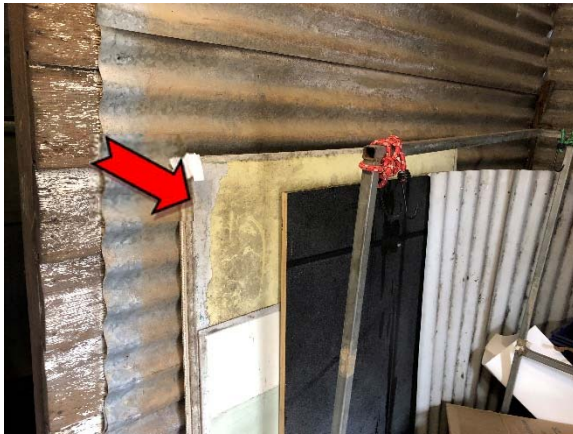
Photo 9. Interior, shed, in front of wall partition, redundant panels – asbestos-containing fibre cement sheeting.

- Remove asbestos-containing debris and redundant panels identified adjacent to the bar and in and around the shed under controlled non-friable asbestos conditions by a Class B (non-friable) licensed asbestos removal contractor.

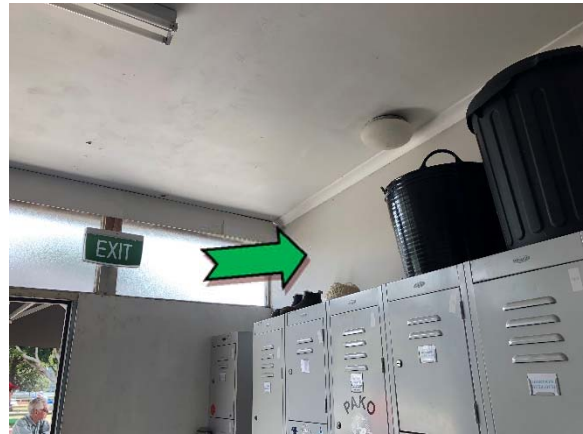
Interior	Shed, in front of partition	Redundant	Fibre cement sheeting	Asbestos	57722-157-002	Positive	Non-friable	High	Poor	Medium	2 m ²	Remove under controlled non-friable asbestos removal conditions prior to refurbishment or demolition works by a Class B (non-friable) licensed asbestos removal contractor.	P1	Aug-18	9
Interior	Locker room, northern elevation	Wall	Fibre cement sheeting	Asbestos	57722-157-005	Negative (Refer to Comments)	Non-friable	Low	Good	Low	16 m ²	Laboratory result returned as no asbestos fibres detected, however due to the visual similarity between this feature and another (57722-157-004) which has returned positive, it is reasonable to suspect this panel to be a replacement. Therefore all panels are to be assumed asbestos-containing. Label as containing asbestos and maintain in current condition if to remain in-situ. Remove under controlled non-friable asbestos removal conditions prior to refurbishment or demolition works by a Class B (non-friable) licensed asbestos removal contractor.	P4	Feb-23	10

Photo 10. Interior, locker room, north elevation, wall – suspected asbestos-containing fibre cement sheeting.

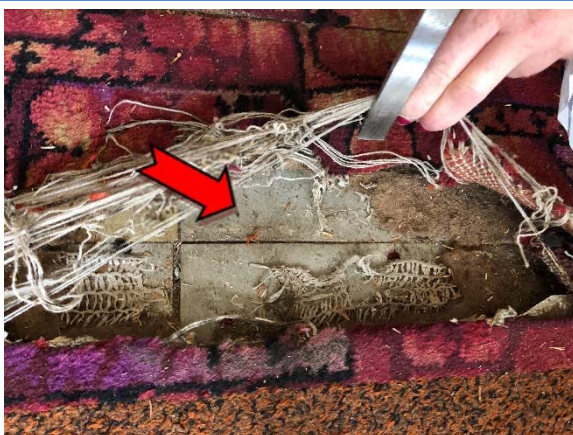
Interior	Locker room, under carpet	Floor coverings - grey	Vinyl floor tiles	Asbestos	57722-157-006A	Positive	Non-friable	Low	Good	Low	15 m ²	Label as containing asbestos and maintain in current condition if to remain in-situ. Remove under controlled non-friable asbestos removal conditions prior to refurbishment or demolition works by a Class B (non-friable) licensed asbestos removal contractor.	P4	Feb-23	11

Photo 11. Interior, locker room, under carpet, floor coverings – asbestos-containing vinyl floor tiles.

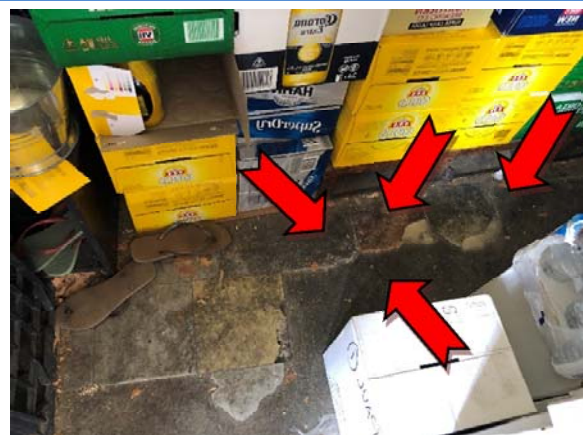
Interior	Behind bar, storage area	Floor coverings - black	Vinyl floor tiles	Asbestos	57722-157-008	Positive	Non-friable	Low	Good	Low	2 m ²	Label as containing asbestos and maintain in current condition if to remain in-situ. Remove under controlled non-friable asbestos removal conditions prior to refurbishment or demolition works by a Class B (non-friable) licensed asbestos removal contractor.	P4	Feb-23	12	
Interior	Behind bar, storage area	Floor coverings - red	Vinyl floor tiles	Asbestos	57722-157-009	Positive	Non-friable	Low	Good	Low	2 m ²	Label as containing asbestos and maintain in current condition if to remain in-situ. Remove under controlled non-friable asbestos removal conditions prior to refurbishment or demolition works by a Class B (non-friable) licensed asbestos removal contractor.	P4	Feb-23	12	
Interior	Behind bar, storage area	Floor coverings - yellow	Vinyl floor tiles	Asbestos	57722-157-010A	Positive	Non-friable	Low	Good	Low	2 m ²	Label as containing asbestos and maintain in current condition if to remain in-situ. Remove under controlled non-friable asbestos removal conditions prior to refurbishment or demolition works by a Class B (non-friable) licensed asbestos removal contractor.	P4	Feb-23	12

Photo 12. Interior, storage area behind bar, floor coverings (red, yellow, black & blue) – asbestos-containing vinyl floor tiles and adhesive.

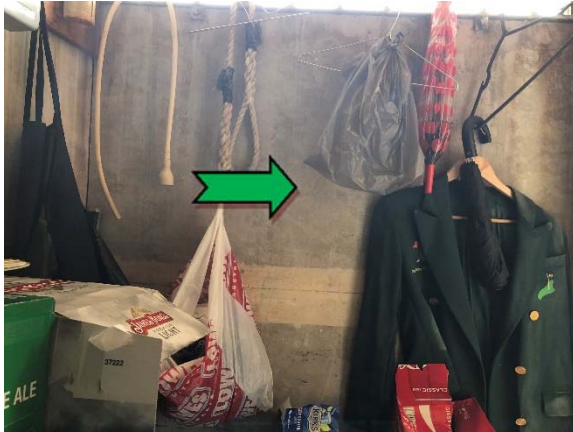
Interior	Behind bar, storage area, south elevation	Wall	Fibre cement sheeting	Asbestos	57722-157-012	Negative	-	-	-	-	-	-	-	-	-	13
Interior	Adjacent bar, on floor	Debris	Compressed cement sheeting	Asbestos	57722-157-013A	Positive	Non-friable	Low	Good	Low	2 m ²	Remove under controlled non-friable asbestos removal conditions prior to refurbishment or demolition works by a Class B (non-friable) licensed asbestos removal contractor.	P1	Aug-18	14	
Interior	Adjacent bar, on floor	Debris	Bituminous material	Asbestos	57722-157-013B	Positive	Non-friable	Low	Good	Low	2 m ²	Remove under controlled non-friable asbestos removal conditions prior to refurbishment or demolition works by a Class B (non-friable) licensed asbestos removal contractor.	P1	Aug-18	-	
Interior	Adjacent bar, under tiles	Floor coverings - white	Vinyl floor tiles	Asbestos	57722-157-014A	Positive	Non-friable	Low	Good	Low	2 m ²	Label as containing asbestos and maintain in current condition if to remain in-situ. Remove under controlled non-friable asbestos removal conditions prior to refurbishment or demolition works by a Class B (non-friable) licensed asbestos removal contractor.	P4	Feb-23	-

Photo 13. Interior, behind bar, storage area, west elevation, wall – non asbestos-containing fibre cement sheeting.

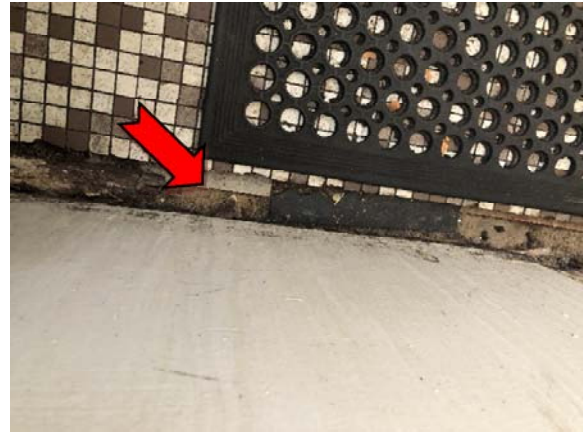
Photo 14. Interior, adjacent bar, on floor, debris – asbestos-containing compressed cement sheeting.

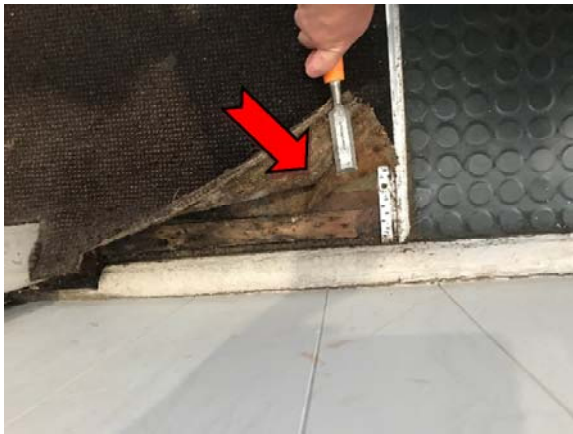
Interior	Bar area, floor covering	Floor coverings - blue	Adhesive	Asbestos	57722-157-011B	Negative (Refer to Comments)	-	-	-	-	-	Laboratory result returned as no asbestos fibres detected, however due to the non homogeneous nature and close proximity between this feature and another (57722-157-010B) which has returned positive, it is reasonable to suspect all adhesive to vinyl tiles to be assumed positive. Therefore all adhesives are to be assumed asbestos-containing. Label as containing asbestos and maintain in current condition if to remain in-situ. Remove under controlled non-friable asbestos removal conditions prior to refurbishment or demolition works by a Class B (non-friable) licensed asbestos removal contractor.	P4	Feb-23	-
Interior	Bar area, floor covering	Floor coverings - yellow	Vinyl floor tiles	Asbestos	Same as: 57722-157-010A	Assumed Positive	Non-friable	Low	Good	Low	10 m ²	Label as containing asbestos and maintain in current condition if to remain in-situ. Remove under controlled non-friable asbestos removal conditions prior to refurbishment or demolition works by a Class B (non-friable) licensed asbestos removal contractor.	P4	Feb-23	15

Photo 15. Interior, bar area, beneath carpet, floor coverings (red, blue, yellow, white and black) – assumed asbestos-containing vinyl floor tiles and adhesive.

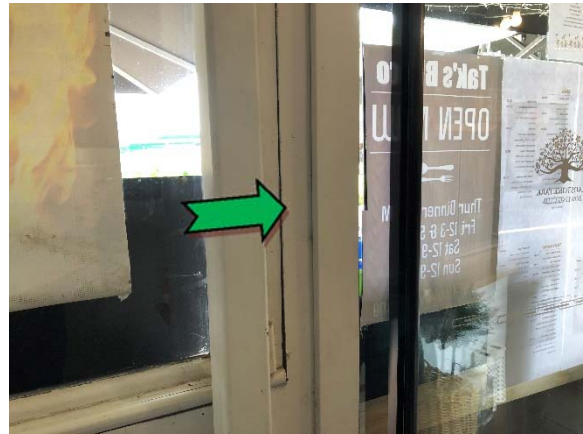
Photo 16. Interior, adjacent gaming room, corridor, infill panel – non asbestos-containing fibre cement sheeting.

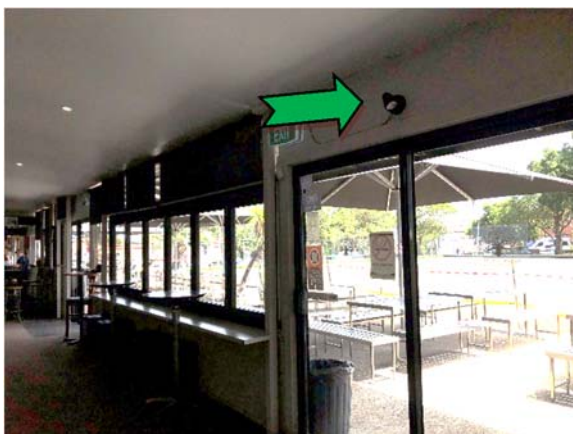
Photo 17. Interior, north-west elevation, door position, infill panels – non asbestos-containing fibre cement sheeting.

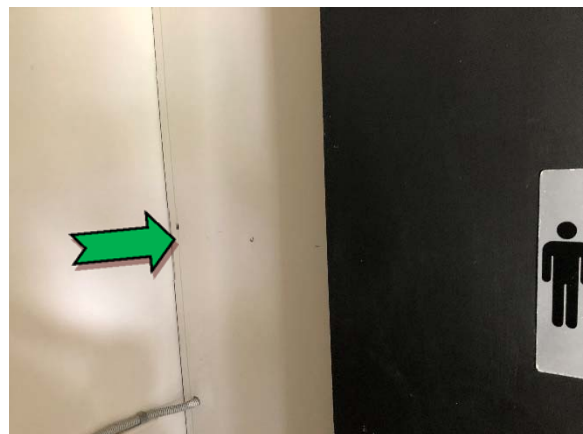
Photo 18. Interior, mens toilet lobby, south elevation, wall – non asbestos-containing fibre cement sheeting.

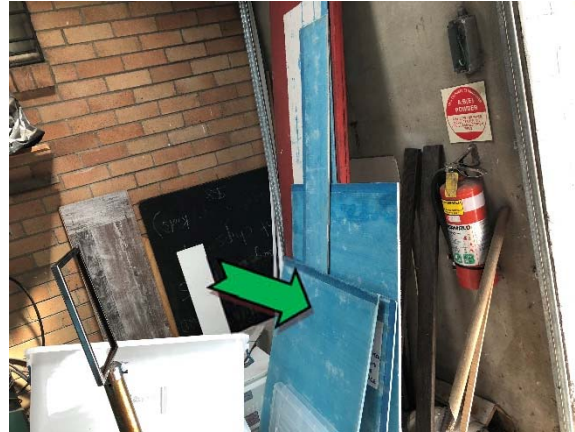
Photo 20. Interior, north elevation, garage/store, redundant panels – non asbestos-containing fibre cement sheeting.

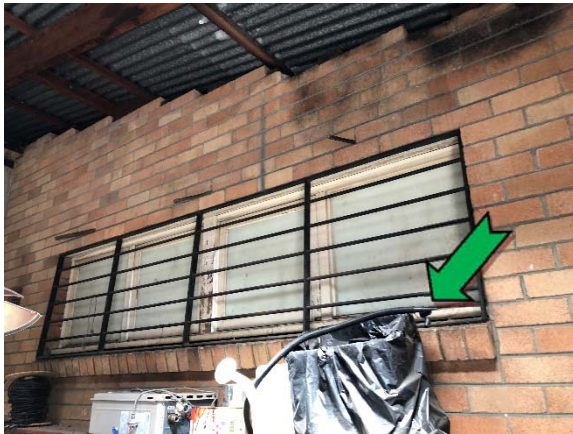
Photo 21. Interior, north elevation, garage/store, window frames – non asbestos-containing window caulking.

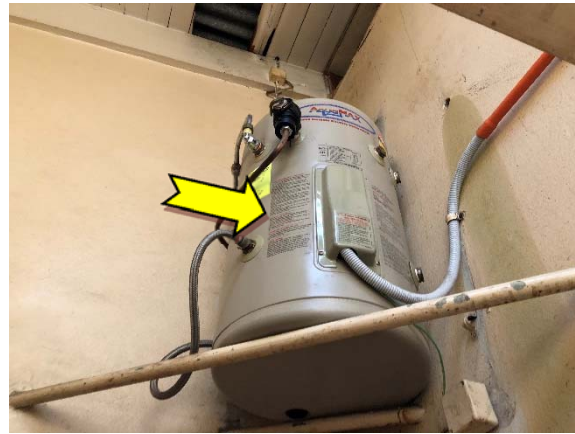
Photo 22. Interior, locker room, toilet, hot water heater – suspected SMF internal insulation material.

- SMF materials that are likely to be disturbed during any proposed demolition/refurbishment works should be handled in accordance with the *Code of Practice for the Safe Use of Synthetic Mineral Fibres* [NOHSC:2006(1990)]. If these materials are impacted upon by accident or by pre-planned works, the Inner West Council must be informed via the contact detailed within Section 7: *Accidental Disturbance of Known or Suspected Hazardous Building Materials*. Following disturbance, inspection by a competent person should be undertaken.

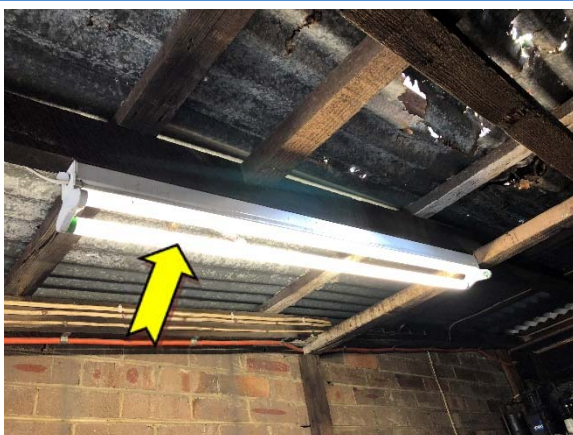
Area / Level	Room & Location	Feature	Item Description	Hazard Type	Sample No.	Sample Status	Friability	Disturb. Potential	Condition	Risk Status	Approx. Quantity	Recommendations & Comments	Control Priority	Reinspect Date	Photo No.
Interior	Northern elevation, garage/store, window	Throughout	Window caulking	Asbestos	57722-157-021	Negative	-	-	-	-	-	-	-	-	21
Interior/ Exterior	Shed, adjacent door	Debris	Fibre cement sheeting	Asbestos	57722-157-022	Negative	-	-	-	-	-	-	-	-	-
Interior	Locker room, toilet	Hot water heater	Insulation material - internal	SMF	-	Suspected Positive	Bonded	Low	Good	Low	1 unit	Maintain in current condition if to remain in-situ. Remove under controlled SMF conditions as per the Code of Practice for the Safe Use of Synthetic Mineral Fibres [NOHSC: 2006 (1990)].	-	-	22
Interior	Shed	Fluorescent light fitting - single tube	Capacitor	PCBs	Not sampled - live	Suspected Positive	-	-	-	-	1 unit	PCB-containing capacitors are suspected due to age & appearance of electrical fittings. Remove and dispose of in accordance with the Polychlorinated Biphenyls Management Plan, Revised Edition April 2003.	-	-	23

Photo 23. Interior, shed, double tube fluorescent light fitting – suspected PCB-containing capacitors.

- Electrical fittings suspected of containing PCB oil capacitors should be treated as containing PCB oils until such time as evidence suggest otherwise e.g. further assessed.
- Electrical fittings that contain or suspected to contain PCB oil-containing capacitors should be removed as hazardous/regulated waste under controlled working conditions prior to the demolition or refurbishment works in accordance with the *Polychlorinated Biphenyls Management Plan, Revised Edition April 2003*.

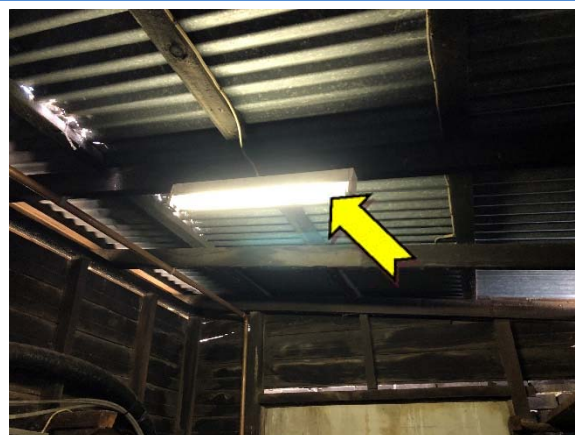
Photo 24. Interior, shed, single tube fluorescent light fitting – suspected PCB-containing capacitors.

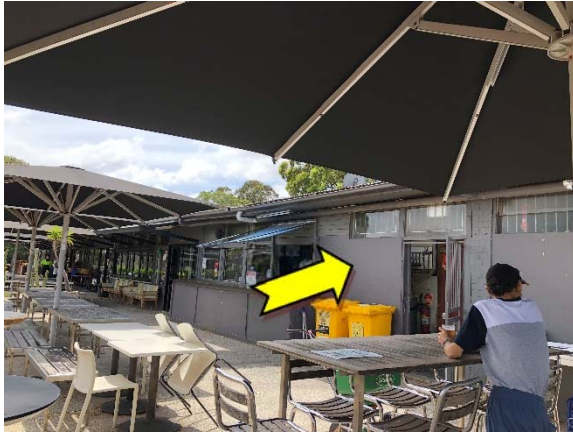
Photo 25. Exterior, throughout, walls – suspected lead-containing grey upper paint systems.

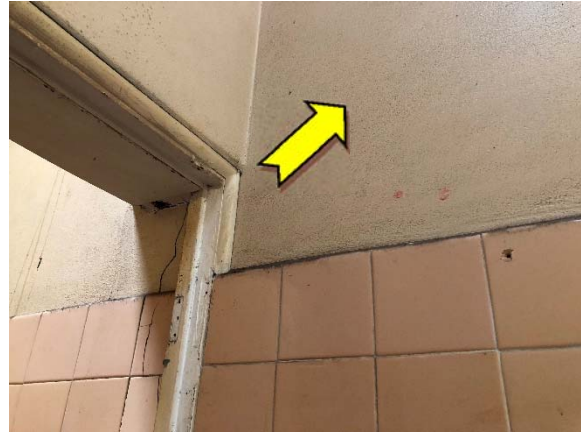
Interior	Locker room, throughout	Walls	Grey (light) - upper coloured paint system	Lead Paint - Swab	-	Suspected Positive	-	Low	Good	Low	40 m ²	Confirm status by quantitative test method, maintain in current condition, over paint with a lead-free paint as part of ongoing maintenance. Remove under controlled conditions in accordance with AS 4361.2:2017 Guide to hazardous paint management prior to renovation or demolition works.	-	-	-
Interior	Locker room, throughout	Ceiling	White - upper coloured paint system	Lead Paint - Swab	-	Suspected Positive	-	Low	Good	Low	15 m ²	Confirm status by quantitative test method, maintain in current condition, over paint with a lead-free paint as part of ongoing maintenance. Remove under controlled conditions in accordance with AS 4361.2:2017 Guide to hazardous paint management prior to renovation or demolition works.	-	-	-
Interior	Locker room, sink and toilet area, throughout	Walls	Cream - upper coloured paint system	Lead Paint - Swab	-	Positive	-	Low	Fair	Low	25 m ²	Maintain in current condition, over paint with a lead-free paint as part of ongoing maintenance. Remove under controlled conditions in accordance with AS 4361.2:2017 Guide to hazardous paint management prior to renovation or demolition works.	-	-	26

Photo 26. Interior, locker room, toilet and sink area, walls – lead-containing cream upper paint systems.

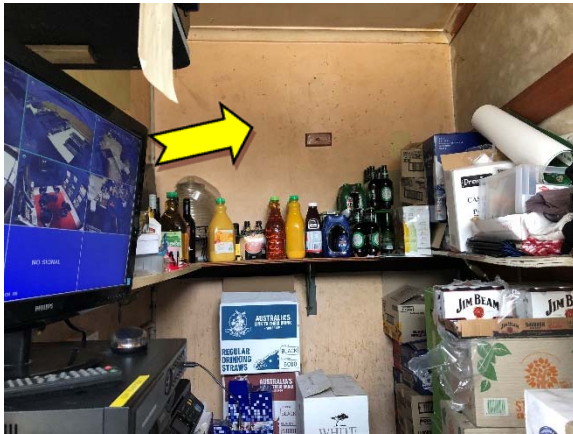
Area / Level	Room & Location	Feature	Item Description	Hazard Type	Sample No.	Sample Status	Friability	Disturb. Potential	Condition	Risk Status	Approx. Quantity	Recommendations & Comments	Control Priority	Reinspect Date	Photo No.
Interior	Behind bar, storage area, throughout	Ceiling	Beige - upper coloured paint system	Lead Paint - Swab	-	Positive	-	Low	Good	Low	20 m ²	Maintain in current condition, over paint with a lead-free paint as part of ongoing maintenance. Remove under controlled conditions in accordance with AS 4361.2:2017 Guide to hazardous paint management prior to renovation or demolition works.	-	-	-
Interior	Adjacent bar, northern wall	Wall	Cream - upper coloured paint system	Lead Paint - Swab	-	Positive	-	Low	Good	Low	6 m ²	Maintain in current condition, over paint with a lead-free paint as part of ongoing maintenance. Remove under controlled conditions in accordance with AS 4361.2:2017 Guide to hazardous paint management prior to renovation or demolition works.	-	-	27

Photo 27. Interior, adjacent bar, storage room, walls – lead-containing cream upper paint systems.

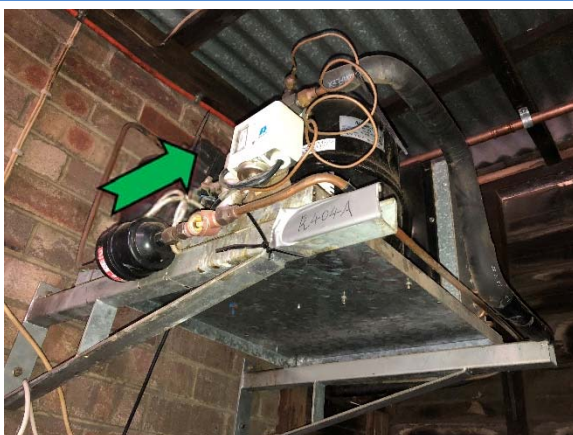
Photo 29. Interior, shed, chiller – Non ODS-containing R410A refrigerant gas.
