# Hazardous Building Materials Assessment

## Balmain East Craft Cottage

13 Union Street,  
Balmain East NSW 2041

April 2018

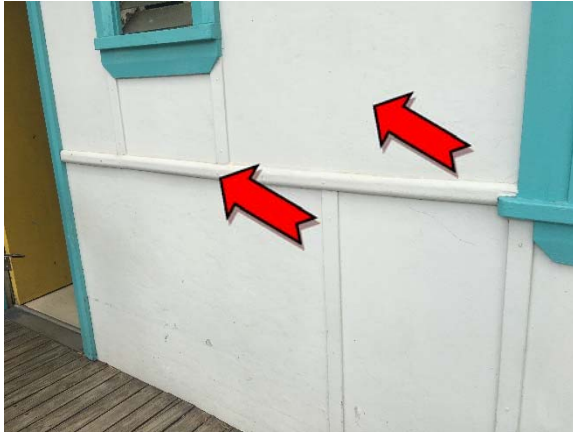
**Photo 1.** Exterior, throughout wall beading and walls – asbestos-containing moulded fibre cement and fibre cement sheeting and suspected lead-containing white upper paint systems.

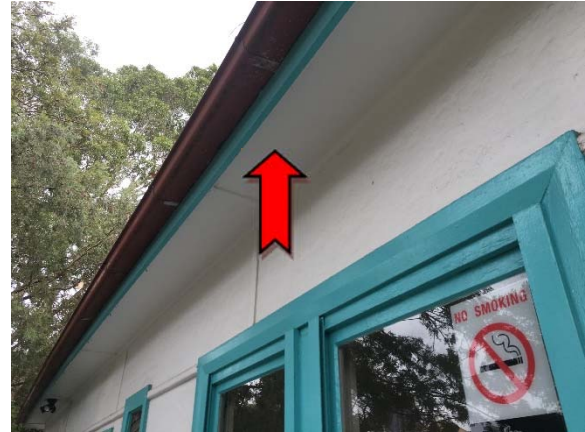
Exterior	Throughout	Eaves	Fibre cement sheeting	Asbestos	Not sampled: occupied	Suspected Positive	Non-friable	Low	Good	Low	20 m <sup>2</sup>	Confirm status, label as containing asbestos and maintain in current condition if to remain in-situ. Remove under controlled non-friable asbestos removal conditions prior to refurbishment or demolition works by a Class B (non-friable) licensed asbestos removal contractor.	P4	Feb-23	2	
Interior	Kitchenette	Walls	Fibre cement sheeting	Asbestos	57722-096-002	Negative	-	-	-	-	-	-	-	-	-	3
Interior	Corridor, east elevation	Walls	Fibre cement sheeting	Asbestos	57722-096-003	Negative	-	-	-	-	-	-	-	-	-	4
Interior	Play room, throughout	Walls	Fibre cement sheeting	Asbestos	Not sampled - timber	Suspected Negative	-	-	-	-	-	Suspected negative due to age and appearance.	-	-	-	5
Interior	Bathroom, throughout	Walls	Fibre cement sheeting	Asbestos	57722-096-005	Negative	-	-	-	-	-	-	-	-	-	6

**Photo 2.** Exterior, throughout, eaves – suspected asbestos-containing fibre cement sheeting.

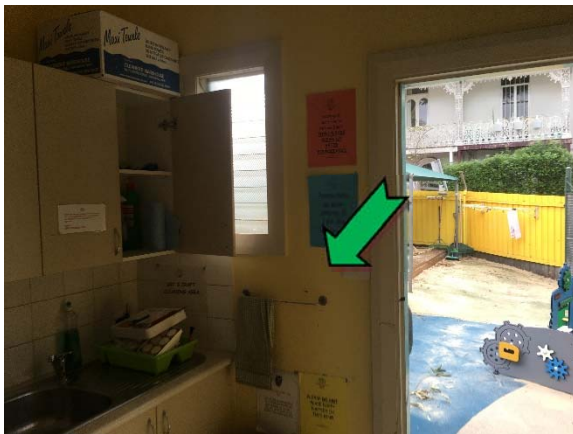
**Photo 3.** Interior, kitchen, walls – non asbestos-containing fibre cement sheeting.

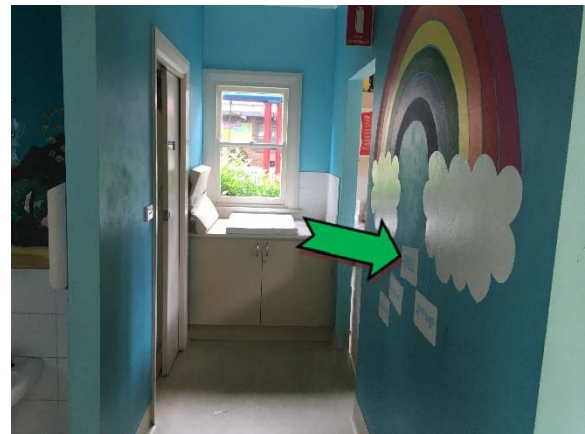
**Photo 4.** Interior, east corridor, walls – non asbestos-containing fibre cement sheeting.

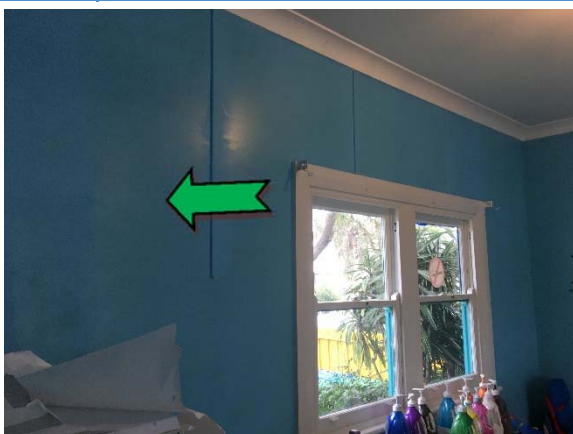
**Photo 5.** Interior, play room, walls – suspected non asbestos-containing material.

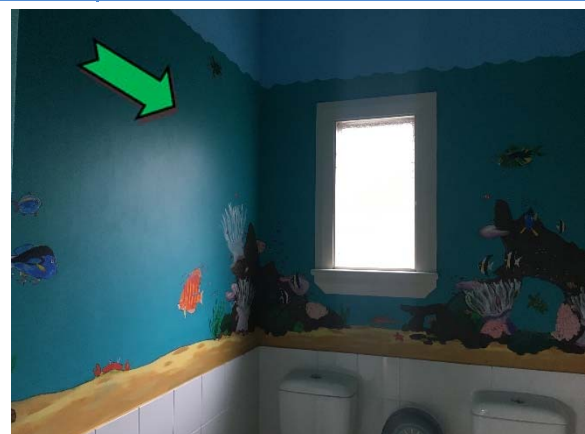
**Photo 6.** Interior, bathroom, walls – non asbestos-containing fibre cement sheeting.

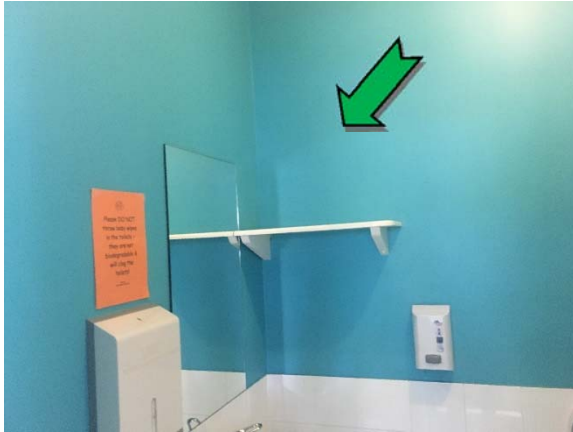
**Photo 7.** Interior, disabled toilet, walls – non asbestos-containing fibre cement sheeting.

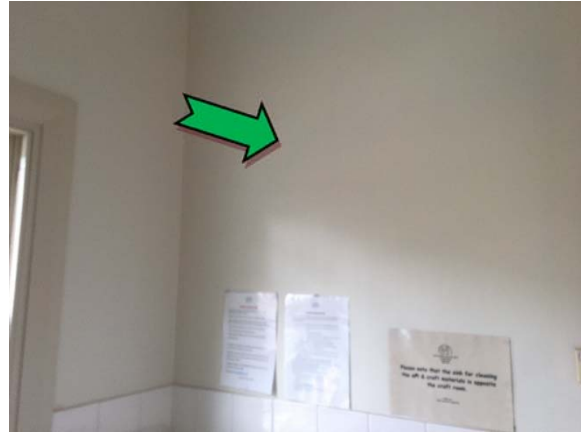
**Photo 8.** Interior, kitchen, walls – non asbestos-containing fibre cement sheeting.

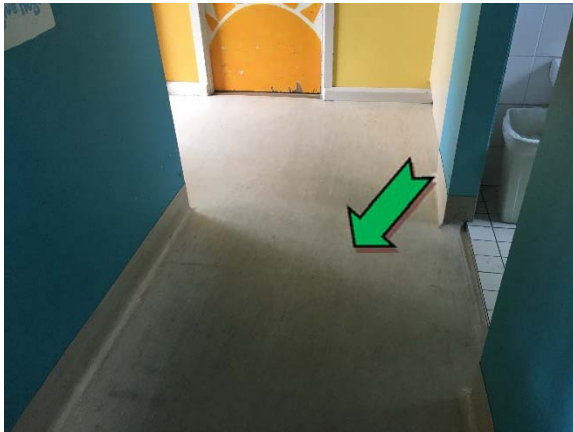
**Photo 9.** Interior, throughout, floor coverings – non asbestos-containing sheet vinyl.

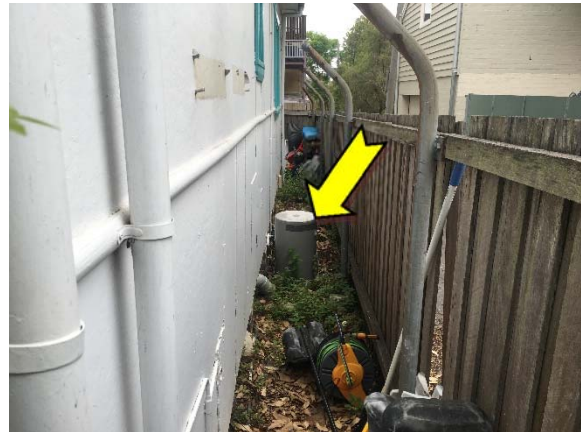
**Photo 10.** Exterior, western elevation, hot water heater – suspected SMF internal insulation material.

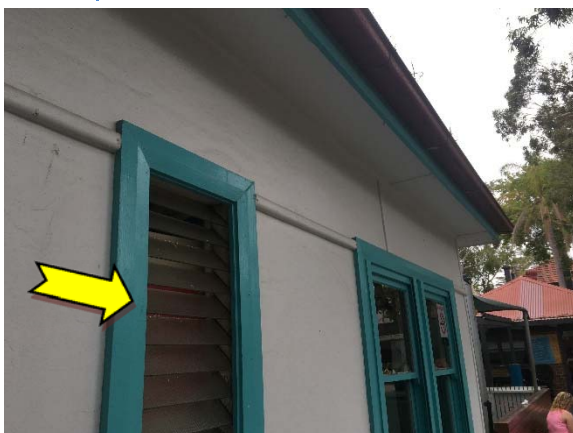
Exterior	Throughout	Door frames, window frames and fascia	Blue - upper coloured paint system	Lead Paint - Swab	-	Suspected Positive	-	Low	Good	Low	20 m <sup>2</sup>	Confirm status by quantitative test method, maintain in current condition, over paint with a lead-free paint as part of ongoing maintenance. Remove under controlled conditions in accordance with AS 4361.2:2017 Guide to hazardous paint management prior to renovation or demolition works.	-	-	11
Exterior	Throughout	Walls	Grey - lower coloured paint system	Lead Paint - Swab	-	Suspected Positive	-	Low	Good	Low	20 m <sup>2</sup>	Confirm status by quantitative test method, maintain in current condition, over paint with a lead-free paint as part of ongoing maintenance. Remove under controlled conditions in accordance with AS 4361.2:2017 Guide to hazardous paint management prior to renovation or demolition works.	-	-	-
Exterior	Throughout	Guttering	Red - upper coloured paint system	Lead Paint - Swab	-	Suspected Positive	-	Low	Good	Low	20 m <sup>2</sup>	Confirm status by quantitative test method, maintain in current condition, over paint with a lead-free paint as part of ongoing maintenance. Remove under controlled conditions in accordance with AS 4361.2:2017 Guide to hazardous paint management prior to renovation or demolition works.	-	-	-

**Photo 11.** Exterior, throughout, window frames – suspected lead-containing blue upper paint systems.

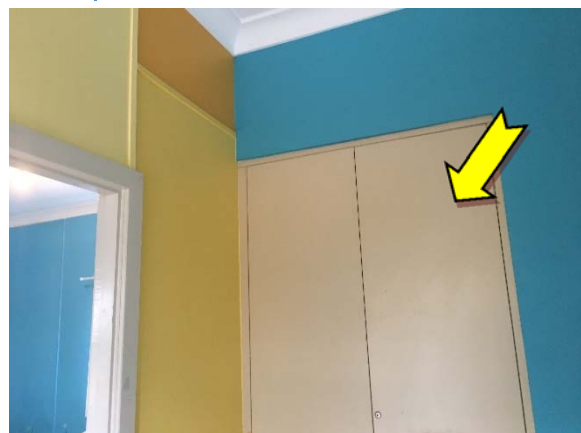
Interior	Throughout	Walls	Blue - upper coloured paint system	Lead Paint - Swab	-	Suspected Positive	-	Low	Good	Low	50 m <sup>2</sup>	Confirm status by quantitative test method, maintain in current condition, over paint with a lead-free paint as part of ongoing maintenance. Remove under controlled conditions in accordance with AS 4361.2:2017 Guide to hazardous paint management prior to renovation or demolition works.	-	-	12
Interior	Throughout	Walls	Yellow - upper coloured paint system	Lead Paint - Swab	-	Suspected Positive	-	Low	Good	Low	50 m <sup>2</sup>	Confirm status by quantitative test method, maintain in current condition, over paint with a lead-free paint as part of ongoing maintenance. Remove under controlled conditions in accordance with AS 4361.2:2017 Guide to hazardous paint management prior to renovation or demolition works.	-	-	12
Interior	Kitchen, throughout	Walls	White - upper coloured paint system	Lead Paint - Swab	-	Suspected Positive	-	Low	Good	Low	50 m <sup>2</sup>	Confirm status by quantitative test method, maintain in current condition, over paint with a lead-free paint as part of ongoing maintenance. Remove under controlled conditions in accordance with AS 4361.2:2017 Guide to hazardous paint management prior to renovation or demolition works.	-	-	-

**Photo 12.** Interior, throughout, walls – suspected lead-containing blue and yellow upper coloured paint systems.
