Hazardous Building Materials Assessment

Balmain East Play Room House

13 Union Street,
Balmain East NSW 2041

Inner West Council
April 2018

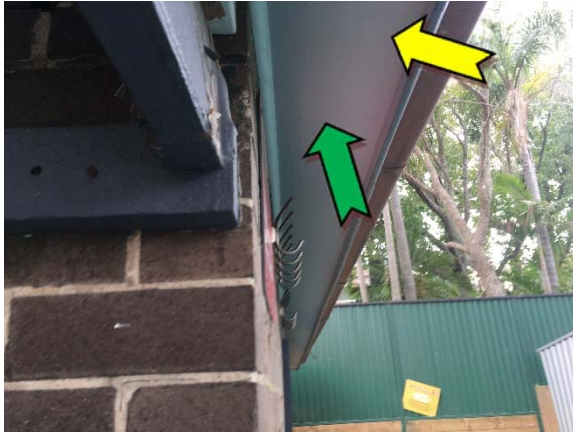
Photo 1. Exterior, throughout, eaves – non asbestos-containing fibre cement sheeting and suspected lead-containing white upper paint system.

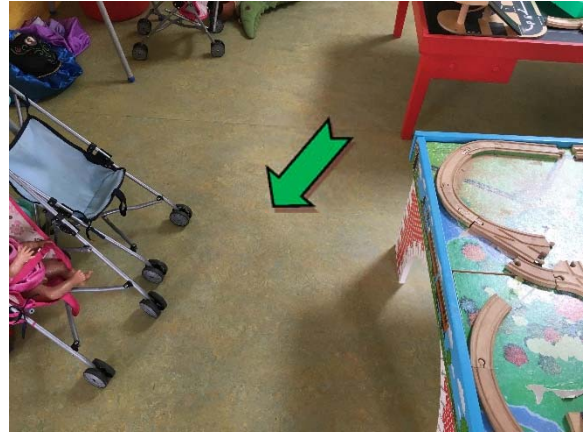
Photo 2. Interior, throughout, floor – non asbestos-containing sheet vinyl.

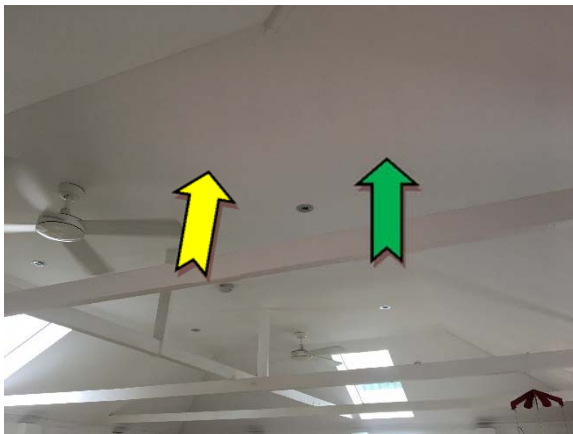
Photo 3. Interior, throughout, ceiling – suspected non asbestos-containing material and suspected lead-containing white upper paint system.

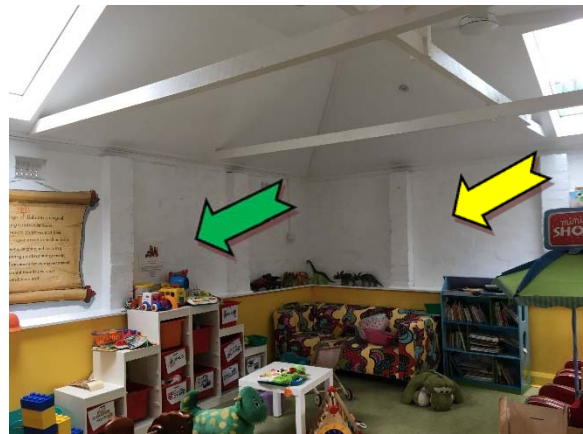
Photo 4. Interior, throughout, walls – suspected non asbestos-containing material and suspected lead-containing white upper paint system.

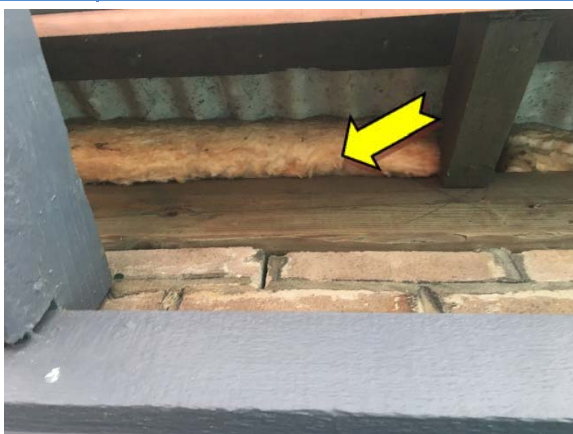
Exterior	Between eaves and wall	Insulation	Sarking insulation	SMF	-	Suspected Positive	Bonded	Low	Good	Low	10 m ²	Maintain in current condition if to remain in-situ. Remove under controlled SMF conditions as per the Code of Practice for the Safe Use of Synthetic Mineral Fibres [NOHSC: 2006 (1990)].	-	-	5
Interior	Throughout	Insulation	Sarking insulation	SMF	-	Suspected Positive	Bonded	Low	Good	Low	60 m ²	Feature not seen at time of Assessment due to sealed plasterboard ceiling, but suspected to be present due to protruding sections at building eaves. Maintain in current condition if to remain in-situ. Remove under controlled SMF conditions as per the Code of Practice for the Safe Use of Synthetic Mineral Fibres [NOHSC: 2006 (1990)].	-	-	-
Throughout	-	-	-	PCBs	-	-	-	-	-	-	-	No suspect PCB-containing capacitors identified at the time of the assessment.	-	-	-
Exterior	Throughout	Eaves	Blue (light) - upper coloured paint system	Lead Paint - Swab	-	Suspected Positive	-	Low	Good	Low	20 m ²	Confirm status by quantitative test method, maintain in current condition, over paint with a lead-free paint as part of ongoing maintenance. Remove under controlled conditions in accordance with AS 4361.2:2017 Guide to hazardous paint management prior to renovation or demolition works.	-	-	1

Photo 5. Exterior, between eaves and wall, insulation – suspected SMF sarking insulation material.

- SMF materials that are likely to be disturbed during any proposed demolition/refurbishment works should be handled in accordance with the *Code of Practice for the Safe Use of Synthetic Mineral Fibres* [NOHSC:2006(1990)]. If these materials are impacted upon by accident or by pre-planned works, the Inner West Council must be informed via the contact detailed within Section 7: *Accidental Disturbance of Known or Suspected Hazardous Building Materials*. Following disturbance, inspection by a competent person should be undertaken.

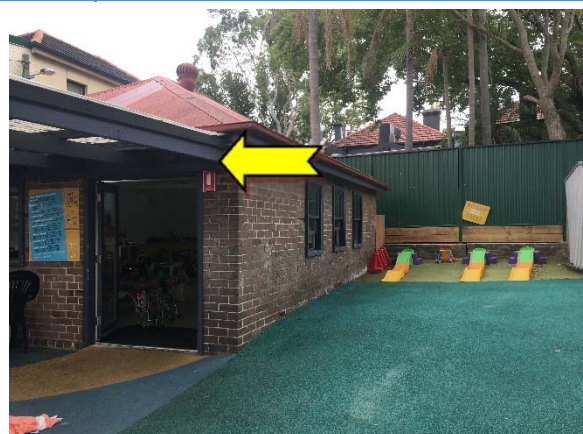
Photo 6. Exterior, throughout, timber supports – suspected lead-containing grey upper coloured paint systems.
