# Hazardous Building Materials Assessment

## Wharf Cafe

107 Elliot Street  
Balmain NSW 2041

Inner West Council  
April 2018

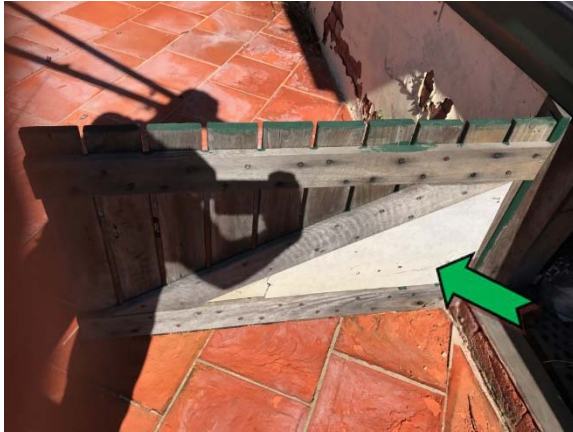
**Photo 1.** Exterior, store, door panel – non asbestos-containing fibre cement sheeting.

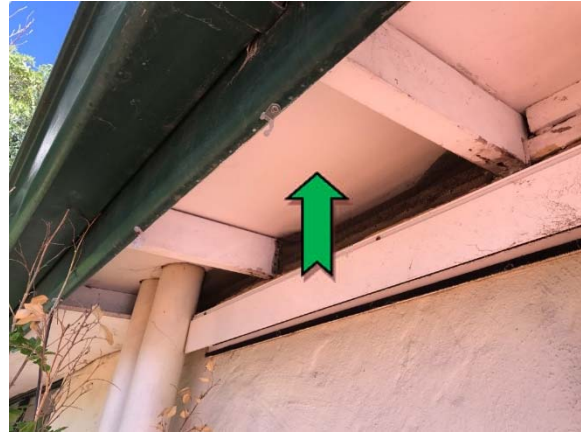
**Photo 2.** Exterior, throughout, eaves – non asbestos-containing fibre cement sheeting.

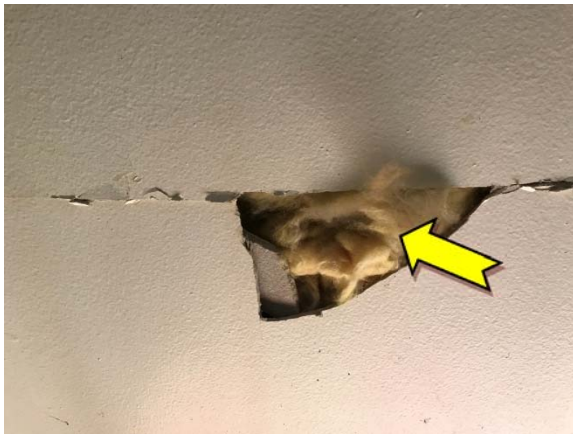
**Photo 3.** Interior, throughout ceiling space, sarking insulation – suspected SMF.

- Suspected SMF sarking insulation above plasterboard ceilings throughout the building.

- SMF materials that are likely to be disturbed during any proposed demolition/refurbishment works should be handled in accordance with the *Code of Practice for the Safe Use of Synthetic Mineral Fibres* [NOHSC:2006(1990)]. If these materials are impacted upon by accident or by pre-planned works, the Inner West Council must be informed via the contact detailed within Section 7: *Accidental Disturbance of Known or Suspected Hazardous Building Materials*. Following disturbance, inspection by a competent person should be undertaken.

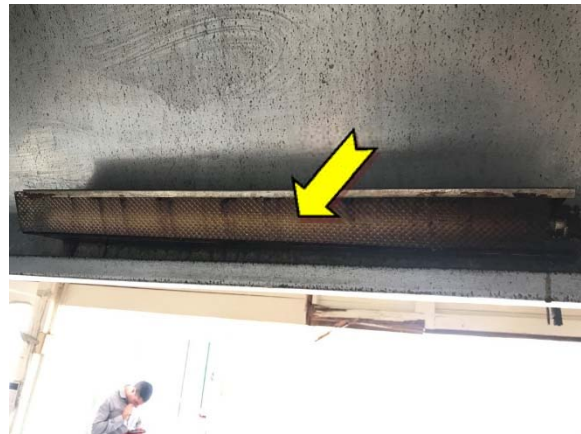
Interior	Throughout	Fluorescent light fitting - single tube	Capacitor	PCBs	Not sampled: Electrical hazard	Suspected Positive	-	-	-	-	10 units	PCB-containing capacitors are suspected due to age & appearance of electrical fittings. Remove and dispose of in accordance with the Polychlorinated Biphenyls Management Plan, Revised Edition April 2003.	-	-	4
Interior	Throughout	Walls	White - upper coloured paint system	Lead Paint - Swab	-	Suspected Positive	-	Low	Fair	Low	100 m <sup>2</sup>	Confirm status by quantitative test method, maintain in current condition, over paint with a lead-free paint as part of ongoing maintenance. Remove under controlled conditions in accordance with AS 4361.2:2017 Guide to hazardous paint management prior to renovation or demolition works.	-	-	-
Interior	Throughout	Ceiling	White - upper coloured paint system	Lead Paint - Swab	-	Suspected Positive	-	Low	Fair	Low	80 m <sup>2</sup>	Confirm status by quantitative test method, maintain in current condition, over paint with a lead-free paint as part of ongoing maintenance. Remove under controlled conditions in accordance with AS 4361.2:2017 Guide to hazardous paint management prior to renovation or demolition works.	-	-	5

**Photo 4.** Interior, throughout, single tube light fittings – suspected PCB containing capacitors.

- PCBs were suspected within the capacitors of the single tubed fluorescent light fittings located throughout the building.

- Electrical fittings suspected of containing PCB oil capacitors should be treated as containing PCB oils until such time as evidence suggest otherwise e.g. further assessed.
- Electrical fittings that contain or suspected to contain PCB oil-containing capacitors should be removed as hazardous/regulated waste under controlled working conditions prior to the demolition or refurbishment works in accordance with the *Polychlorinated Biphenyls Management Plan, Revised Edition April 2003*.

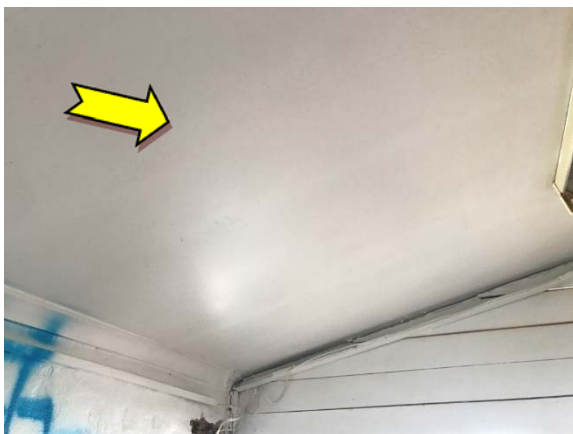
**Photo 5.** Interior, throughout, ceiling – suspected lead-containing white upper paint system.

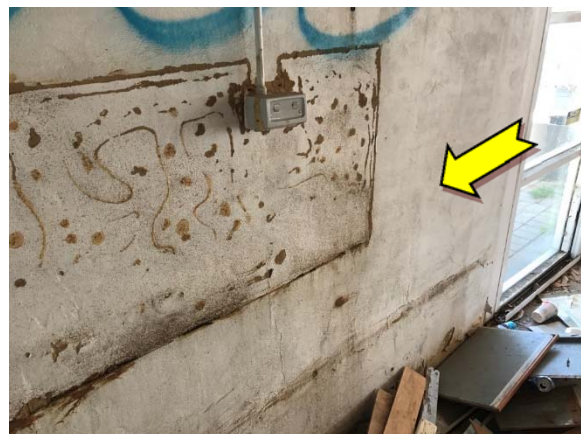
**Photo 6.** Interior, throughout, walls – suspected lead-containing white upper paint system.
