Hazardous Building Materials Assessment Dawn Fraser Pool Amenities Block / Pavilion / Office 48 Fitzroy Avenue, Balmain NSW 2041

Inner West Council
April 2018

Job No.: 57722-076

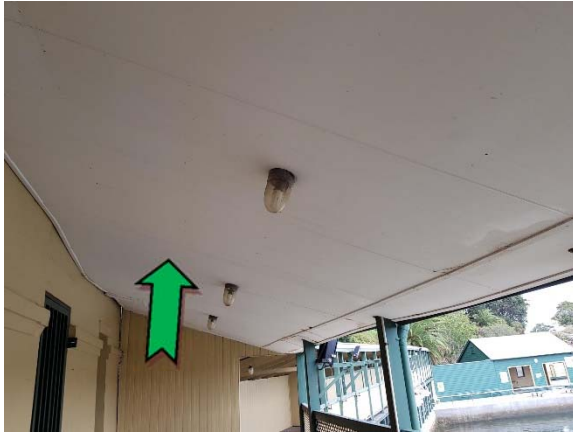
Photo 1. Exterior, level one, above kiosk, awning – non asbestos-containing fibre cement sheeting.

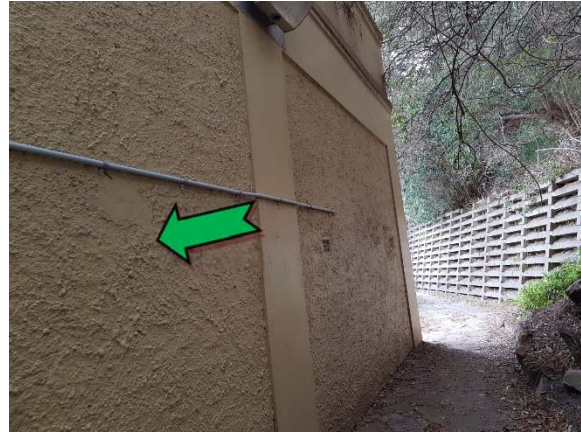
Photo 2. Exterior, north elevation, wall – non asbestos-containing textured coating.

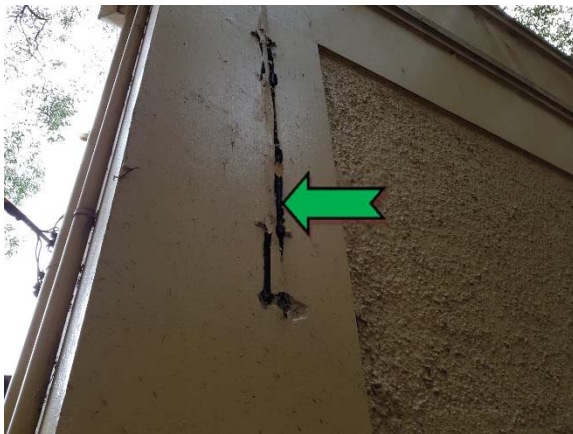
Photo 3. Exterior, north elevation, wall – non asbestos-containing bituminous material.

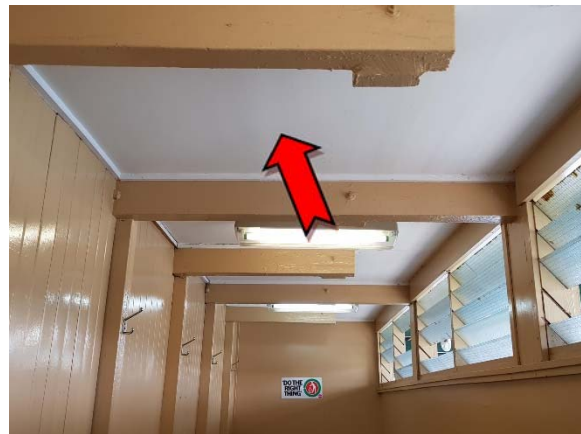
Area / Level	Room & Location	Feature	Item Description	Hazard Type	Sample No.	Sample Status	Friability	Disturb. Potential	Condition	Risk Status	Approx. Quantity	Recommendations & Comments	Control Priority	Reinspect Date	Photo No.
Exterior, Level 1	Above kiosk	Awning	Fibre cement sheeting	Asbestos	57722-076-001	Negative	-	-	-	-	-	-	-	-	1
Exterior, ground level	North elevation	Wall	Textured coatings	Asbestos	57722-076-008	Negative	-	-	-	-	-	-	-	-	2
Exterior, ground level	North elevation	Wall	Bituminous material	Asbestos	57722-076-009	Negative	-	-	-	-	-	-	-	-	3
Interior, ground level	Female changeroom	Ceiling	Fibre cement sheeting	Asbestos	57722-076-002	Positive	Non-friable	Low	Good	Low	10 m ²	Label as containing asbestos and maintain in current condition if to remain in-situ. Remove under controlled non-friable asbestos removal conditions prior to refurbishment or demolition works by a Class B (non-friable) licensed asbestos removal contractor.	P4	Feb-23	4

Photo 4. Interior, female change rooms, ceiling – asbestos-containing fibre cement sheeting.

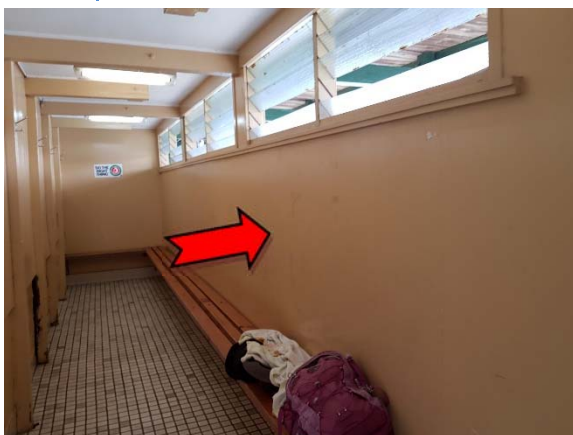
Photo 5. Interior, female change rooms, wall – asbestos-containing fibre cement sheeting.

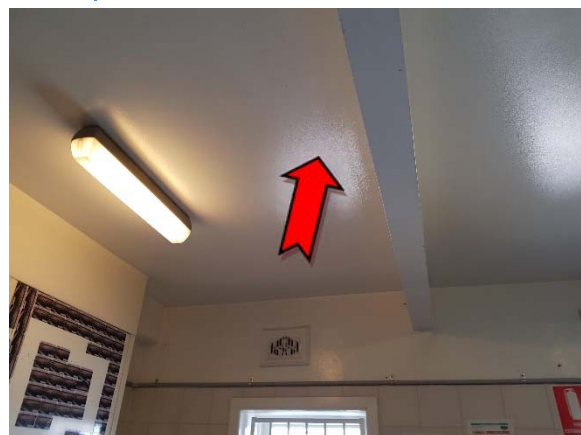
Photo 6. Interior, ladies toilets/showers, ceiling – asbestos-containing fibre cement sheeting.

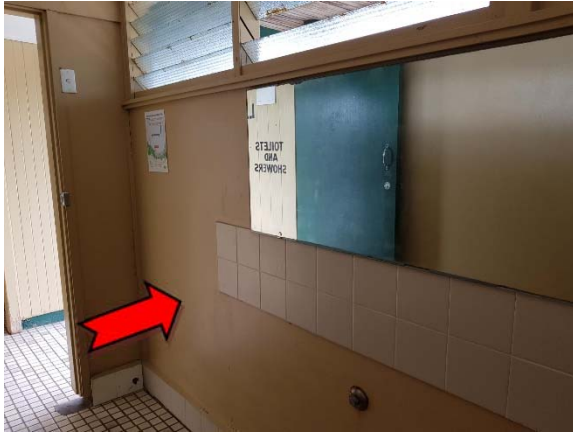
Interior, ground level	Female change room, north elevation	Wall	Fibre cement sheeting	Asbestos	57722-076-010	Positive	Non-friable	Low	Good	Low	6 m ²	Label as containing asbestos and maintain in current condition if to remain in-situ. Remove under controlled non-friable asbestos removal conditions prior to refurbishment or demolition works by a Class B (non-friable) licensed asbestos removal contractor.	P4	Feb-23	5
Interior, ground level	Ladies toilets/showers	Ceiling	Fibre cement sheeting	Asbestos	Same as 57722-076-006	Assumed Positive	Non-friable	Low	Good	Low	15 m ²	Label as containing asbestos and maintain in current condition if to remain in-situ. Remove under controlled non-friable asbestos removal conditions prior to refurbishment or demolition works by a Class B (non-friable) licensed asbestos removal contractor.	P4	Feb-23	6
Interior, ground level	Ladies toilets/showers	Wall	Fibre cement sheeting	Asbestos	Same as 57722-076-010	Assumed Positive	Non-friable	Low	Good	Low	6 m ²	Label as containing asbestos and maintain in current condition if to remain in-situ. Remove under controlled non-friable asbestos removal conditions prior to refurbishment or demolition works by a Class B (non-friable) licensed asbestos removal contractor.	P4	Feb-23	7

Photo 7. Interior, ladies toilets/showers, wall – asbestos-containing fibre cement sheeting.

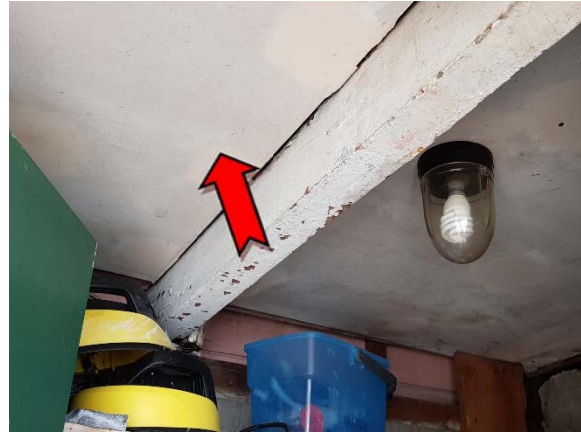
Photo 8. Interior, store room, ceiling – asbestos-containing fibre cement sheeting.

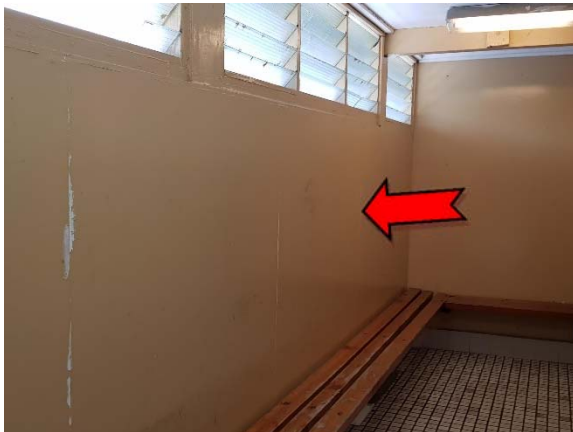
Photo 9. Interior, men's change room, wall – asbestos-containing fibre cement sheeting.

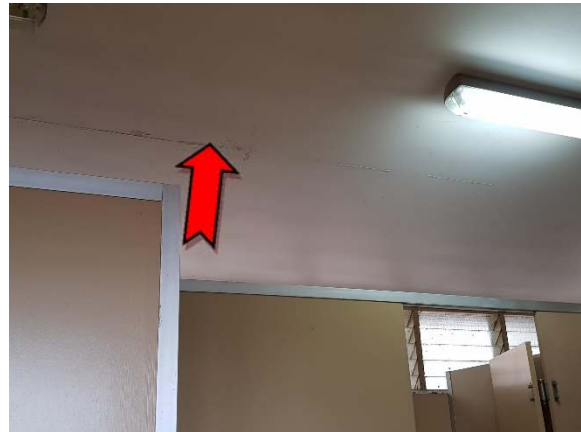
Interior, ground level	Store room	Ceiling	Fibre cement sheeting	Asbestos	57722-076-003	Positive	Non-friable	Low	Good	Low	2 m ²	Label as containing asbestos and maintain in current condition if to remain in-situ. Remove under controlled non-friable asbestos removal conditions prior to refurbishment or demolition works by a Class B (non-friable) licensed asbestos removal contractor.	P4	Feb-23	8
Interior, ground level	Men's change room, north elevation	Wall	Fibre cement sheeting	Asbestos	57722-076-004	Positive	Non-friable	Low	Good	Low	4 m ²	Label as containing asbestos and maintain in current condition if to remain in-situ. Remove under controlled non-friable asbestos removal conditions prior to refurbishment or demolition works by a Class B (non-friable) licensed asbestos removal contractor.	P4	Feb-23	9
Interior, ground level	Men's change room	Ceiling	Fibre cement sheeting	Asbestos	57722-076-005	Positive	Non-friable	Low	Good	Low	10 m ²	Label as containing asbestos and maintain in current condition if to remain in-situ. Remove under controlled non-friable asbestos removal conditions prior to refurbishment or demolition works by a Class B (non-friable) licensed asbestos removal contractor.	P4	Feb-23	10

Photo 10. Interior, men's change room, ceiling – asbestos-containing fibre cement sheeting.

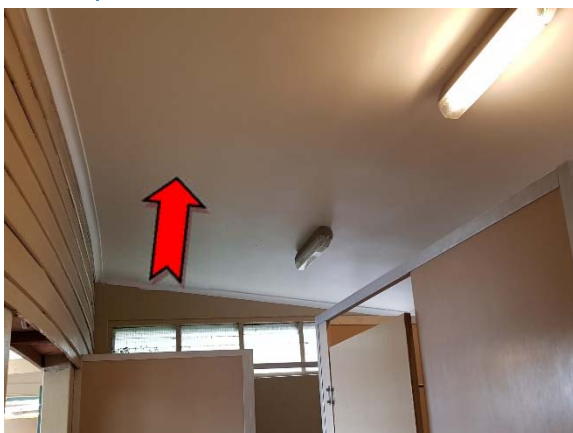
Photo 11. Interior, men's toilets/showers, ceiling – asbestos-containing fibre cement sheeting.

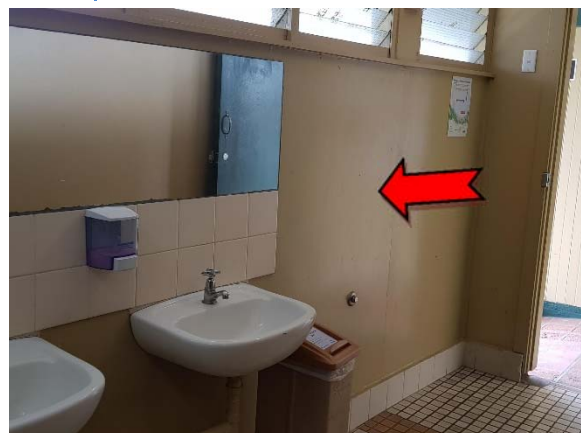
Photo 12. Interior, men's toilets/showers, wall – asbestos-containing fibre cement sheeting.

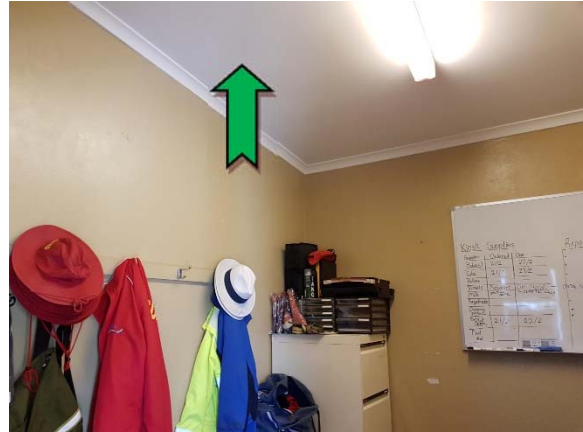
Photo 14. Interior, office/first aid room, ceiling – non asbestos-containing fibre cement sheeting.

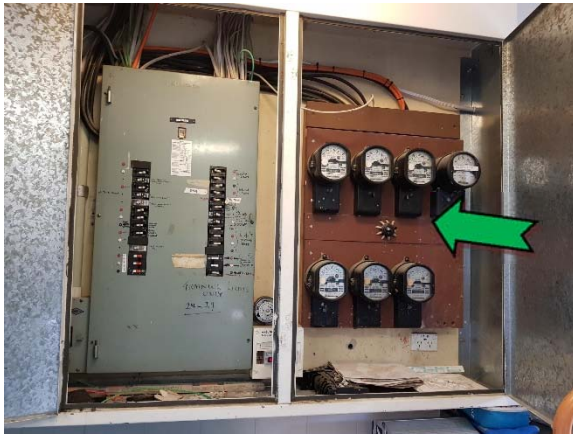
Photo 15. Interior, kitchen/kiosk, electrical backing board – suspected non asbestos-containing bituminous backing board.

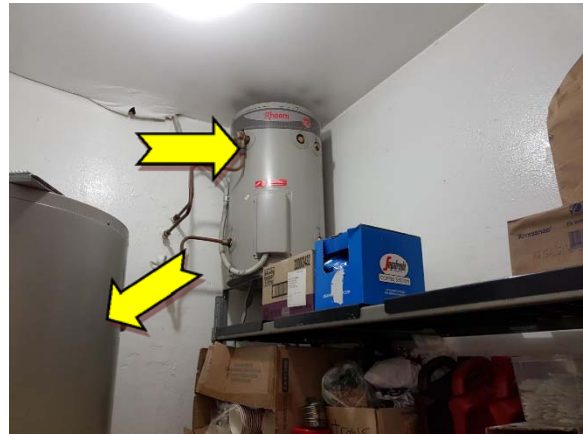
Photo 16. Interior, kitchen/kiosk, hot water heaters – suspected SMF internal insulation.

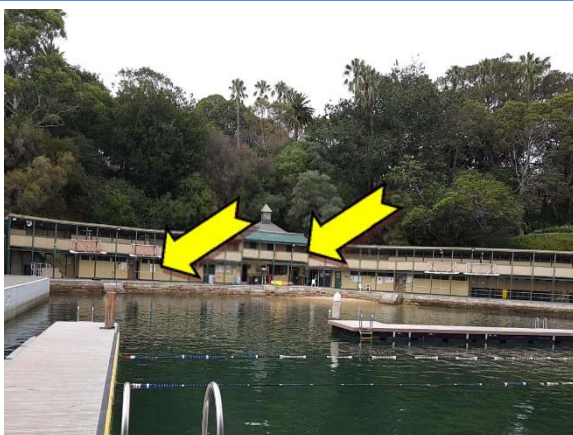
Photo 17. Exterior, throughout, walls and beams – suspected lead-containing yellow and green upper coloured paint systems.
