Hazardous Building Materials Assessment Dawn Fraser Pool – Open Shed 48 Fitzroy Avenue, Balmain NSW 2041

Inner West Council
April 2018

Job No.: 57722-077

Count ID: CID: 117

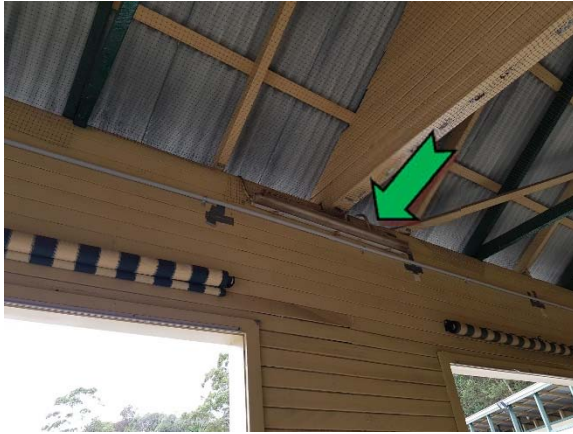
Photo 1. Interior, throughout, single tubed fluorescent light fitting – suspected non PCB-containing capacitors.

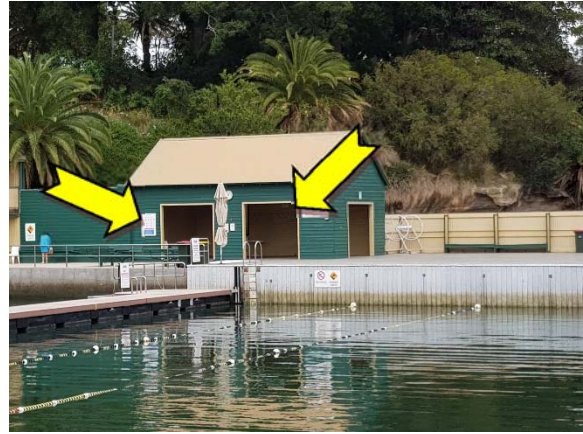
Exterior	Throughout	Door frame	Yellow - upper coloured paint system	Lead Paint - Swab	-	Suspected Positive	-	Low	Good	Low	20 m	Confirm status by quantitative test method, maintain in current condition, over paint with a lead-free paint as part of ongoing maintenance. Remove under controlled conditions in accordance with AS 4361.2:2017 Guide to hazardous paint management prior to renovation or demolition works.	-	-	-
Interior	Throughout	Walls	Yellow - upper coloured paint system	Lead Paint - Swab	-	Suspected Positive	-	Low	Good	Low	50 m ²	Confirm status by quantitative test method, maintain in current condition, over paint with a lead-free paint as part of ongoing maintenance. Remove under controlled conditions in accordance with AS 4361.2:2017 Guide to hazardous paint management prior to renovation or demolition works.	-	-	-
Interior	Throughout	Window frames	Green - upper coloured paint system	Lead Paint - Swab	-	Suspected Positive	-	Low	Good	Low	10 m	Confirm status by quantitative test method, maintain in current condition, over paint with a lead-free paint as part of ongoing maintenance. Remove under controlled conditions in accordance with AS 4361.2:2017 Guide to hazardous paint management prior to renovation or demolition works.	-	-	-

Photo 2. Exterior, throughout, walls and frames – suspected lead-containing green and yellow upper coloured paint systems.

- The *LeadCheck* paint swab method can detect lead in paint at concentrations of 0.5% and above, and may indicate lead in some paint films as low as 0.2%. As paint with a lead content greater than 0.1% by dry weight is now considered to be lead-containing, Prensa recommends confirming status of suspected LCP identified during the Assessment by quantitative test method.

- The safest method of dealing with LCP is to replace or remove the items in their entirety that have LCP on them and replace them with new items that do not contain lead. This allows the items to be disposed of as regular building or demolition unsegregated waste in accordance with the NSW Environment Protection Authority (EPA) *Waste Classification Guidelines 2014 Part 1 – Classifying Waste*. The advantage of this method is the reduction in labour requirements to remove the lead paint and also this reduces the risk to workers from exposure to lead dust or fumes. If the removal of the LCP or coatings is the preferred or required option this may generate significant amounts of potential hazardous waste. This waste must be removed, collected and disposed of by an appropriately licensed contractor under controlled conditions that minimises the release to air, water and soil. Disposal of lead waste must be disposed of as hazardous waste at an approved waste facility.

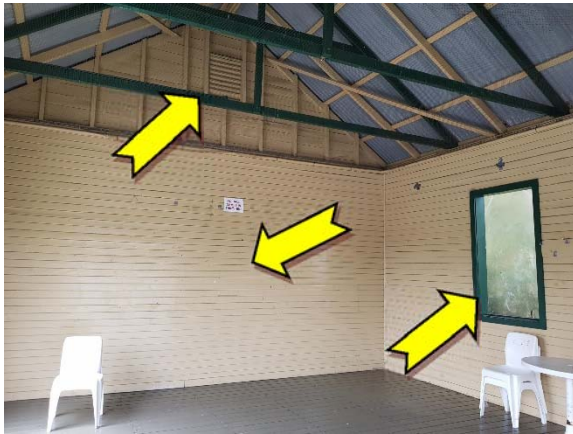
Interior	Throughout	Beams	Green - upper coloured paint system	Lead Paint - Swab	-	Suspected Positive	-	Low	Good	Low	20 m	Confirm status by quantitative test method, maintain in current condition, over paint with a lead-free paint as part of ongoing maintenance. Remove under controlled conditions in accordance with AS 4361.2:2017 Guide to hazardous paint management prior to renovation or demolition works.	-	-	-
Interior	Throughout	Floor	Green (dark) - upper coloured paint system	Lead Paint - Swab	-	Suspected Positive	-	Low	Good	Low	65 m ²	Confirm status by quantitative test method, maintain in current condition, over paint with a lead-free paint as part of ongoing maintenance. Remove under controlled conditions in accordance with AS 4361.2:2017 Guide to hazardous paint management prior to renovation or demolition works.	-	-	-
Throughout	-	-	-	Ozone Depleting Substances	-	-	-	-	-	-	-	No suspect ODS's identified at the time of the assessment.	-	-	-

Photo 3. Interior, throughout, walls, frames and beams – suspected lead-containing yellow and green upper coloured paint systems.
