Hazardous Building Materials Assessment Dawn Fraser Pools – Superstructure / Pavilion (North) 48 Fitzroy Avenue, Balmain NSW 2041

Inner West Council
April 2018

Job No.: 57722-073

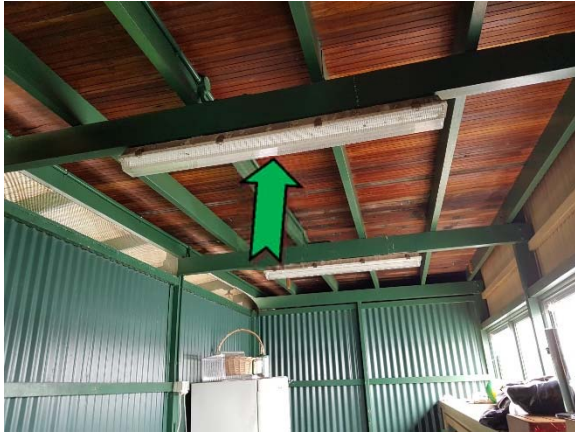
Photo 1. Exterior, throughout, single tubed fluorescent light fitting – suspected non PCB-containing capacitors.

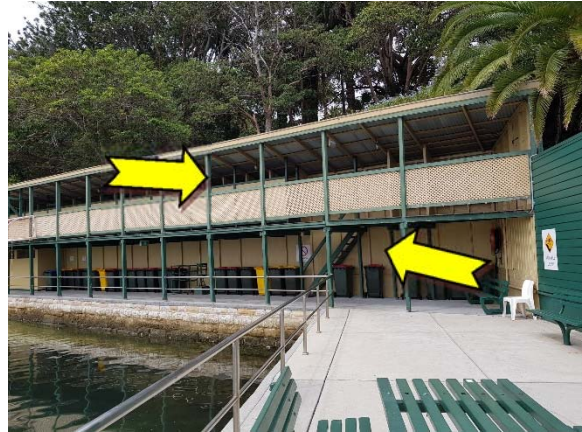
Photo 2. Exterior, throughout, walls and beams – suspected lead-containing yellow and green upper coloured paint systems.

- LCP was suspected in the form of yellow, white and green upper coloured paint systems throughout the exterior of the building during the Assessment.
- LCP was suspected in the form of pink lower paint systems to the external beams during the Assessment.

Area / Level	Room & Location	Feature	Item Description	Hazard Type	Sample No.	Sample Status	Friability	Disturb. Potential	Condition	Risk Status	Approx. Quantity	Recommendations & Comments	Control Priority	Reinspect Date	Photo No.
Throughout	-	-	-	Asbestos	-	-	-	-	-	-	-	No suspect asbestos material identified at the time of the assessment.	-	-	-
Throughout	-	-	-	SMF	-	-	-	-	-	-	-	No suspect SMF material identified at the time of the assessment.	-	-	-
Exterior	Throughout	Fluorescent light fitting - single tube	Capacitor	PCBs	Not sampled: Electrical hazard	Suspected Negative	-	-	-	-	-	PCB-containing capacitors are unlikely to be present due to age and appearance of light fittings. Confirm PCB status prior to refurbishment or demolition works.	-	-	1
Exterior	Throughout	Walls	Yellow - upper coloured paint system	Lead Paint - Swab	-	Suspected Positive	-	Low	Good	Low	300 m ²	Confirm status by quantitative test method, maintain in current condition, over paint with a lead-free paint as part of ongoing maintenance. Remove under controlled conditions in accordance with AS 4361.2:2017 Guide to hazardous paint management prior to renovation or demolition works.	-	-	2

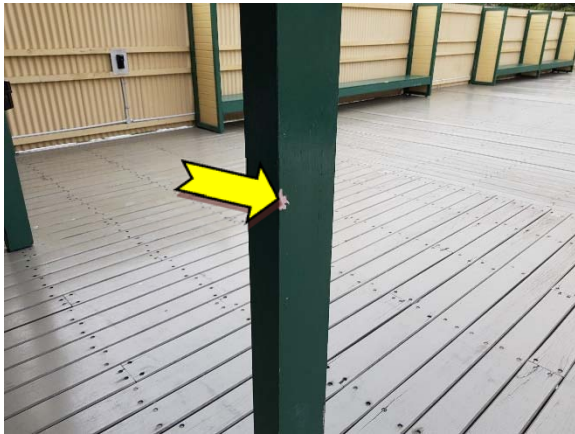
Photo 3. Exterior, throughout, beams – suspected lead-containing pink lower paint systems.

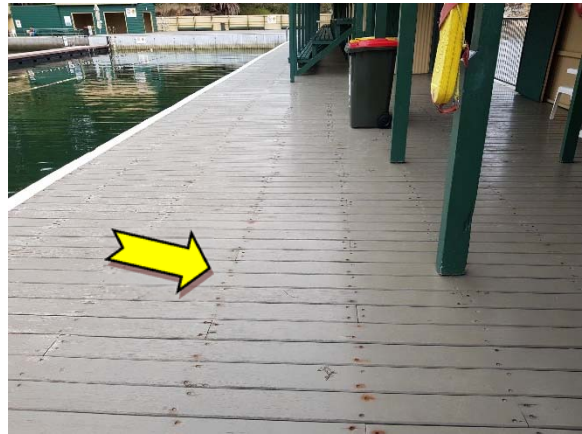
Photo 4. Exterior, throughout, floor – suspected lead-containing green upper paint systems.

Exterior	Throughout	Beams	Green - upper coloured paint system	Lead Paint - Swab	-	Suspected Positive	-	Low	Good	Low	100 m ²	Confirm status by quantitative test method, maintain in current condition, over paint with a lead-free paint as part of ongoing maintenance. Remove under controlled conditions in accordance with AS 4361.2:2017 Guide to hazardous paint management prior to renovation or demolition works.	-	-	2
Exterior	Throughout	Beams	Pink - lower coloured paint system	Lead Paint - Swab	-	Suspected Positive	-	Low	Good	Low	100 m ²	Confirm status by quantitative test method, maintain in current condition, over paint with a lead-free paint as part of ongoing maintenance. Remove under controlled conditions in accordance with AS 4361.2:2017 Guide to hazardous paint management prior to renovation or demolition works.	-	-	3
Exterior	Throughout	Floor	Green (dark) - upper coloured paint system	Lead Paint - Swab	-	Suspected Positive	-	Low	Good	Low	150 m ²	Confirm status by quantitative test method, maintain in current condition, over paint with a lead-free paint as part of ongoing maintenance. Remove under controlled conditions in accordance with AS 4361.2:2017 Guide to hazardous paint management prior to renovation or demolition works.	-	-	4

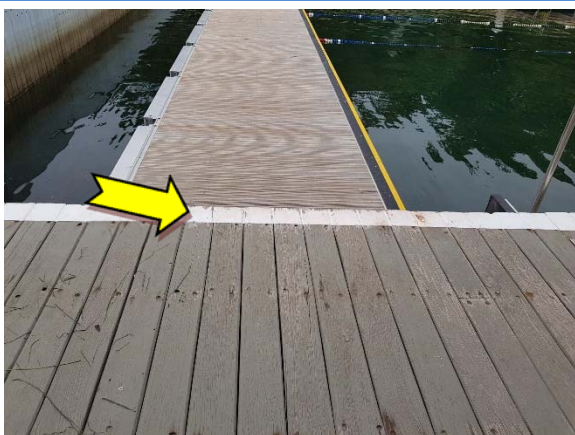
Photo 5. Exterior, throughout, edge of floor – suspected lead-containing white upper paint systems.

Exterior	Throughout	Floor	White - upper coloured paint system	Lead Paint - Swab	-	Suspected Positive	-	Low	Good	Low	15 m ²	Confirm status by quantitative test method, maintain in current condition, over paint with a lead-free paint as part of ongoing maintenance. Remove under controlled conditions in accordance with AS 4361.2:2017 Guide to hazardous paint management prior to renovation or demolition works.	-	-	4
Throughout	-	-	-	Ozone Depleting Substances	-	-	-	-	-	-	-	No suspect ODS's identified at the time of the assessment.	-	-	-
