# Hazardous Building Materials Assessment Dawn Fraser Pools – Superstructure / Pavilion (South)

48 Fitzroy Avenue,  
Balmain NSW 2041

Inner West Council  
April 2018

Job No.: 57722-074

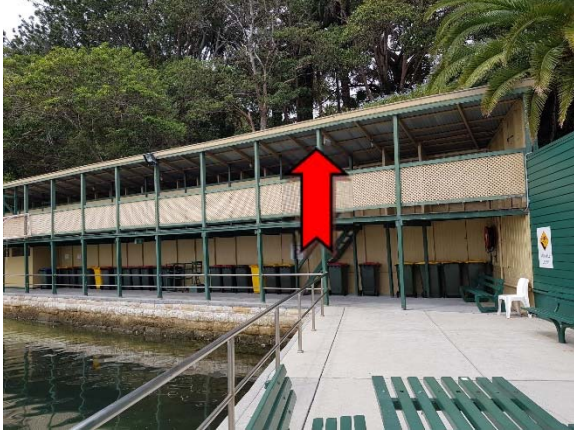
**Photo 1.** Exterior, throughout, walls and beams – suspected lead-containing yellow and green upper coloured paint systems.

- LCP was suspected in the form of yellow and green upper coloured paint systems throughout the site during the Assessment.

Exterior	Throughout	Beams	Green - upper coloured paint system	Lead Paint - Swab	-	Suspected Positive	-	Low	Good	Low	100 m	Confirm status by quantitative test method, maintain in current condition, over paint with a lead-free paint as part of ongoing maintenance. Remove under controlled conditions in accordance with AS 4361.2:2017 Guide to hazardous paint management prior to renovation or demolition works.	-	-	1
Throughout	-	-	-	Ozone Depleting Substances	-	-	-	-	-	-	-	No suspect ODS's identified at the time of the assessment.	-	-	-
Level 1, room above kiosk	-	-	-	-	-	-	-	-	-	-	-	No access at the time of the assessment.	-	-	-

- The *LeadCheck* paint swab method can detect lead in paint at concentrations of 0.5% and above, and may indicate lead in some paint films as low as 0.2%. As paint with a lead content greater than 0.1% by dry weight is now considered to be lead-containing, Prensa recommends confirming status of suspected LCP identified during the Assessment by quantitative test method.

- The safest method of dealing with LCP is to replace or remove the items in their entirety that have LCP on them and replace them with new items that do not contain lead. This allows the items to be disposed of as regular building or demolition unsegregated waste in accordance with the NSW Environment Protection Authority (EPA) *Waste Classification Guidelines 2014 Part 1 – Classifying Waste*. The advantage of this method is the reduction in labour requirements to remove the lead paint and also this reduces the risk to workers from exposure to lead dust or fumes. If the removal of the LCP or coatings is the preferred or required option this may generate significant amounts of potential hazardous waste. This waste must be removed, collected and disposed of by an appropriately licensed contractor under controlled conditions that minimises the release to air, water and soil. Disposal of lead waste must be disposed of as hazardous waste at an approved waste facility.
