Hazardous Building Materials Assessment Elkington Park Caretakers Cottage Fitzroy Avenue, Balmain NSW 2041

Inner West Council

April 2018

Job No.: 57722-156

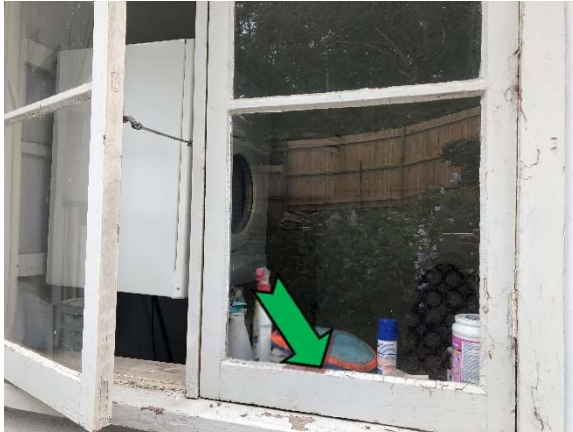
Photo 1. Exterior, throughout, window frames – non asbestos-containing window caulking.

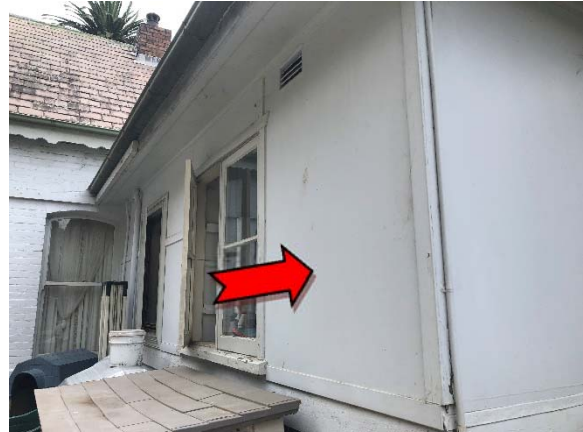
Photo 2. Exterior, rear extensions, throughout, upper walls – asbestos-containing fibre cement sheeting.

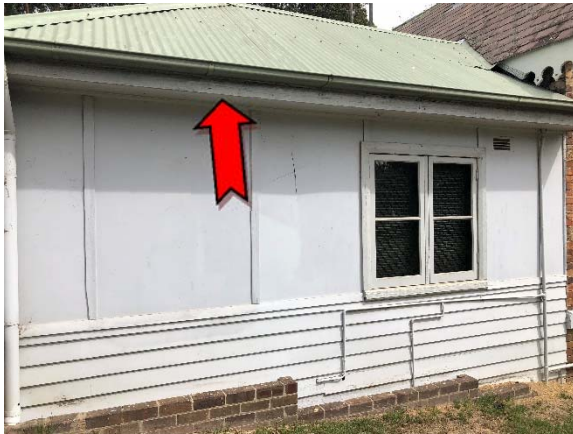
Photo 3. Exterior, rear extensions, throughout, eaves – suspected asbestos-containing fibre cement sheeting.

Area / Level	Room & Location	Feature	Item Description	Hazard Type	Sample No.	Sample Status	Friability	Disturb. Potential	Condition	Risk Status	Approx. Quantity	Recommendations & Comments	Control Priority	Reinspect Date	Photo No.
Exterior	Throughout	Window frames	Window caulking	Asbestos	57722-156-003	Negative	-	-	-	-	-	-	-	-	1
Exterior	Rear extensions, throughout	Upper walls	Fibre cement sheeting	Asbestos	57722-156-004	Positive	Non-friable	Low	Fair	Medium	30 m ²	Encapsulate exposed sections, label as containing asbestos and maintain in a good condition if to remain in-situ. Remove under controlled non-friable asbestos removal conditions prior to refurbishment or demolition works by a Class B (non-friable) licensed asbestos removal contractor.	P3	Mar-20	2
Exterior	Rear extensions, laundry, kitchen, bathroom, throughout	Eaves	Fibre cement sheeting	Asbestos	Not sampled: Height restriction	Suspected Positive	Non-friable	Low	Good	Low	16 m ²	Confirm status, label as containing asbestos and maintain in current condition if to remain in-situ. Remove under controlled non-friable asbestos removal conditions prior to refurbishment or demolition works by a Class B (non-friable) licensed asbestos removal contractor.	P4	Mar-23	3

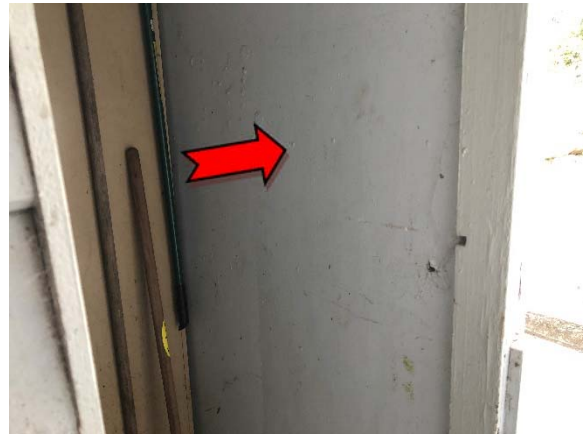
Photo 4. Interior, shed/rear toilet, walls – asbestos-containing fibre cement sheeting.

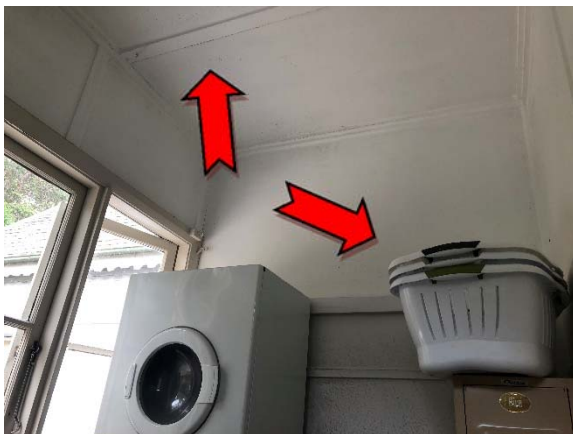
Photo 5. Interior, laundry, walls and ceiling – asbestos-containing fibre cement sheeting.

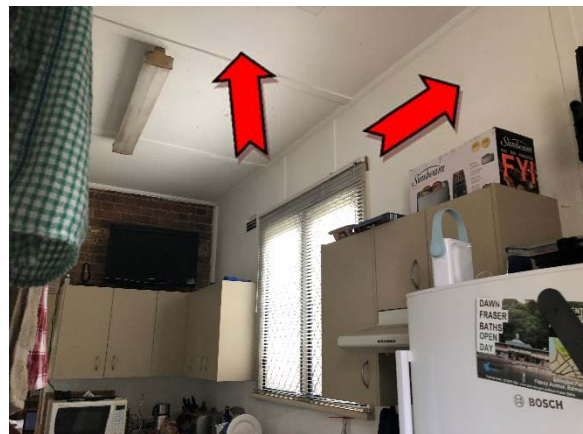
Photo 6. Interior, kitchen, walls and ceiling – assumed asbestos-containing fibre cement sheeting.

Interior	Shed/ rear toilet, throughout	Walls	Fibre cement sheeting	Asbestos	57722-156-001	Positive	Non-friable	Low	Good	Low	20 m ²	Label as containing asbestos and maintain in current condition if to remain in-situ. Remove under controlled non-friable asbestos removal conditions prior to refurbishment or demolition works by a Class B (non-friable) licensed asbestos removal contractor.	P4	Mar-23	4
Interior	Laundry, throughout	Walls	Fibre cement sheeting	Asbestos	57722-156-002	Positive	Non-friable	Low	Good	Low	20 m ²	Label as containing asbestos and maintain in current condition if to remain in-situ. Remove under controlled non-friable asbestos removal conditions prior to refurbishment or demolition works by a Class B (non-friable) licensed asbestos removal contractor.	P4	Mar-23	5
Interior	Kitchen, throughout	Walls	Fibre cement sheeting	Asbestos	Same as 57722-156-002	Assumed Positive	Non-friable	Low	Good	Low	40 m	Label as containing asbestos and maintain in current condition if to remain in-situ. Remove under controlled non-friable asbestos removal conditions prior to refurbishment or demolition works by a Class B (non-friable) licensed asbestos removal contractor.	P4	Mar-23	6

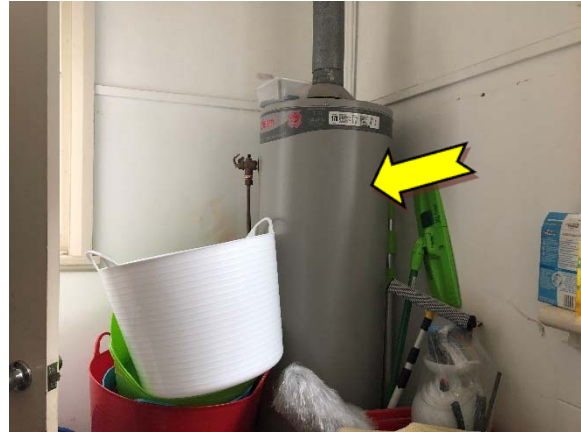
Photo 8. Interior, laundry, hot water heater – suspected SMF internal insulation material.

- SMF materials that are likely to be disturbed during any proposed demolition/refurbishment works should be handled in accordance with the *Code of Practice for the Safe Use of Synthetic Mineral Fibres* [NOHSC:2006(1990)]. If these materials are impacted upon by accident or by pre-planned works, the Inner West Council must be informed via the contact detailed within Section 7: *Accidental Disturbance of Known or Suspected Hazardous Building Materials*. Following disturbance, inspection by a competent person should be undertaken.

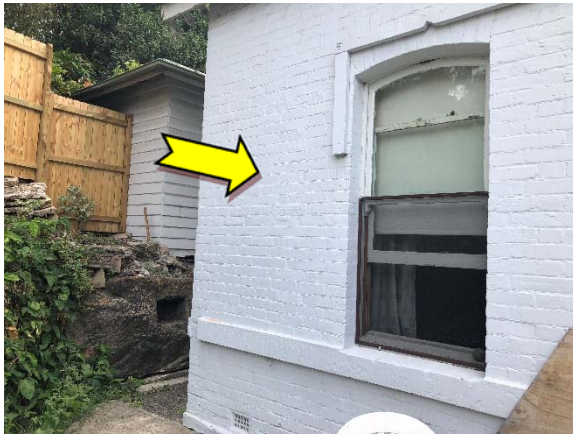
Photo 9. Exterior, throughout, walls and awnings – suspected lead-containing white upper paint systems.

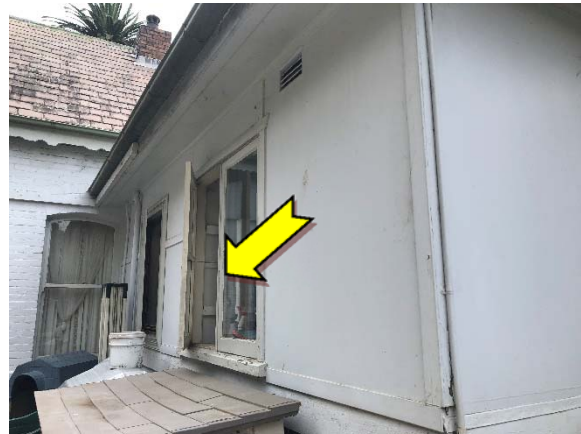
Photo 10. Exterior, windows and door frames – lead-containing beige upper paint systems.

Area / Level	Room & Location	Feature	Item Description	Hazard Type	Sample No.	Sample Status	Friability	Disturb. Potential	Condition	Risk Status	Approx. Quantity	Recommendations & Comments	Control Priority	Reinspect Date	Photo No.
Exterior	Throughout	Walls and awning features	White - upper coloured paint system	Lead Paint - Swab	-	Suspected Positive	-	Low	Good	Low	500 m ²	Confirm status by quantitative test method, maintain in current condition, over paint with a lead-free paint as part of ongoing maintenance. Remove under controlled conditions in accordance with AS 4361.2:2017 Guide to hazardous paint management prior to renovation or demolition works.	-	-	9
Exterior	Throughout	Windows and door frames	Beige - upper coloured paint system	Lead Paint - Swab	-	Positive	-	Low	Poor	Medium	60 m	Remove flaking sections and over paint with a lead-free paint. Remove under controlled conditions in accordance with AS 4361.2:2017 Guide to hazardous paint management prior to renovation or demolition works.	-	-	10

- Remove flaking lead containing paint to window surrounds throughout the property in accordance with AS4361.2-2017 Guide to Hazardous Paint Management and relevant legislation.
