# Hazardous Building Materials Assessment

## Balmain Depot Administration and Store

35 Llewellyn Street  
Balmain NSW 2041

April 2018

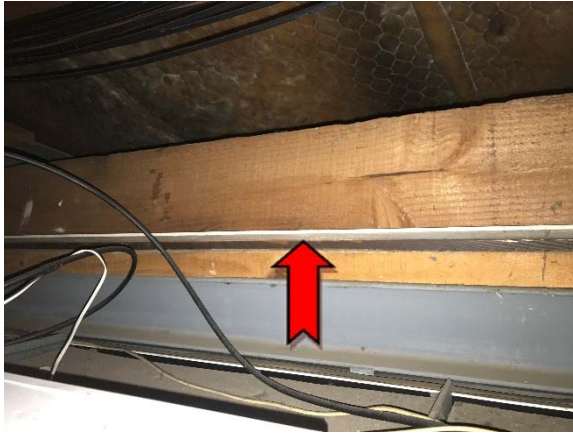
**Photo 1.** Interior, level 1, office area, ceiling space, lining beneath metal support – asbestos-containing fibre cement sheeting.

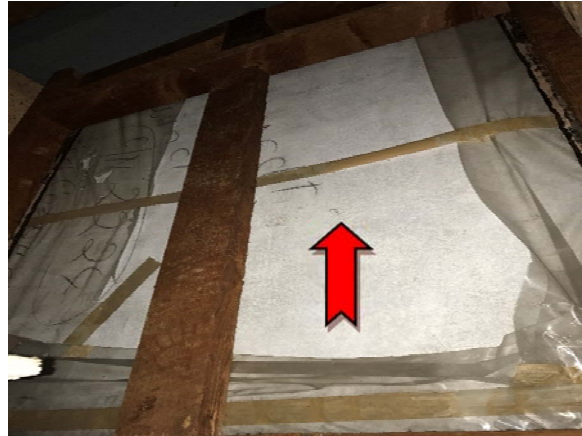
Interior, level 1	Staircase	Ceiling space, redundant window position	Fibre cement sheeting	Asbestos	57722-031-003	Positive	Non-friable	Low	Fair	Medium	2 m <sup>2</sup>	Encapsulate exposed sections, label as containing asbestos and maintain in a good condition if to remain in-situ. Remove under controlled non-friable asbestos removal conditions prior to refurbishment or demolition works by a Class B (non-friable) licensed asbestos removal contractor.	P3	Feb-23	2
Interior, level 1	Office area	Ceiling	Fibre cement sheeting	Asbestos	57722-031-002	Positive	Non-friable	Medium	Good	Low	25 m <sup>2</sup>	Encapsulate exposed sections, label as containing asbestos and maintain in a good condition if to remain in-situ. Remove under controlled non-friable asbestos removal conditions prior to refurbishment or demolition works by a Class B (non-friable) licensed asbestos removal contractor.	P3	Feb-23	
Interior, level 1	Throughout	Ceiling space	Insulation material	SMF	-	Suspected Positive	Bonded	Low	Good	Low	60 m <sup>2</sup>	Maintain in current condition if to remain in-situ. Remove under controlled SMF conditions as per the Code of Practice for the Safe Use of Synthetic Mineral Fibres [NOHSC: 2006 (1990)].	-	-	7

**Photo 2.** Interior, level 1, staircase, ceiling space, redundant window position – asbestos-containing fibre cement sheeting.

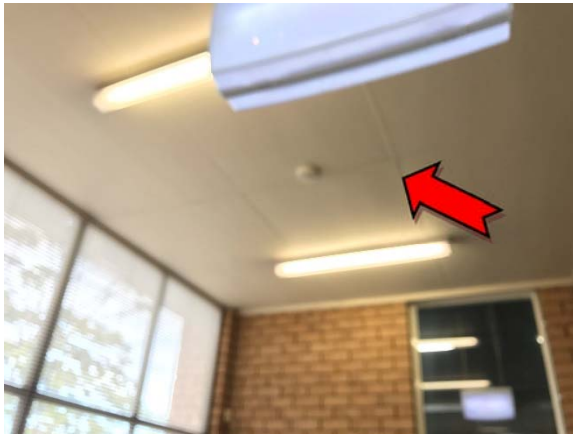
**Photo 3.** Interior, ground level, office area, ceiling – asbestos-containing fibre cement sheeting.

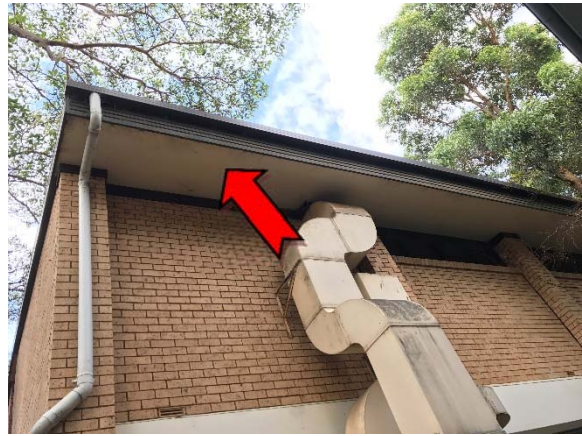
**Photo 4.** Exterior, north and south elevations, eaves – asbestos-containing fibre cement sheeting.

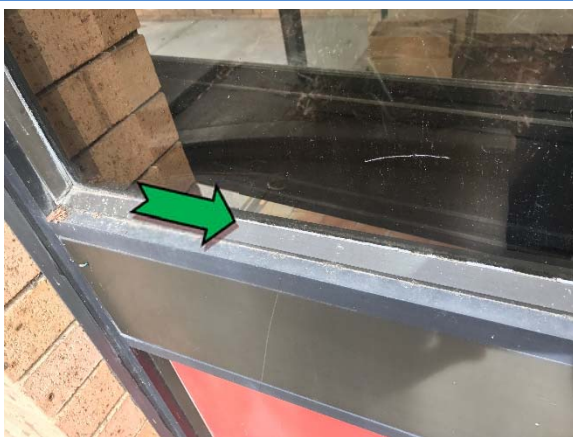
**Photo 5.** Exterior, throughout, window frames – non asbestos-containing window caulking.

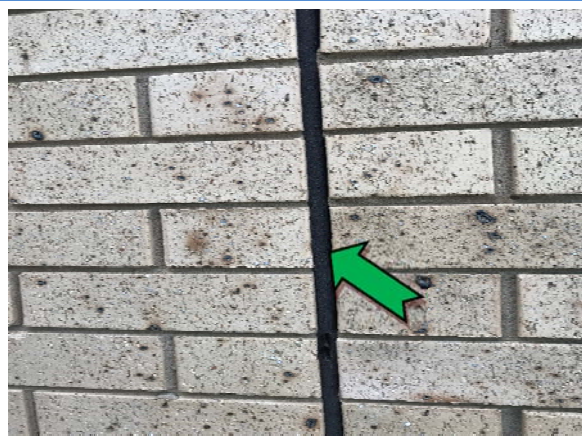
**Photo 6.** Exterior, throughout, wall joints – non asbestos-containing mastic sealant.

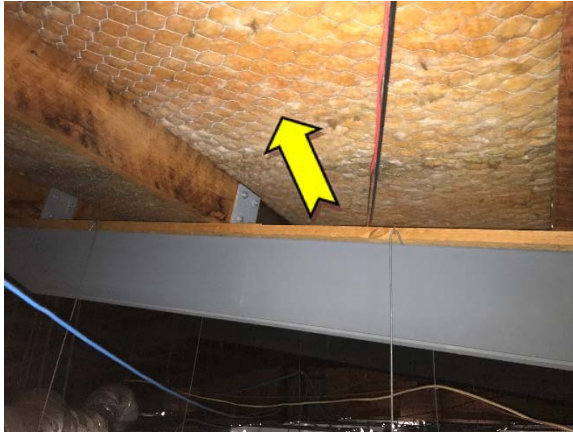
**Photo 7.** Interior, level 1, throughout ceiling space – suspected SMF sarking insulation.

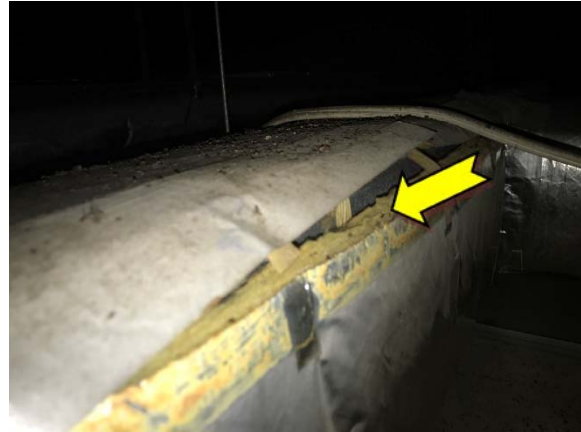
Interior, level 1	Ceiling space, throughout	Flexible ductwork	Insulation material	SMF	-	Suspected Positive	Bonded	Low	Good	Low	80 m	Maintain in current condition if to remain in-situ. Remove under controlled SMF conditions as per the Code of Practice for the Safe Use of Synthetic Mineral Fibres [NOHSC: 2006 (1990)].	-	-	8
Throughout	-	-	-	PCBs	-	-	-	-	-	-	-	No suspect PCB-containing capacitors identified at the time of the assessment.	-	-	
Exterior	North and south elevation	Eaves	Beige - upper coloured paint system	Lead Paint - Swab	-	Suspected Positive	-	Low	Good	Low	15 m <sup>2</sup>	Confirm status by quantitative test method, maintain in current condition, over paint with a lead-free paint as part of ongoing maintenance. Remove under controlled conditions in accordance with AS 4361.2:2017 Guide to hazardous paint management prior to renovation or demolition works.	-	-	9
Exterior	Mid level, throughout	Wall	Beige - upper coloured paint system	Lead Paint - Swab	-	Suspected Positive	-	Low	Good	Low	15m <sup>2</sup>	Confirm status by quantitative test method, maintain in current condition, over paint with a lead-free paint as part of ongoing maintenance. Remove under controlled conditions in accordance with AS 4361.2:2017 Guide to hazardous paint management prior to renovation or demolition works.	-	-	10

**Photo 8.** Interior, level 1, throughout, ductwork – suspected SMF internal insulation.

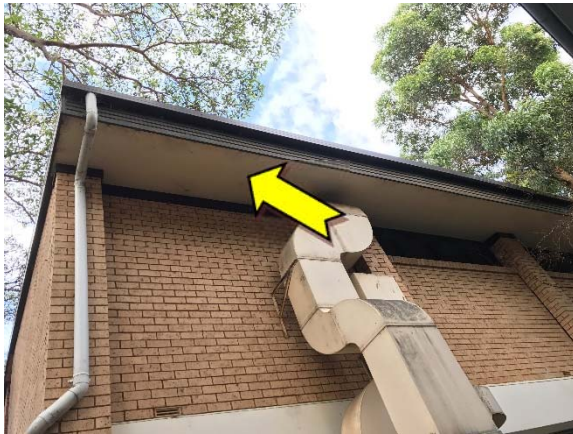
**Photo 9.** Exterior, north and south elevation, eaves – suspected lead-containing beige upper paint system.

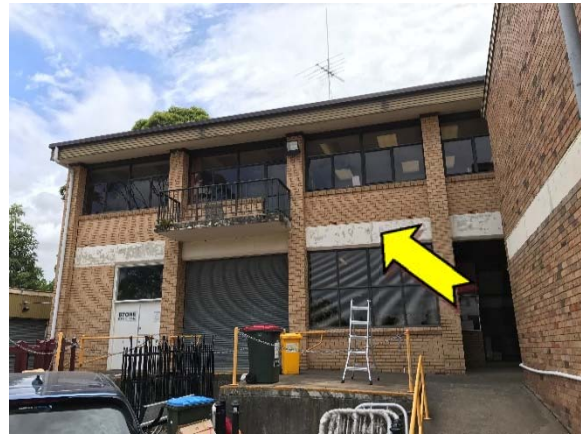
**Photo 10.** Exterior, north and south elevation, mid-level walls – suspected lead-containing beige upper paint system.

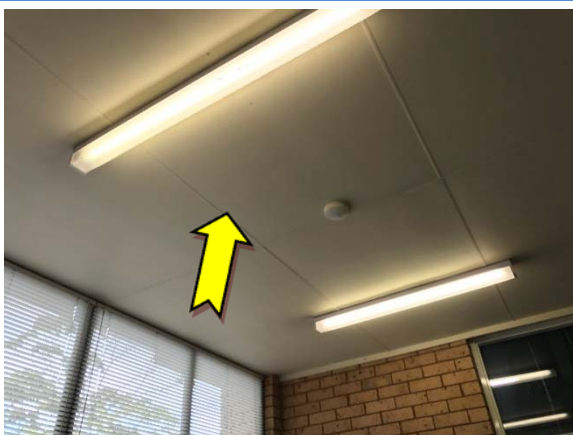
**Photo 11.** Interior, throughout, ceiling – suspected lead-containing cream upper paint system.
