Hazardous Building Materials Assessment

Balmain Depot Amenities Block

35 Llewellyn Street
Balmain NSW 2204

Inner West Council
April 2018

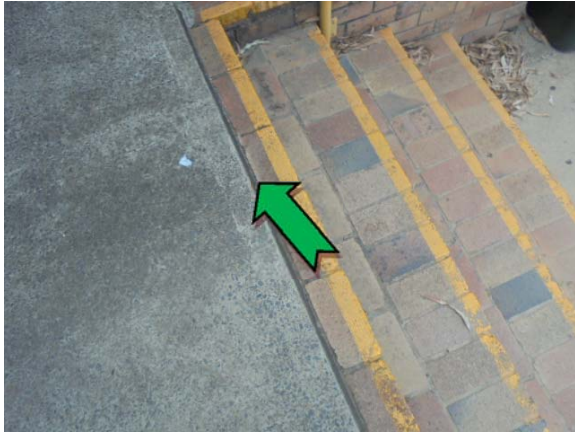
Photo 1. Exterior, entrance, expansion joint – non asbestos-containing bituminous material.

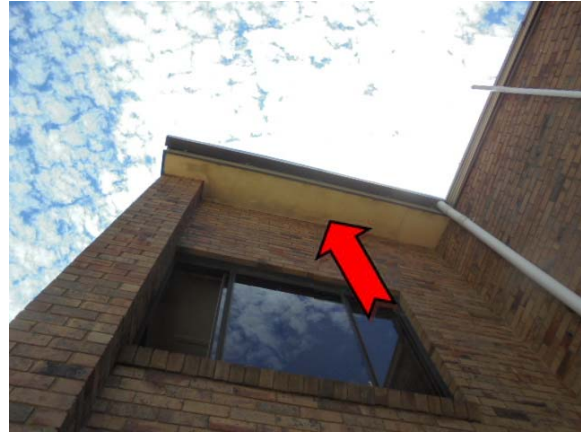
Photo 2. Exterior, north and south elevations, eaves – suspected asbestos-containing fibre cement sheeting.

- Non-friable asbestos was suspected in the form of fibre cement sheeting eaves to the north and south elevation of the amenities block.

- Most ACM were found not to be appropriately labelled. ACM on-site should be labelled in accordance with the relevant state / territory Legislation and AS 1319-1994 *Safety signs for the occupational environment* to warn of the dangers of disturbing these materials.

- Schedule periodic reassessment of ACM remaining on-site to monitor their aging/deterioration so that the site controller can be alerted if any ACM require encapsulation or removal – in accordance with the relevant state / territory Legislation and Codes of Practice.

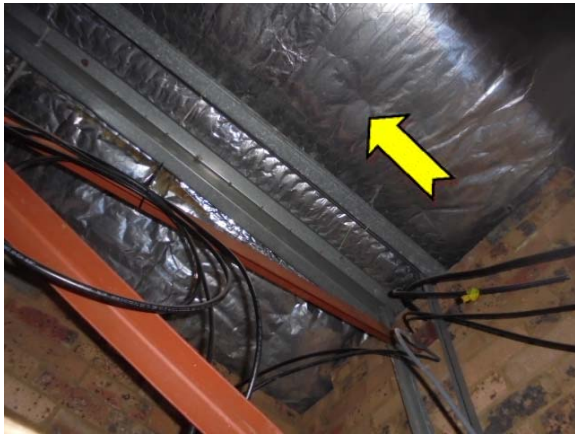
Photo 3. Interior, level 1, loft, ceiling – suspected SMF sarking insulation.

- Suspected SMF was located in the form of sarking insulation to the loft area.
- Suspected SMF was located in the form of internal insulation to hot water heater.

- SMF materials that are likely to be disturbed during any proposed demolition/refurbishment works should be handled in accordance with the *Code of Practice for the Safe Use of Synthetic Mineral Fibres* [NOHSC:2006(1990)]. If these materials are impacted upon by accident or by pre-planned works, the Inner West Council must be informed via the contact detailed within Section 7: *Accidental Disturbance of Known or Suspected Hazardous Building Materials*. Following disturbance, inspection by a competent person should be undertaken.
