Hazardous Building Materials Assessment

Balmain Depot Paper Store and Gardeners Shed

35 Llewellyn Street
Balmain NSW 2041

Inner West Council
April 2018

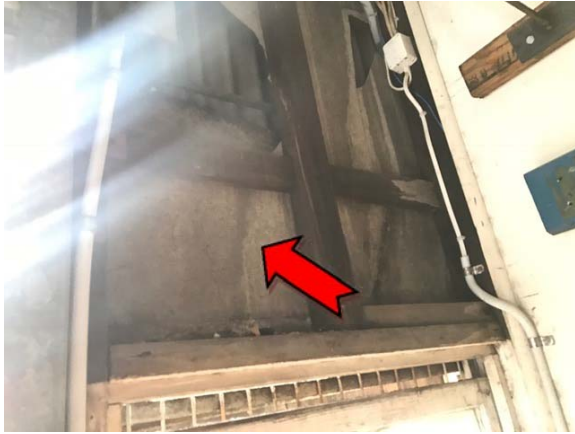
Photo 1. Interior, ground level, paper store, east wall panels – asbestos-containing fibre cement sheeting.

- Non-friable asbestos was identified in the form of fibre cement sheeting wall panels to the eastern elevation of the building.

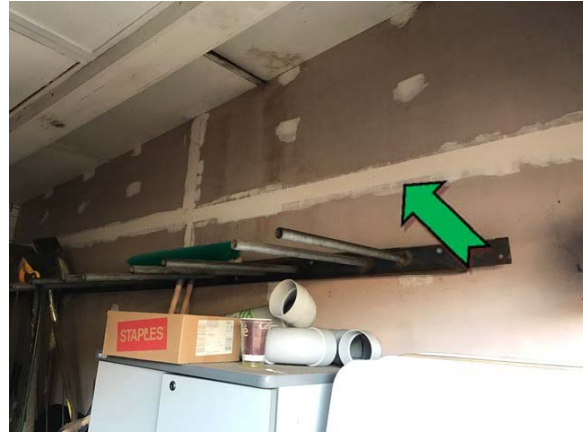
Photo 2. Interior, ground level, paper store, north wall panels – non asbestos-containing fibre cement sheeting.

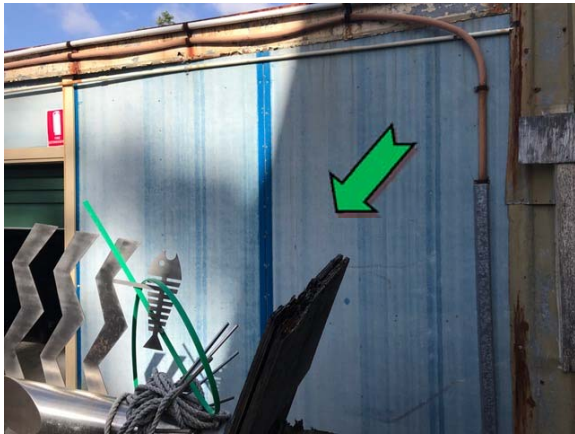
Photo 3. Exterior, north elevation, wall panels – non asbestos-containing fibre cement sheeting.

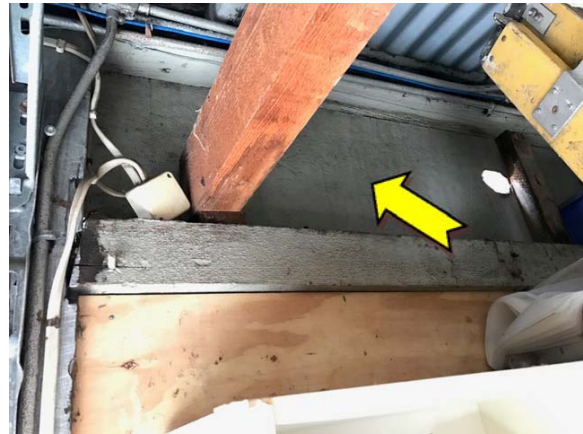
Photo 4. Interior, gardeners shed, west elevation, wall – suspected lead-containing beige upper paint system.

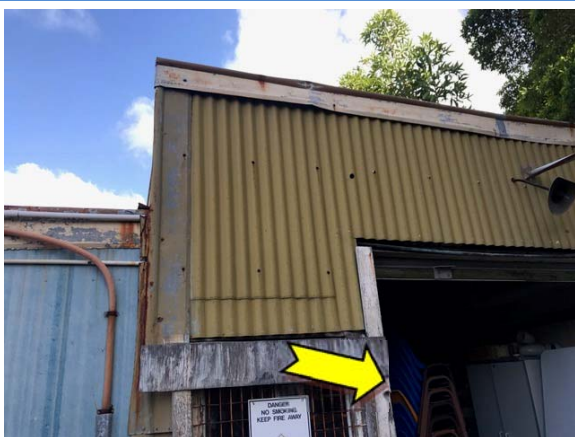
Exterior	Window and door frames	Throughout	Cream - upper coloured paint system	Lead Paint - Swab	-	Suspected Positive	-	Low	Good	Low	15 m ²	Confirm status by quantitative test method, maintain in current condition, over paint with a lead-free paint as part of ongoing maintenance. Remove under controlled conditions in accordance with AS 4361.2:2017 Guide to hazardous paint management prior to renovation or demolition works.	-	-	-	5
Interior	Gardeners shed, west elevation	Wall	Silver - upper coloured paint system	Lead Paint - Swab	-	Suspected Positive	-	Low	Good	Low	8 m ²	Confirm status by quantitative test method, maintain in current condition, over paint with a lead-free paint as part of ongoing maintenance. Remove under controlled conditions in accordance with AS 4361.2:2017 Guide to hazardous paint management prior to renovation or demolition works.	-	-	-	4
Throughout	-	-	-	Ozone Depleting Substances	-	-	-	-	-	-	-	No suspect ODS's identified at the time of the assessment.	-	-	-	-

Photo 5. Exterior, throughout, window and door frames – suspected lead-containing beige upper paint system.
