Hazardous Building Materials Assessment

Balmain Depot Maintenance Shed

35 Llewellyn Street
Balmain NSW 2041

April 2018

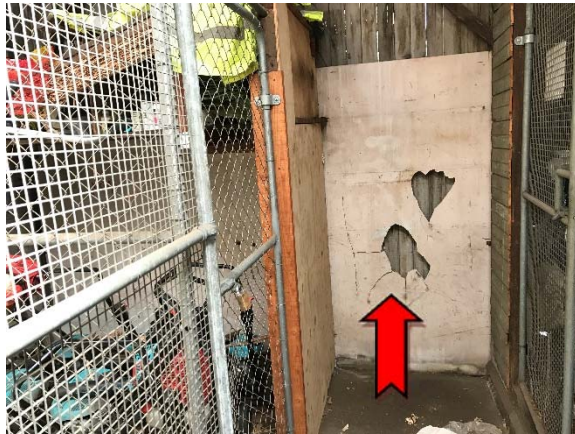
Photo 1. Interior, ground level, maintenance shed, south wall – asbestos-containing fibre cement sheeting.

- Non-friable asbestos was identified in the form of fibre cement sheeting to the southern wall.

- Remove the damaged fibre cement sheeting to the southern wall of the maintenance shed. Works to be undertaken by a Class B or A licensed asbestos removal contractor.

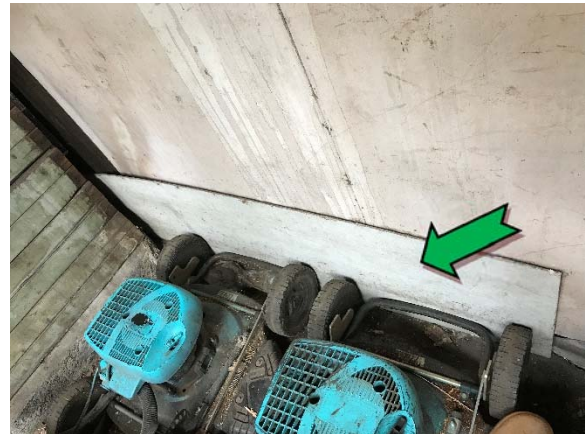
Photo 2. Interior, ground level, maintenance shed, south wall redundant panel – non asbestos-containing fibre cement sheeting.

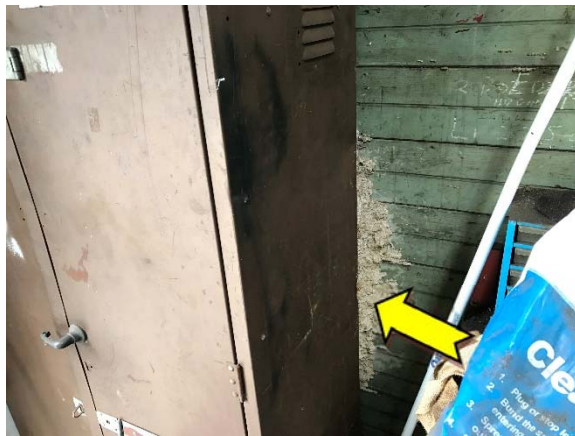
Photo 3. Interior, ground level, maintenance shed, east wall – non asbestos-containing vermiculite.

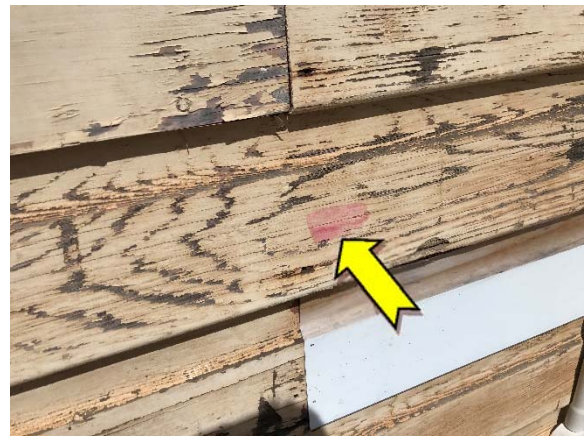
Throughout	-	-	-	PCBs	-	-	-	-	-	-	-	No suspect PCB-containing capacitors identified at the time of the assessment.	-	-	-
Exterior	Throughout	Walls	Cream - upper coloured paint system	Lead Paint - Swab	-	Positive	-	Low	Fair	Low	150 m ²	Remove flaking sections and over paint with a lead-free paint. Remove under controlled conditions in accordance with AS 4361.2:2017 Guide to hazardous paint management prior to renovation or demolition works.	-	-	3
Exterior	Maintenance door	Door	Green - lower coloured paint system	Lead Paint - Swab	-	Positive	-	Low	Fair	Low	2 m ²	Remove flaking sections and over paint with a lead-free paint. Remove under controlled conditions in accordance with AS 4361.2:2017 Guide to hazardous paint management prior to renovation or demolition works.	-	-	4
Exterior	Maintenance door	Door	Green - upper coloured paint system	Lead Paint - Swab	-	Positive	-	Low	Fair	Low	2 m ²	Remove flaking sections and over paint with a lead-free paint. Remove under controlled conditions in accordance with AS 4361.2:2017 Guide to hazardous paint management prior to renovation or demolition works.	-	-	5

Photo 4. Exterior, throughout, walls – suspected lead-containing cream upper paint system.

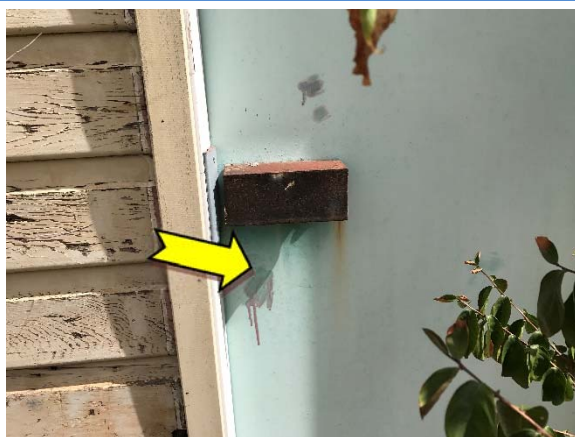
Photo 5. Exterior, throughout, doors – suspected lead-containing green upper paint system.

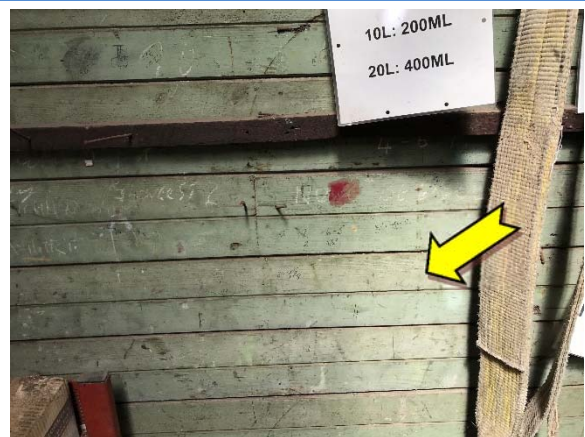
Interior	Maintenance shed, internal walls	Wall	Green - upper coloured paint system	Lead Paint - Swab	-	Positive	-	Low	Fair	Low	50 m ²	Remove flaking sections and over paint with a lead-free paint. Remove under controlled conditions in accordance with AS 4361.2:2017 Guide to hazardous paint management prior to renovation or demolition works.	-	-	-
Throughout	-	-	-	Ozone Depleting Substances	-	-	-	-	-	-	-	No suspect ODS's identified at the time of the assessment.	-	-	-

Photo 6. Interior, throughout, walls – suspected lead-containing green upper paint system.
