Hazardous Building Materials Assessment

Balmain Depot Partitioned Garage

35 Llewellyn Street
Balmain NSW 2041

Inner West Council
April 2018

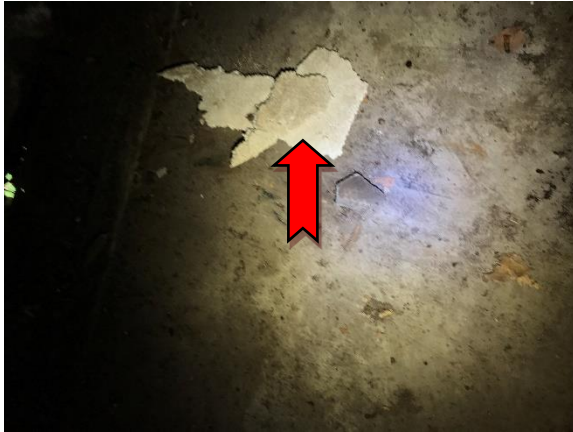
| Area / Level | Room & Location | Feature | Item Description | Hazard Type | Sample No. | Sample Status | Friability | Disturb. Potential | Condition | Risk Status | Approx. Quantity | Recommendations & Comments | Control Priority | Reinspect Date | Photo No. |
|---|---|---|---|---|---|---|---|---|---|---|---|---|---|---|---|
| Interior | Partitioned garage, west room | Debris | Fibre cement sheeting | Asbestos | 57722-032-001 | Positive | Non-friable | Medium | Poor | Medium | 1 m ² | Remove under controlled non-friable asbestos removal conditions prior to refurbishment or demolition works by a Class B (non-friable) licensed asbestos removal contractor. | P2 | Mar-19 | 1 |

Photo 1. Interior, ground level, west room, debris – asbestos-containing fibre cement sheeting.

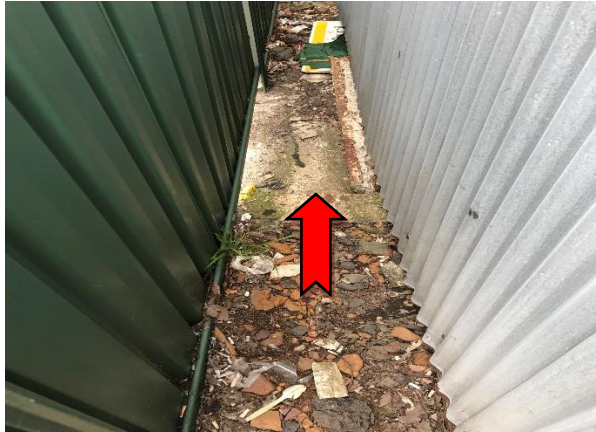
| Area / Level | Room & Location | Feature | Item Description | Hazard Type | Sample No. | Sample Status | Friability | Disturb. Potential | Condition | Risk Status | Approx. Quantity | Recommendations & Comments | Control Priority | Reinspect Date | Photo No. |
|---|---|---|---|---|---|---|---|---|---|---|---|---|---|---|---|
| Exterior | Exterior throughout, ground surface | Debris | Fibre cement sheeting | Asbestos | 57722-032-002 | Positive | Non-friable | Medium | Poor | Medium | 5 m ² | Remove under controlled non-friable asbestos removal conditions prior to refurbishment or demolition works by a Class B (non-friable) licensed asbestos removal contractor. | P2 | Mar-23 | 2 |

Photo 2. Exterior, throughout, debris – asbestos-containing fibre cement sheeting.

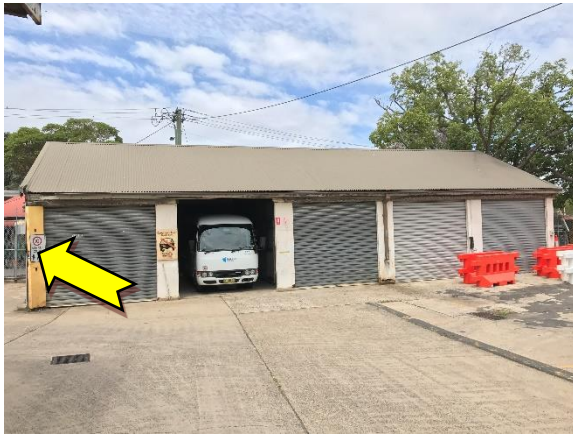
| Area / Level | Room & Location | Feature | Item Description | Hazard Type | Sample No. | Sample Status | Friability | Disturb. Potential | Condition | Risk Status | Approx. Quantity | Recommendations & Comments | Control Priority | Reinspect Date | Photo No. |
|---|---|---|---|---|---|---|---|---|---|---|---|---|---|---|---|
| Exterior | Throughout | Metal frame | Yellow - upper coloured paint system | Lead Paint - Swab | - | Suspected Positive | - | Low | Good | Low | 30 m ² | Confirm status by quantitative test method, maintain in current condition, over paint with a lead-free paint as part of ongoing maintenance. Remove under controlled conditions in accordance with AS 4361.2:2017 Guide to hazardous paint management prior to renovation or demolition works. | - | - | 3 |

Photo 3. Exterior, throughout, walls – suspected lead-containing yellow upper paint system.

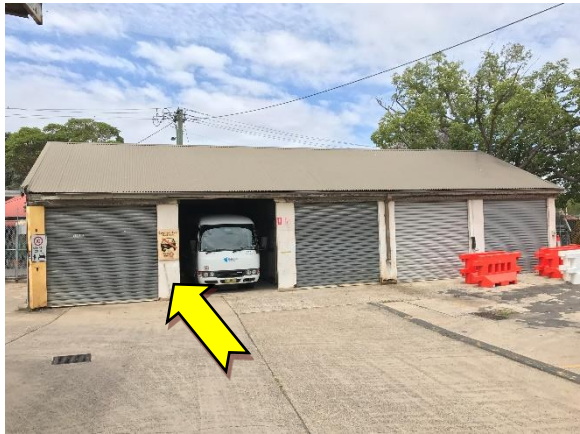
| Area / Level | Room & Location | Feature | Item Description | Hazard Type | Sample No. | Sample Status | Friability | Disturb. Potential | Condition | Risk Status | Approx. Quantity | Recommendations & Comments | Control Priority | Reinspect Date | Photo No. |
|---|---|---|---|---|---|---|---|---|---|---|---|---|---|---|---|
| Exterior | North elevation | Wall | White - upper coloured paint system | Lead Paint - Swab | - | Suspected Positive | - | Low | Good | Low | 30 m ² | Confirm status by quantitative test method, maintain in current condition, over paint with a lead-free paint as part of ongoing maintenance. Remove under controlled conditions in accordance with AS 4361.2:2017 Guide to hazardous paint management prior to renovation or demolition works. | - | - | 4 |

Photo 4. Exterior, north elevation, wall – suspected lead-containing white upper paint system.

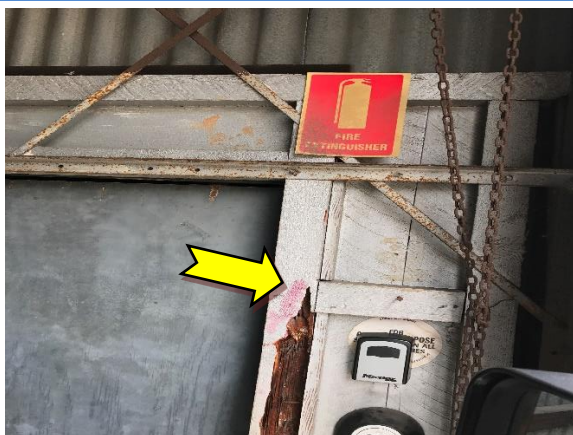
| Area / Level | Room & Location | Feature | Item Description | Hazard Type | Sample No. | Sample Status | Friability | Disturb. Potential | Condition | Risk Status | Approx. Quantity | Recommendations & Comments | Control Priority | Reinspect Date | Photo No. |
|---|---|---|---|---|---|---|---|---|---|---|---|---|---|---|---|
| Interior | Centre room | Door frame | White - upper coloured paint system | Lead Paint - Swab | - | Suspected Positive | - | Low | Fair | Low | 20 m ² | Confirm status by quantitative test method, maintain in current condition, over paint with a lead-free paint as part of ongoing maintenance. Remove under controlled conditions in accordance with AS 4361.2:2017 Guide to hazardous paint management prior to renovation or demolition works. | - | - | 5 |

Photo 5. Interior, centre room, door frame – suspected lead-containing white upper paint system.
