# Hazardous Building Materials Assessment

## Balmain Depot Carpenters/Painters Workshop

35 Llewellyn Street  
Balmain NSW 2041

April 2018

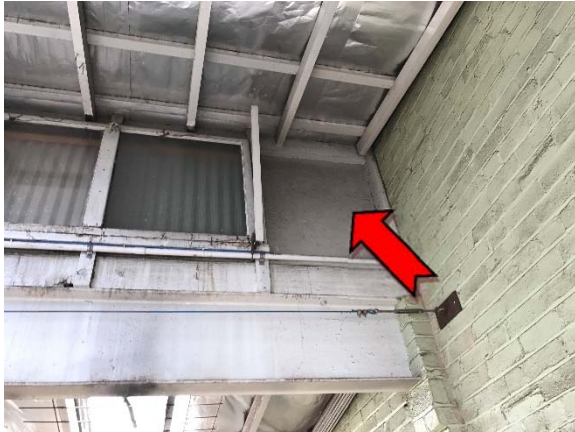
**Photo 1.** Interior, ground level, throughout, workshop, high level infill panels – asbestos-containing fibre cement sheeting.

- Non-friable asbestos was identified in the form of fibre cement sheeting high level panels throughout the workshop.
- Non-friable asbestos was also located in the form of fibre cement sheeting wall panels in store room 2.

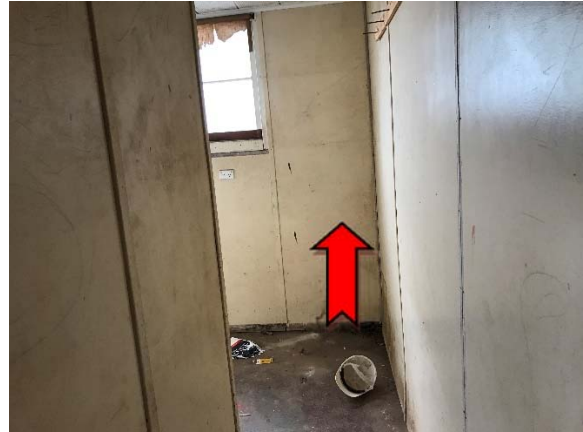
**Photo 2.** Interior, ground level, store 2, wall – asbestos-containing fibre cement sheeting.

Area / Level	Room & Location	Feature	Item Description	Hazard Type	Sample No.	Sample Status	Friability	Disturb. Potential	Condition	Risk Status	Approx. Quantity	Recommendations & Comments	Control Priority	Reinspect Date	Photo No.
Exterior	Throughout	Window frames	Window caulking	Asbestos	57722-033-004	Negative	-	-	-	-	-	-	-	-	4
Exterior	Workshop, surrounding, below roof	Infill panels	Fibre cement sheeting	Asbestos	57722-033-005	Negative	-	-	-	-	-	-	-	-	5
Interior, ground level	Workshop, high level, throughout	Infill panels	Fibre cement sheeting	Asbestos	57722-033-001	Positive	Non-friable	Low	Fair	Low	12 m <sup>2</sup>	Label as containing asbestos and maintain in current condition if to remain in-situ. Remove under controlled non-friable asbestos removal conditions prior to refurbishment or demolition works by a Class B (non-friable) licensed asbestos removal contractor.	P4	Mar-23	1
Interior, ground level	Store two	Walls	Fibre cement sheeting	Asbestos	57722-033-002	Positive	Non-friable	Medium	Poor	Medium	15 m <sup>2</sup>	Encapsulate exposed sections, label as containing asbestos and maintain in a good condition if to remain in-situ. Remove under controlled non-friable asbestos removal conditions prior to refurbishment or demolition works by a Class B (non-friable) licensed asbestos removal contractor.	P2	Mar-19	2

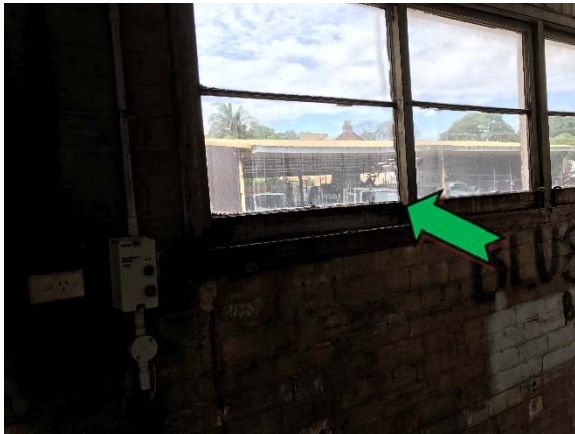
**Photo 3.** Interior, ground level, throughout workshop, window frames – non asbestos-containing bituminous material.

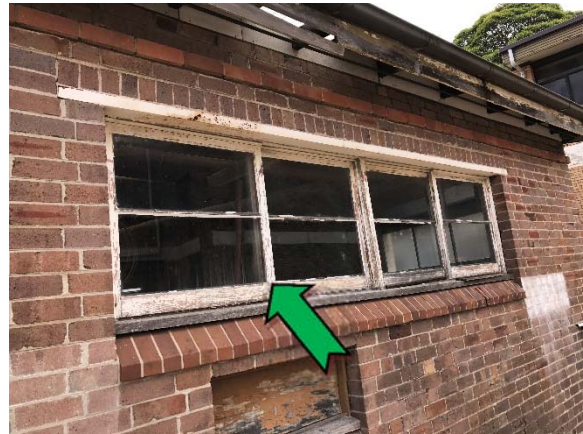
**Photo 4.** Exterior, ground level, throughout, window frames – non asbestos-containing window caulking.

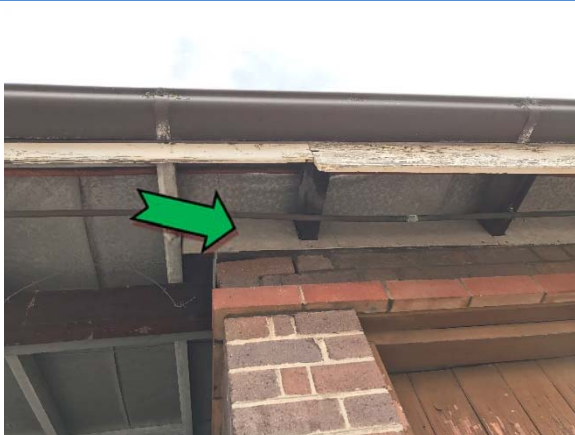
**Photo 5.** Exterior, throughout, infill panels below roof – non asbestos-containing fibre cement sheeting.

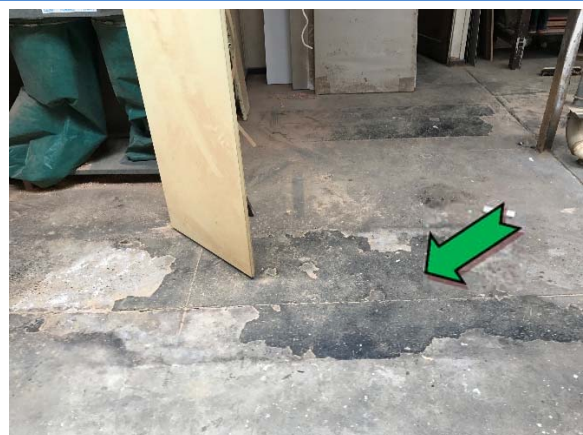
**Photo 6.** Interior, carpenter's workshop, black floor covering – non asbestos-containing bituminous material.

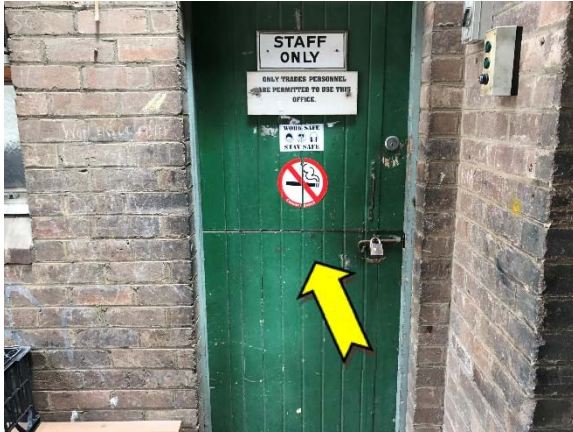
**Photo 7.** Exterior, office, door and door frame – suspected lead-containing green upper paint system.

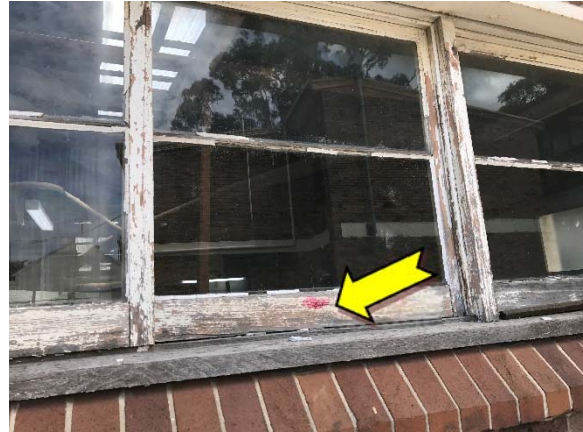
Exterior	Workshops	Window frames	White - upper coloured paint system	Lead Paint - Swab	-	Positive	-	Low	Poor	Low	25 m <sup>2</sup>	Remove flaking sections and over paint with a lead-free paint. Remove under controlled conditions in accordance with AS 4361.2:2017 Guide to hazardous paint management prior to renovation or demolition works.	-	-	8
Interior, ground level	Carpenters workshop, western wall	Wall	Green (dark) - upper coloured paint system	Lead Paint - Swab	-	Positive	-	Low	Poor	Low	20 m <sup>2</sup>	Remove flaking sections and over paint with a lead-free paint. Remove under controlled conditions in accordance with AS 4361.2:2017 Guide to hazardous paint management prior to renovation or demolition works.	-	-	9
Interior, ground level	Storeroom	Walls	Cream - upper coloured paint system	Lead Paint - Swab	-	Suspected Positive	-	Low	Good	Low	15 m <sup>2</sup>	Confirm status by quantitative test method, maintain in current condition, over paint with a lead-free paint as part of ongoing maintenance. Remove under controlled conditions in accordance with AS 4361.2:2017 Guide to hazardous paint management prior to renovation or demolition works.	-	-	-

**Photo 8.** Exterior, throughout, window frames – lead-containing white upper paint system.

- Remove flaking lead containing paint to window surrounds throughout the property in accordance with AS4361.2-2017 Guide to Hazardous Paint Management and relevant legislation.

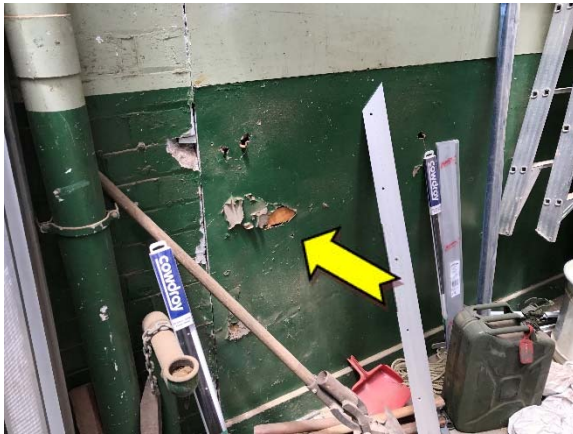
**Photo 9.** Interior, carpenter's workshop, western wall –lead-containing green upper paint system.
