Hazardous Building Materials Assessment Clontarf Cottage Community Centre 4 Wallace Street, Balmain NSW 2041

Inner West Council
April 2018

Executive Summary

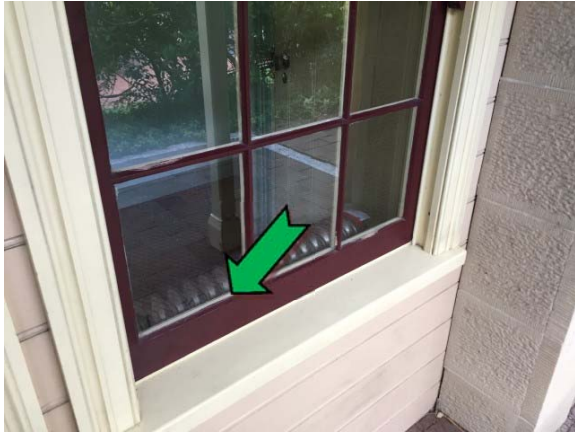
Photo 1. Exterior, throughout, window frames – non asbestos-containing window caulking.

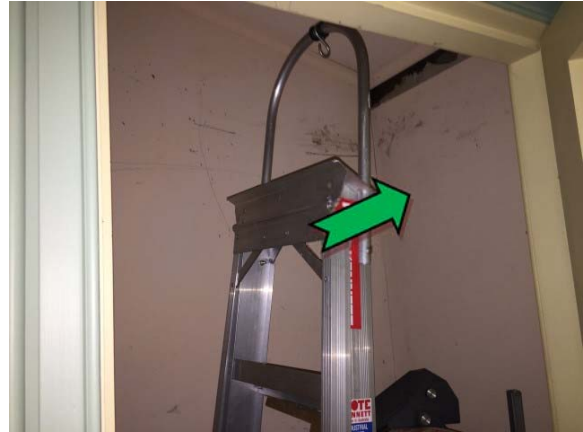
Photo 2. Interior, southern elevation, east cupboard, lining – non asbestos-containing fibre cement sheeting.

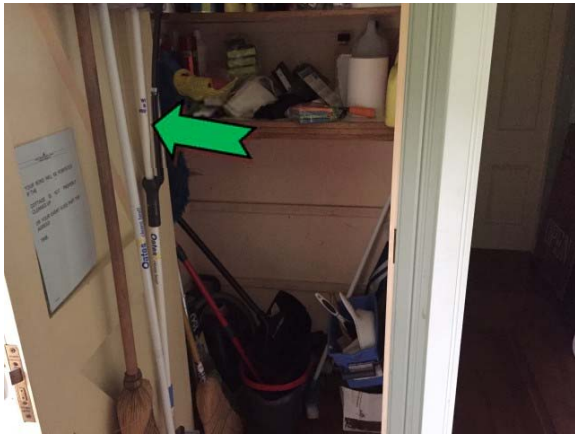
Photo 3. Interior, southern elevation, west cupboard, lining – assumed non asbestos-containing fibre cement sheeting.

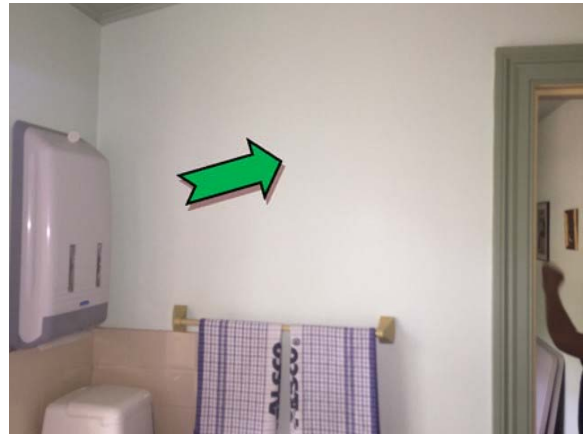
Photo 4. Interior, kitchen, western wall – assumed non asbestos-containing fibre cement sheeting.

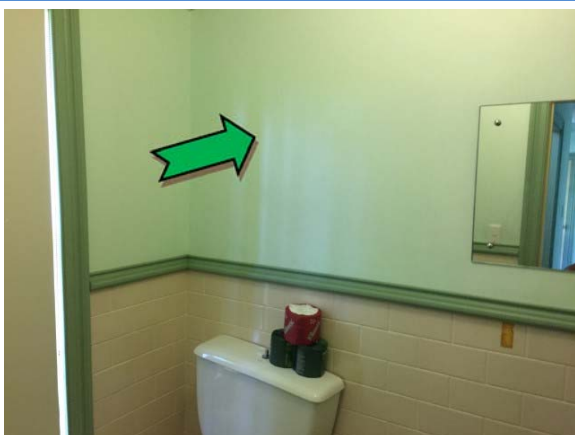
Interior	Toilets, walls	Lining	Fibre cement sheeting	Asbestos	57722-017-003A	Negative	-	-	-	-	-	-	-	-	5
Interior	Toilets, walls	Grey flexible mastic material attached to sample 57722-017-003A	Mastic sealant	Asbestos	57722-017-003B	Negative	-	-	-	-	-	-	-	-	-
Interior	Roof space, throughout	Lining	Sarking insulation	SMF	-	Suspected Positive	Bonded	Low	Good	Low	1 unit	Maintain in current condition if to remain in-situ. Remove under controlled SMF conditions as per the Code of Practice for the Safe Use of Synthetic Mineral Fibres [NOHSC: 2006 (1990)].	-	-	6
Interior	Southern elevation, eastern cupboard	Hot water heater	Insulation material - Internal	SMF	-	Suspected Positive	Bonded	Low	Good	Low	1 unit	Maintain in current condition if to remain in-situ. Remove under controlled SMF conditions as per the Code of Practice for the Safe Use of Synthetic Mineral Fibres [NOHSC: 2006 (1990)].	-	-	7
Throughout	-	-	-	PCBs	-	-	-	-	-	-	-	No suspect PCB-containing capacitors identified at the time of the assessment.	-	-	-

Photo 5. Interior, toilets, walls – non asbestos-containing fibre cement sheeting and grey mastic sealant.

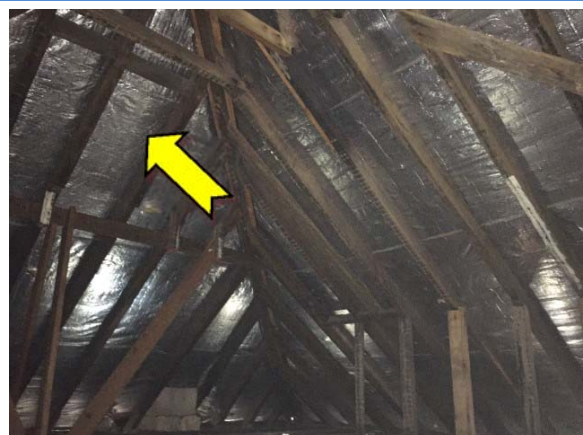
Photo 6. Interior, roof space, throughout – suspected SMF sarking insulation.

- SMF materials that are likely to be disturbed during any proposed demolition/refurbishment works should be handled in accordance with the *Code of Practice for the Safe Use of Synthetic Mineral Fibres* [NOHSC:2006(1990)]. If these materials are impacted upon by accident or by pre-planned works, the Inner West Council must be informed via the contact detailed within Section 7: *Accidental Disturbance of Known or Suspected Hazardous Building Materials*. Following disturbance, inspection by a competent person should be undertaken.

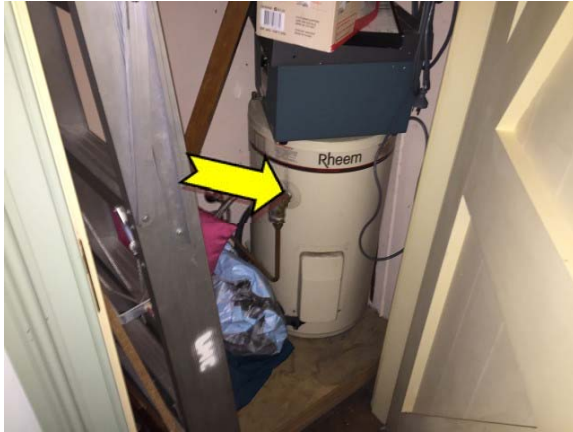
Photo 7. Interior, south elevation, east cupboard, hot water heater – suspected SMF internal insulation.

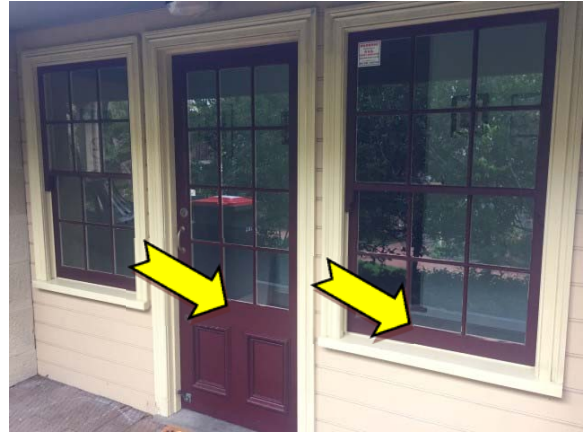
Exterior	Throughout	Windows & door frames	Red (dark) - upper coloured paint system	Lead Paint - Swab	-	Suspected Positive	-	Low	Good	Low	20 m ²	Confirm status by quantitative test method, maintain in current condition, over paint with a lead-free paint as part of ongoing maintenance. Remove under controlled conditions in accordance with AS 4361.2:2017 Guide to hazardous paint management prior to renovation or demolition works.	-	-	8
Exterior	Throughout	Awning	Green (light) - upper coloured paint system	Lead Paint - Swab	-	Suspected Positive	-	Low	Good	Low	40 m ²	Confirm status by quantitative test method, maintain in current condition, over paint with a lead-free paint as part of ongoing maintenance. Remove under controlled conditions in accordance with AS 4361.2:2017 Guide to hazardous paint management prior to renovation or demolition works.	-	-	9
Exterior	Columns and features to building	Surrounding	Yellow (light) - upper coloured paint system	Lead Paint - Swab	-	Suspected Positive	-	Low	Good	Low	30 m ²	Confirm status by quantitative test method, maintain in current condition, over paint with a lead-free paint as part of ongoing maintenance. Remove under controlled conditions in accordance with AS 4361.2:2017 Guide to hazardous paint management prior to renovation or demolition works.	-	-	10

Photo 8. Exterior, throughout, window and door frames – suspected lead-containing red upper paint system.

- The *LeadCheck* paint swab method can detect lead in paint at concentrations of 0.5% and above, and may indicate lead in some paint films as low as 0.2%. As paint with a lead content greater than 0.1% by dry weight is now considered to be lead-containing, Prensa recommends confirming status of suspected LCP identified during the assessment by quantitative test method.

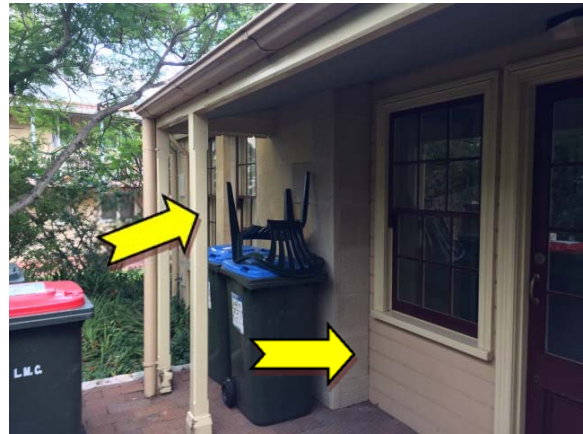
Photo 10. Exterior, throughout, walls, columns and features – suspected lead-containing yellow and beige upper coloured paint systems.

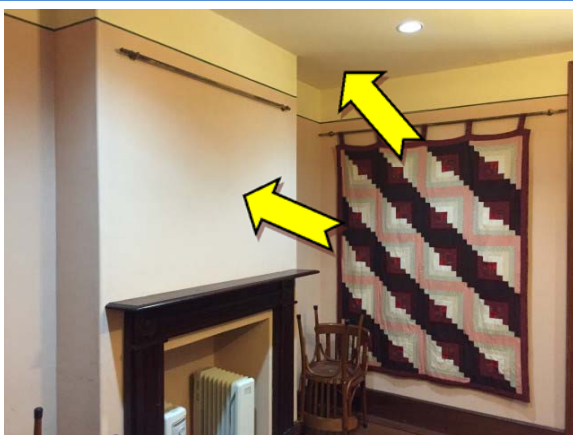
Interior	Room 1, 2 & hallway	Upper walls and ceiling	Cream - upper coloured paint system	Lead Paint - Swab	-	Suspected Positive	-	Low	Good	Low	200 m ²	Confirm status by quantitative test method, maintain in current condition, over paint with a lead-free paint as part of ongoing maintenance. Remove under controlled conditions in accordance with AS 4361.2:2017 Guide to hazardous paint management prior to renovation or demolition works.	-	-	11
Interior	Hall & back of house	Walls and ceiling	Green (light) - upper coloured paint system	Lead Paint - Swab	-	Suspected Positive	-	Low	Good	Low	100 m ²	Confirm status by quantitative test method, maintain in current condition, over paint with a lead-free paint as part of ongoing maintenance. Remove under controlled conditions in accordance with AS 4361.2:2017 Guide to hazardous paint management prior to renovation or demolition works.	-	-	12
Interior	Back of house	Windows & door frames	Green (dark) - upper coloured paint system	Lead Paint - Swab	-	Suspected Positive	-	Low	Good	Low	5 m ²	Confirm status by quantitative test method, maintain in current condition, over paint with a lead-free paint as part of ongoing maintenance. Remove under controlled conditions in accordance with AS 4361.2:2017 Guide to hazardous paint management prior to renovation or demolition works.	-	-	12

Photo 11. Interior, rooms 1 and 2, walls, upper level walls and ceiling – suspected lead-containing pink and cream upper coloured paint systems.

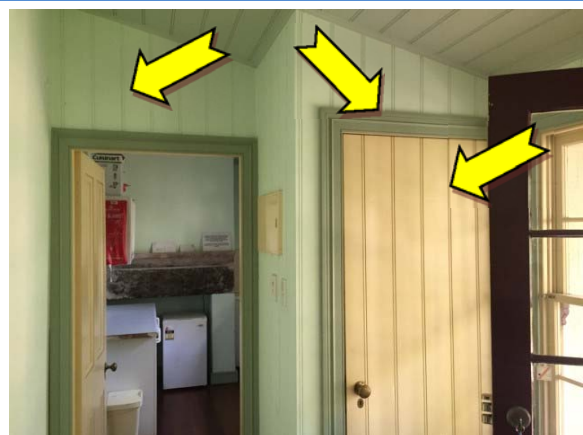
Interior	Back of house	Door	Yellow (light) - upper coloured paint system	Lead Paint - Swab	-	Suspected Positive	-	Low	Good	Low	20 m ²	Confirm status by quantitative test method, maintain in current condition, over paint with a lead-free paint as part of ongoing maintenance. Remove under controlled conditions in accordance with AS 4361.2:2017 Guide to hazardous paint management prior to renovation or demolition works.	-	-	12
Throughout	-	-	-	Ozone Depleting Substances	-	-	-	-	-	-	-	No suspect ODS's identified at the time of the assessment.	-	-	-

Photo 12. Interior, hall and back of house, walls, ceiling door and frames – suspected lead-containing light green, dark green and yellow upper coloured paint systems.
