# Hazardous Building Materials Assessment Elkington Park Bandstand White Street, Balmain NSW 2041

Inner West Council  
April 2018

Job No.: 57722-030

Count ID: CID: 132

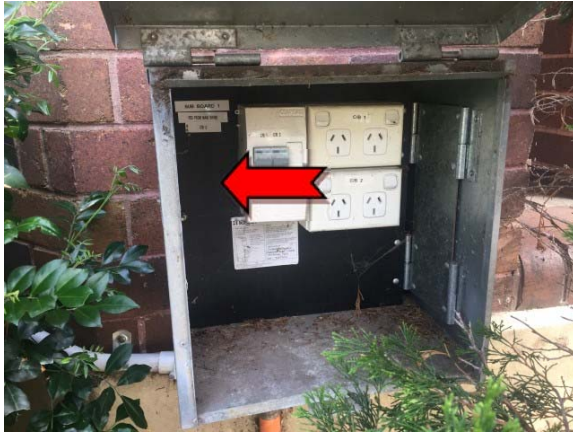
**Photo 1.** Exterior, south elevation, adjacent stairs, electrical backing board – suspected asbestos-containing bituminous backing board.

- Non-friable asbestos was suspected in the form of a bituminous backing board located to the south exterior of the bandstand adjacent the stairs.

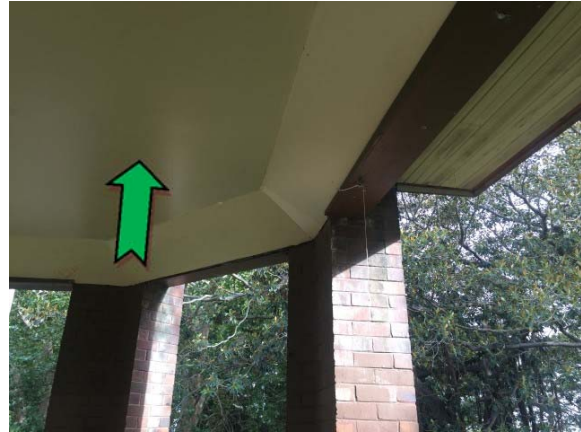
**Photo 2.** Exterior, throughout, ceiling – non asbestos-containing fibre cement sheeting and suspected lead-containing cream upper paint systems.

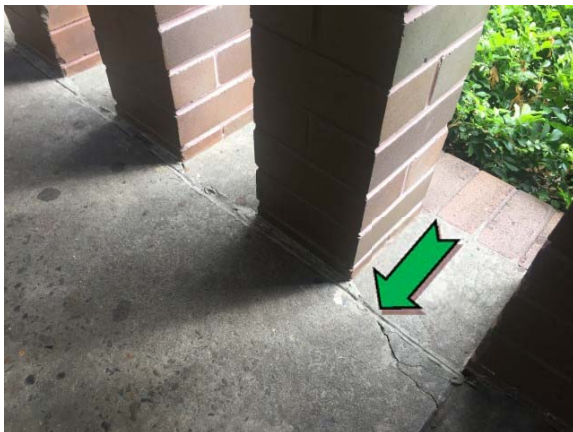
**Photo 3.** Exterior, throughout, ground, expansion joints – non asbestos-containing construction joint mastic.

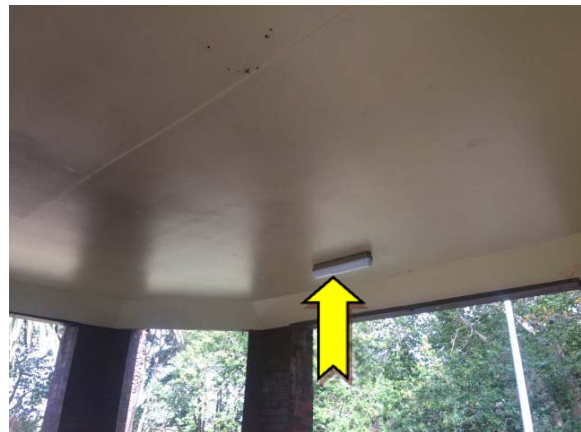
**Photo 4.** Exterior, throughout, single tubed fluorescent light fitting – suspected PCB-containing capacitors.

- PCBs were suspected within the capacitors of the single tubed fluorescent light fittings throughout the bandstand.

- Electrical fittings suspected of containing PCB oil capacitors should be treated as containing PCB oils until such time as evidence suggest otherwise e.g. further assessed.
- Electrical fittings that contain or suspected to contain PCB oil-containing capacitors should be removed as hazardous/regulated waste under controlled working conditions prior to the demolition or refurbishment works in accordance with the *Polychlorinated Biphenyls Management Plan, Revised Edition April 2003*.

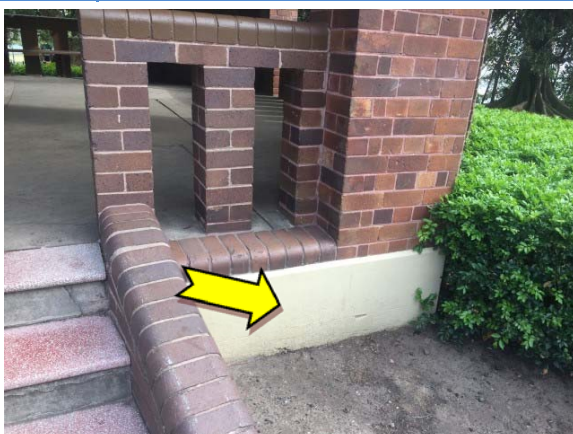
**Photo 5.** Exterior, throughout, lower level, walls – suspected lead-containing cream upper paint systems.

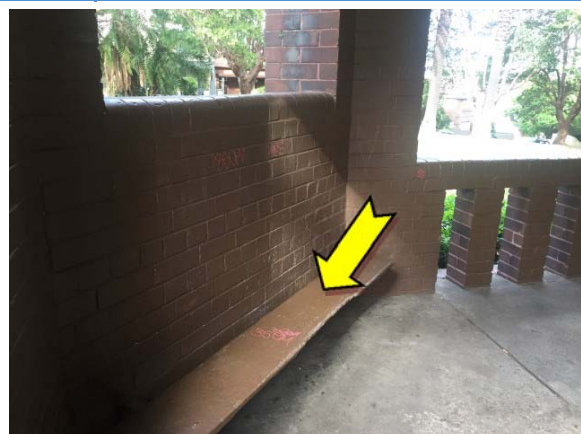
**Photo 6.** Exterior, throughout, walls – suspected lead containing brown upper paint systems.

- LCP was suspected in the form of cream and brown upper coloured paint systems throughout the bandstand.
