Hazardous Building Materials Assessment Elkington Park Toilet Block White Street, Balmain NSW 2041

Inner West Council
April 2018

Job No.: 57722-071

Count ID: CID: 133

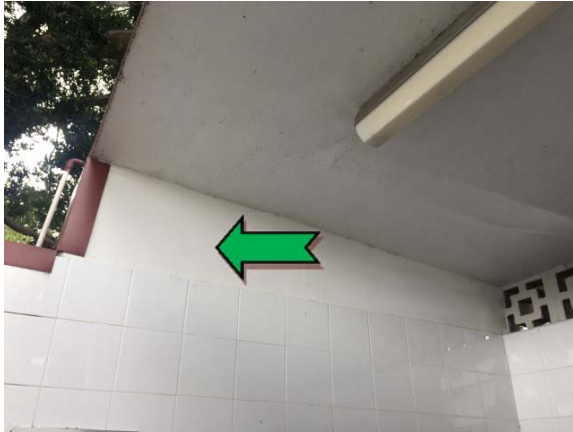
Area / Level	Room & Location	Feature	Item Description	Hazard Type	Sample No.	Sample Status	Friability	Disturb. Potential	Condition	Risk Status	Approx. Quantity	Recommendations & Comments	Control Priority	Reinspect Date	Photo No.
Ground level	Tops of partition walls	Lining	Fibre cement sheeting	Asbestos	57722-071-001	Negative	-	-	-	-	-	-	-	-	1

Photo 1. Interior, top of partition walls – non asbestos-containing fibre cement sheeting.

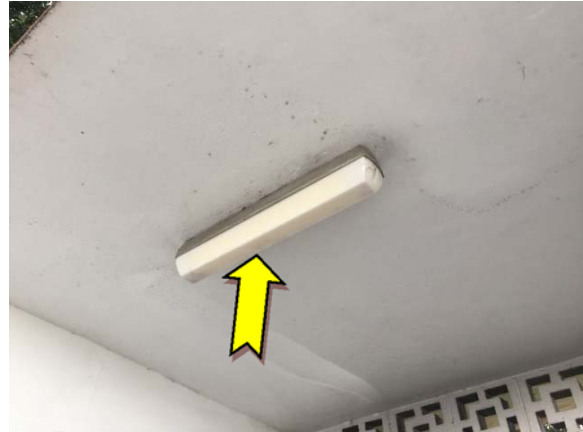
-	Throughout	-	-	SMF	-	-	-	-	-	-	-	No suspect SMF material identified at the time of the assessment.	-	-	-
Ground level	Throughout	Fluorescent light fitting - single tube	Capacitor	PCBs	Not sampled: electrical hazard	Suspected Positive	-	Low	Good	Low	5 units	PCB-containing capacitors are suspected due to age & appearance of electrical fittings. Remove and dispose of in accordance with the Polychlorinated Biphenyls Management Plan, Revised Edition April 2003.	-	-	2
Exterior	Throughout	Roof	Red (dark) - upper coloured paint system	Lead Paint - Swab	-	Suspected Positive	-	Low	Good	Low	30 m ²	Confirm status by quantitative test method, maintain in current condition, over paint with a lead-free paint as part of ongoing maintenance. Remove under controlled conditions in accordance with AS 4361.2:2017 Guide to hazardous paint management prior to renovation or demolition works.	-	-	-
Exterior	Southwest wall	Walls - external	Multicoloured - upper coloured paint system	Lead Paint - Swab	-	Suspected Positive	-	Low	Good	Low	30 m ²	Confirm status by quantitative test method, maintain in current condition, over paint with a lead-free paint as part of ongoing maintenance. Remove under controlled conditions in accordance with AS 4361.2:2017 Guide to hazardous paint management prior to renovation or demolition works.	-	-	3

Photo 2. Interior, ground level, single tubed fluorescent light fitting – suspected PCB-containing capacitors.

- PCBs were suspected within the capacitors of the single tubed fluorescent light fittings located throughout the building.

- Electrical fittings suspected of containing PCB oil capacitors should be treated as containing PCB oils until such time as evidence suggest otherwise e.g. further assessed.
- Electrical fittings that contain or suspected to contain PCB oil-containing capacitors should be removed as hazardous/regulated waste under controlled working conditions prior to the demolition or refurbishment works in accordance with the *Polychlorinated Biphenyls Management Plan, Revised Edition April 2003*.

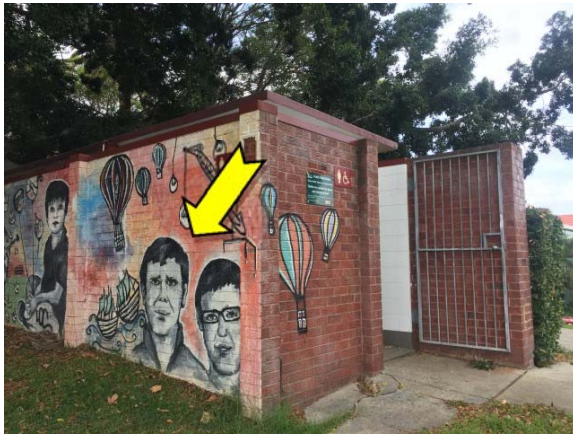
Photo 3. Exterior, throughout, graffiti wall – suspected lead-containing various upper coloured paint systems.

- LCP was suspected in the form of red, white and multi-coloured upper paint systems throughout.

- The *LeadCheck* paint swab method can detect lead in paint at concentrations of 0.5% and above, and may indicate lead in some paint films as low as 0.2%. As paint with a lead content greater than 0.1% by dry weight is now considered to be lead-containing, Prensa recommends confirming status of suspected LCP identified during the Assessment by quantitative test method.

- The safest method of dealing with LCP is to replace or remove the items in their entirety that have LCP on them and replace them with new items that do not contain lead. This allows the items to be disposed of as regular building or demolition unsegregated waste in accordance with the NSW Environment Protection Authority (EPA) *Waste Classification Guidelines 2014 Part 1 – Classifying Waste*. The advantage of this method is the reduction in labour requirements to remove the lead paint and also this reduces the risk to workers from exposure to lead dust or fumes. If the removal of the LCP or coatings is the preferred or required option this may generate significant amounts of potential hazardous waste. This waste must be removed, collected and disposed of by an appropriately licensed contractor under controlled conditions that minimises the release to air, water and soil. Disposal of lead waste must be disposed of as hazardous waste at an approved waste facility.
