Hazardous Building Materials Assessment Birchgrove Park Amenities, Dressing Rooms and Toilet Rose Street, Birchgrove NSW 2041

Inner West Council
April 2018

Job No.: 57722-099

Count ID: CID: 068

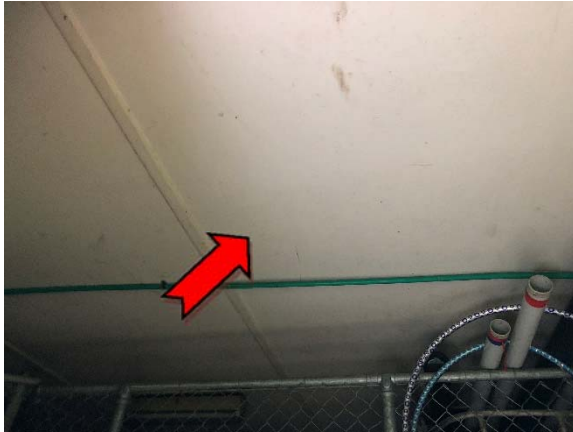
Photo 1. Interior, store room, ceiling – asbestos-containing fibre cement sheeting.

- Non-friable asbestos was identified in the form of fibre cement sheeting to the store room ceiling; and
- Non-friable asbestos was suspected in the form of bituminous backing board in the storeroom.

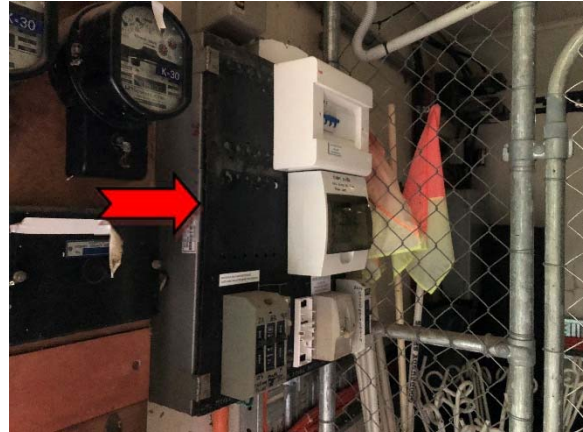
Photo 2. Interior, store room, south-eastern wall – suspected asbestos-containing bituminous backing board.

Area / Level	Room & Location	Feature	Item Description	Hazard Type	Sample No.	Sample Status	Friability	Disturb. Potential	Condition	Risk Status	Approx. Quantity	Recommendations & Comments	Control Priority	Reinspect Date	Photo No.
Interior	Store room, throughout	Ceiling	Fibre cement sheeting	Asbestos	57722-099-001	Positive	Non-friable	Low	Good	Low	16 m ²	Label as containing asbestos and maintain in current condition if to remain in-situ. Remove under controlled non-friable asbestos removal conditions prior to refurbishment or demolition works by a Class B (non-friable) licensed asbestos removal contractor.	P4	Feb-23	1
Interior	Kitchen	Floor coverings - cream	Sheet vinyl	Asbestos	Not sampled - Modern	Suspected Negative	-	-	-	-	-	Suspected negative due to age and appearance.	-	-	3
Interior	Store room, south-east wall	Electrical backing board	Bituminous backing board	Asbestos	Not sampled: Electrical Hazard	Suspected Positive	Non-friable	Low	Good	Low	1 unit	Confirm status, label as containing asbestos and maintain in current condition if to remain in-situ. Remove under controlled non-friable asbestos removal conditions prior to refurbishment or demolition works by a Class B (non-friable) licensed asbestos removal contractor.	P4	Feb-23	2

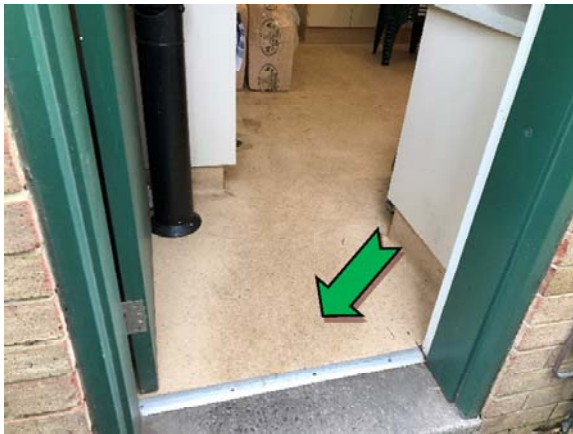
Photo 3. Interior, kitchen, to floor, throughout – non asbestos-containing sheet vinyl.

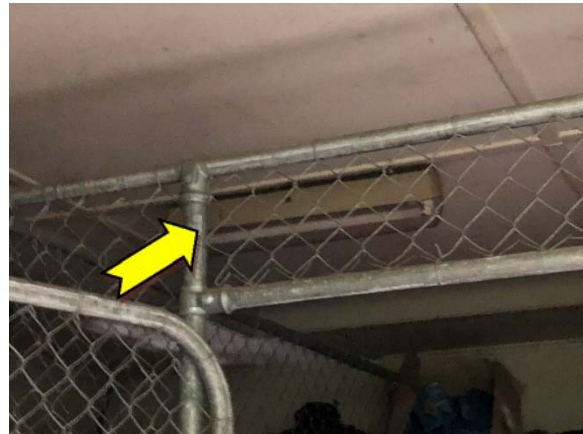
Throughout	-	-	-	SMF	-	-	-	-	-	-	-	No suspect SMF material identified at the time of the assessment.	-	-	-
Exterior	Northern elevation	Fluorescent light fitting - single tube	Capacitor	PCBs	Not sampled - live	Suspected Positive	-	-	-	-	3 units	PCB-containing capacitors are suspected due to age & appearance of electrical fittings. Remove and dispose of in accordance with the Polychlorinated Biphenyls Management Plan, Revised Edition April 2003.	-	-	4
Interior	Western changing room	Fluorescent light fitting - single tube	Capacitor	PCBs	Not sampled - live	Suspected Positive	-	-	-	-	3 units	PCB-containing capacitors are suspected due to age & appearance of electrical fittings. Remove and dispose of in accordance with the Polychlorinated Biphenyls Management Plan, Revised Edition April 2003.	-	-	4
Interior	Eastern changing room	Fluorescent light fitting - single tube	Capacitor	PCBs	Not sampled - live	Suspected Positive	-	-	-	-	3 units	PCB-containing capacitors are suspected due to age & appearance of electrical fittings. Remove and dispose of in accordance with the Polychlorinated Biphenyls Management Plan, Revised Edition April 2003.	-	-	4

Photo 4. Interior, throughout, single tube fluorescent light fittings – suspected PCB-containing capacitors.

- Electrical fittings suspected of containing PCB oil capacitors should be treated as containing PCB oils until such time as evidence suggest otherwise e.g. further assessed.
- Electrical fittings that contain or suspected to contain PCB oil-containing capacitors should be removed as hazardous/regulated waste under controlled working conditions prior to the demolition or refurbishment works in accordance with the *Polychlorinated Biphenyls Management Plan, Revised Edition April 2003*.

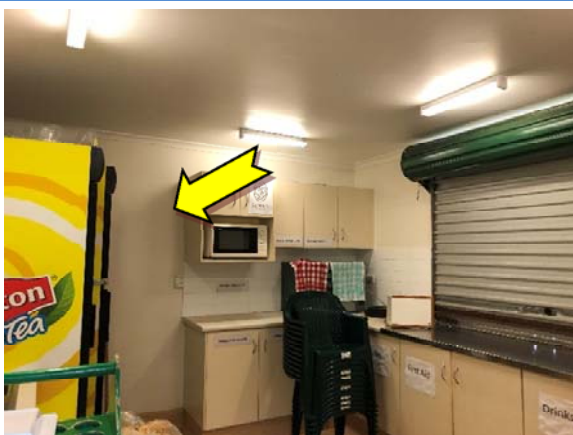
Photo 5. Interior, kitchen, walls, throughout – suspected lead-containing cream paint system.

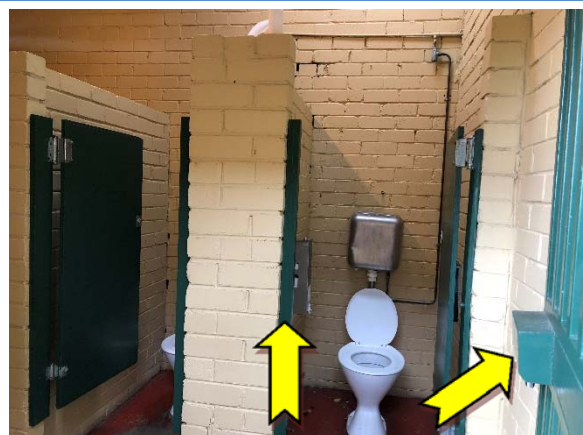
Interior	Store room	Fluorescent light fitting - single tube	Capacitor	PCBs	Not sampled - live	Suspected Positive	-	-	-	-	1 unit	PCB-containing capacitors are suspected due to age & appearance of electrical fittings. Remove and dispose of in accordance with the Polychlorinated Biphenyls Management Plan, Revised Edition April 2003.	-	-	-
Exterior	Throughout	Awning supports, fascia panels, doors and door frames	Green - upper coloured paint system	Lead Paint - Swab	-	Suspected Positive	-	Low	Good	Low	30 m ²	Confirm status by quantitative test method, maintain in current condition, over paint with a lead-free paint as part of ongoing maintenance. Remove under controlled conditions in accordance with AS 4361.2:2017 Guide to hazardous paint management prior to renovation or demolition works.	-	-	-
Interior	Male and female toilets	Doors and door frames	Green - upper coloured paint system	Lead Paint - Swab	-	Suspected Positive	-	Low	Good	Low	18 m ²	Confirm status by quantitative test method, maintain in current condition, over paint with a lead-free paint as part of ongoing maintenance. Remove under controlled conditions in accordance with AS 4361.2:2017 Guide to hazardous paint management prior to renovation or demolition works.	-	-	6

Photo 6. Interior, male and female toilets, doors and door handles, throughout – suspected lead-containing green paint system.
