# Hazardous Building Materials Assessment

## Birchgrove Park Shed

Rose Street  
Birchgrove NSW 2041

Inner West Council  
April 2018

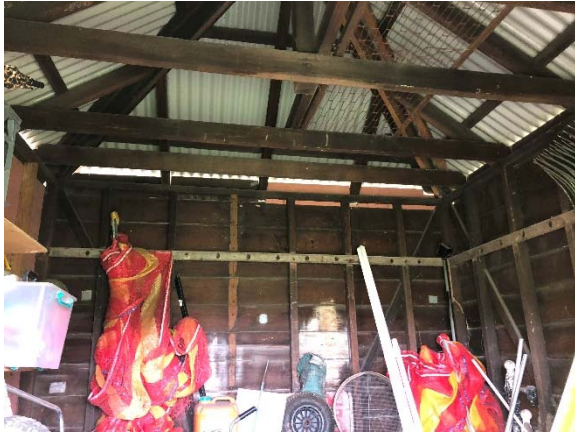
**Photo 1.** Interior, structure and roofing – non asbestos-containing materials.

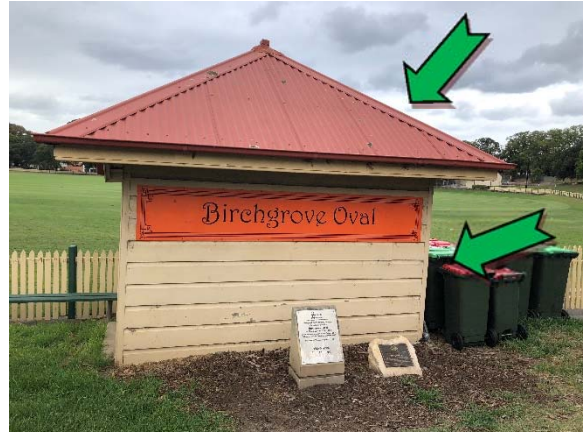
Exterior	Throughout	Roof and guttering	Red - upper coloured paint system	Lead Paint - Swab	-	Suspected Positive	-	Low	Fair	Low	12 m <sup>2</sup>	Confirm status by quantitative test method, maintain in current condition, over paint with a lead-free paint as part of ongoing maintenance. Remove under controlled conditions in accordance with AS 4361.2:2017 Guide to hazardous paint management prior to renovation or demolition works.	-	-	2
Throughout	-	-	-	Ozone Depleting Substances	-	-	-	-	-	-	-	No suspect ODS's identified at the time of the assessment.	-	-	-

**Photo 2.** Exterior, walls, guttering and roof – suspected lead-containing beige and red paint systems.

- LCP was suspected in beige and red paints to the external walls and roof.

- The *LeadCheck* paint swab method can detect lead in paint at concentrations of 0.5% and above, and may indicate lead in some paint films as low as 0.2%. As paint with a lead content greater than 0.1% by dry weight is now considered to be lead-containing, Prensa recommends confirming status of suspected LCP identified during the Assessment by quantitative test method.

- The safest method of dealing with LCP is to replace or remove the items in their entirety that have LCP on them and replace them with new items that do not contain lead. This allows the items to be disposed of as regular building or demolition unsegregated waste in accordance with the NSW Environment Protection Authority (EPA) *Waste Classification Guidelines 2014 Part 1 – Classifying Waste*. The advantage of this method is the reduction in labour requirements to remove the lead paint and also this reduces the risk to workers from exposure to lead dust or fumes. If the removal of the LCP or coatings is the preferred or required option this may generate significant amounts of potential hazardous waste. This waste must be removed, collected and disposed of by an appropriately licensed contractor under controlled conditions that minimises the release to air, water and soil. Disposal of lead waste must be disposed of as hazardous waste at an approved waste facility.
