Hazardous Building Materials Assessment Birchgrove Park – Caretakers Residence The Terrace, Birchgrove NSW 2041

Inner West Council
April 2018

Executive Summary

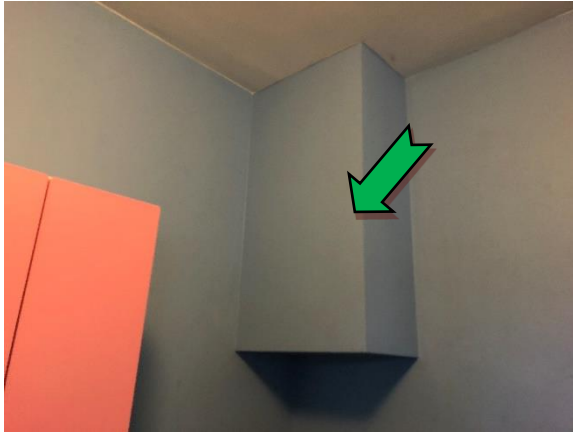
Photo 1. Interior, level one, boy's room, boxing – suspected non asbestos-containing fibre cement sheeting.

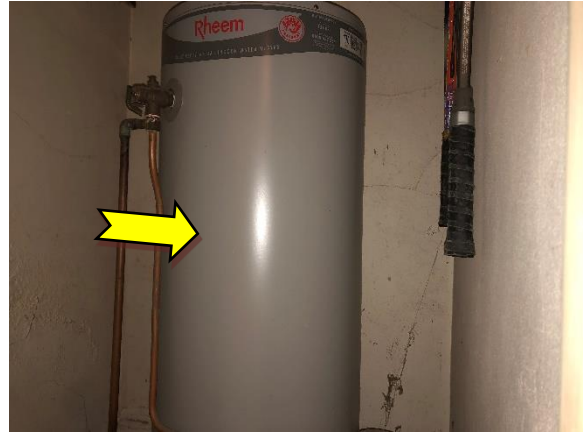
Photo 2. Interior, cupboard, hot water heater – suspected SMF internal insulation material.

- SMF internal insulation was suspected within the hot water heater located to the interior cupboard of the residence.

- SMF materials that are likely to be disturbed during any proposed demolition/refurbishment works should be handled in accordance with the *Code of Practice for the Safe Use of Synthetic Mineral Fibres* [NOHSC:2006(1990)]. If these materials are impacted upon by accident or by pre-planned works, the Inner West Council must be informed via the contact detailed within Section 7: *Accidental Disturbance of Known or Suspected Hazardous Building Materials*. Following disturbance, inspection by a competent person should be undertaken.

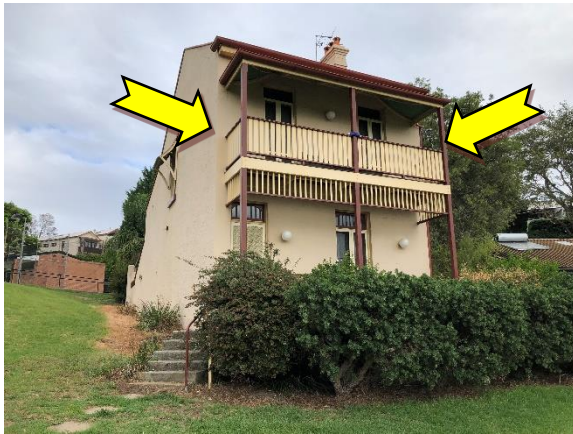
Photo 3. Exterior, throughout, walls and features – suspected lead-containing cream and red upper coloured paint systems.

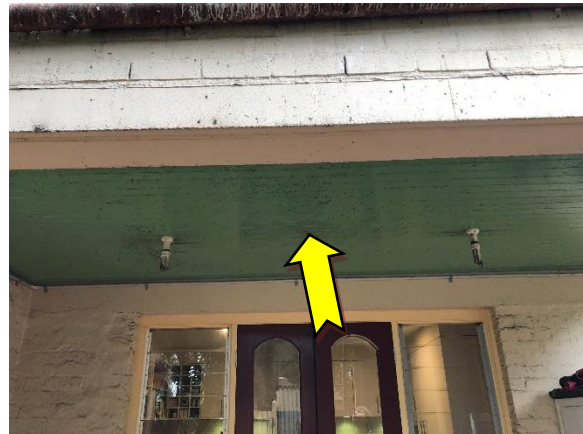
Exterior	Backyard	Eaves	Green - upper coloured paint system	Lead Paint - Swab	-	Suspected Positive	-	Low	Good	Low	6m ²	Confirm status by quantitative test method, maintain in current condition, over paint with a lead-free paint as part of ongoing maintenance. Remove under controlled conditions in accordance with AS 4361.2:2017 Guide to hazardous paint management prior to renovation or demolition works.	-	-	4
Interior, level 1	Boys room	Walls	Blue (light) - upper coloured paint system	Lead Paint - Swab	-	Suspected Positive	-	Low	Good	Low	20m ²	Confirm status by quantitative test method, maintain in current condition, over paint with a lead-free paint as part of ongoing maintenance. Remove under controlled conditions in accordance with AS 4361.2:2017 Guide to hazardous paint management prior to renovation or demolition works.	-	-	5
Interior, level 1	Boys room	Windows & door frames	Blue (dark) - upper coloured paint system	Lead Paint - Swab	-	Suspected Positive	-	Low	Good	Low	14m	Confirm status by quantitative test method, maintain in current condition, over paint with a lead-free paint as part of ongoing maintenance. Remove under controlled conditions in accordance with AS 4361.2:2017 Guide to hazardous paint management prior to renovation or demolition works.	-	-	-

Photo 4. Exterior, backyard, eaves – suspected lead-containing green upper coloured paint system.

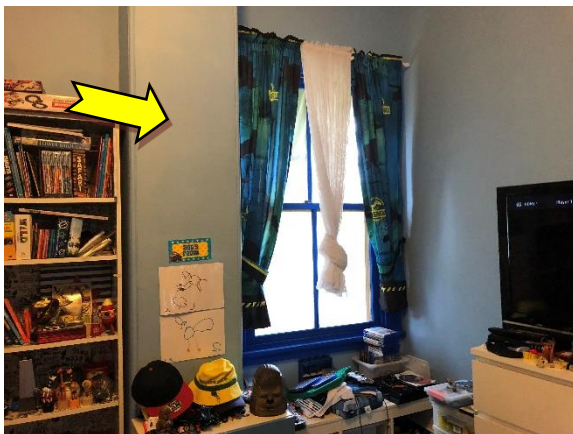
Photo 5. Exterior, boys room, walls – suspected lead-containing blue upper paint systems.

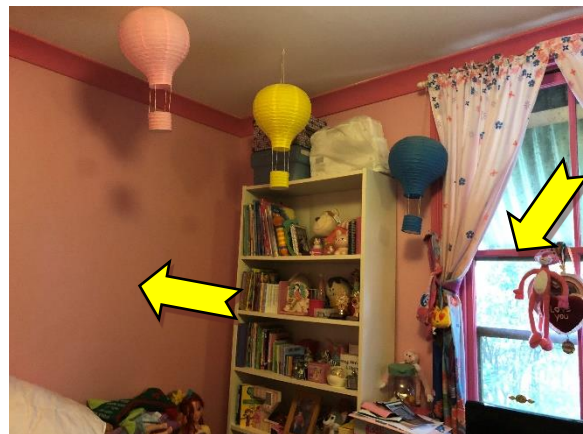
Photo 6. Interior, girl's room, walls and window frames – suspected lead-containing light and dark pink upper coloured paint systems.

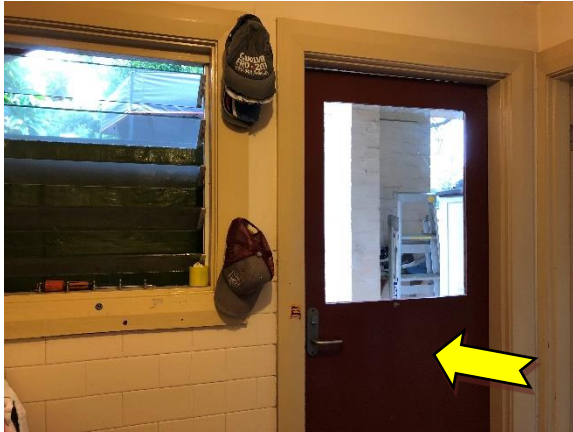
Photo 7. Interior, throughout, door – suspected lead-containing red upper paint system.

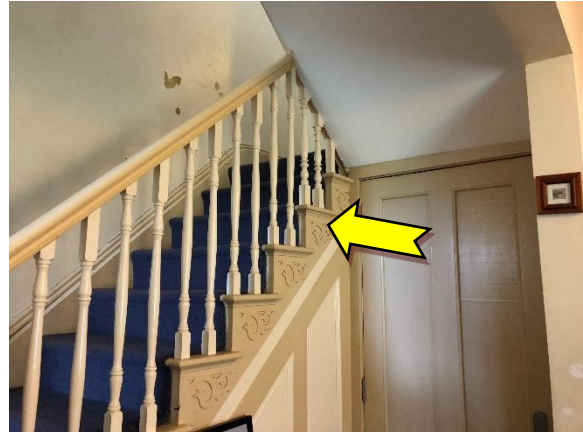
Interior	Throughout	Staircase	Beige - upper coloured paint system	Lead Paint - Swab	-	Suspected Positive	-	Low	Good	Low	10m ²	Confirm status by quantitative test method, maintain in current condition, over paint with a lead-free paint as part of ongoing maintenance. Remove under controlled conditions in accordance with AS 4361.2:2017 Guide to hazardous paint management prior to renovation or demolition works.	-	-	8
Interior	Throughout	Walls	Cream - upper coloured paint system	Lead Paint - Swab	-	Suspected Positive	-	Low	Good	Low	400m ²	Confirm status by quantitative test method, maintain in current condition, over paint with a lead-free paint as part of ongoing maintenance. Remove under controlled conditions in accordance with AS 4361.2:2017 Guide to hazardous paint management prior to renovation or demolition works.	-	-	-
Exterior	Backyard	Air conditioning unit	R410A Hydrofluorocarbon (HFC)	Ozone Depleting Substances	-	Negative	-	-	-	-	1 unit	Hydrofluorocarbon (HFC) non ozone depleting substances.	-	-	9

Photo 8. Interior, throughout, staircase – suspected lead-containing beige coloured paint systems.

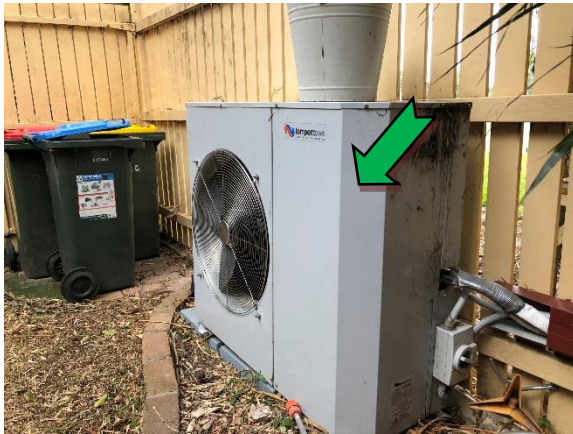
Photo 9. Exterior, backyard, air conditioning unit – non ODS depleting R410A refrigerant.

- No ODS-containing air conditioning units were identified or suspected during the Assessment.
