Hazardous Building Materials Assessment

Australia Street Art Camp

24A Australia Street
Camperdown NSW 2050

Inner West Council
April 2018

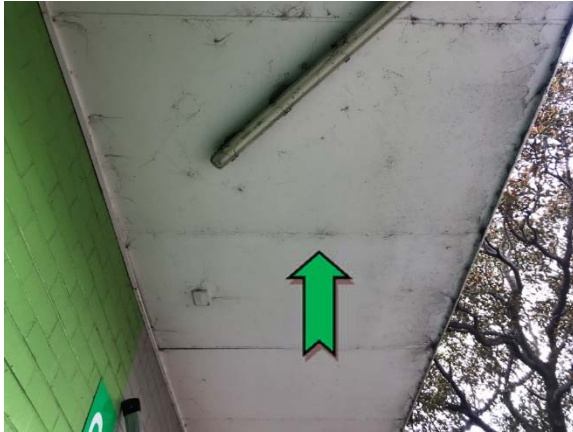
Photo 1. Exterior, south-east elevation, awning – non asbestos-containing fibre cement sheeting.

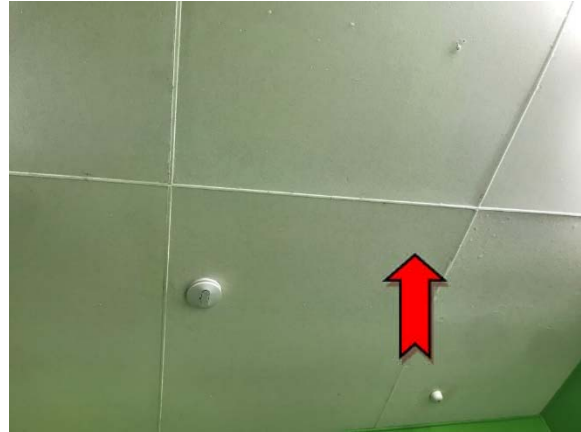
Photo 2. Interior, throughout, ceiling – asbestos-containing fibre cement sheeting.

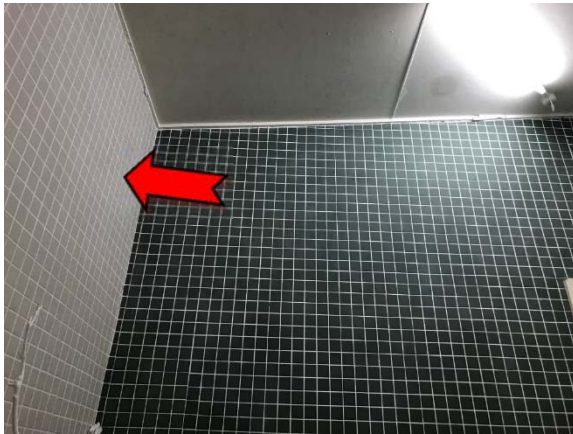
Photo 3. Interior, bathroom, walls – suspected asbestos-containing fibre cement sheeting

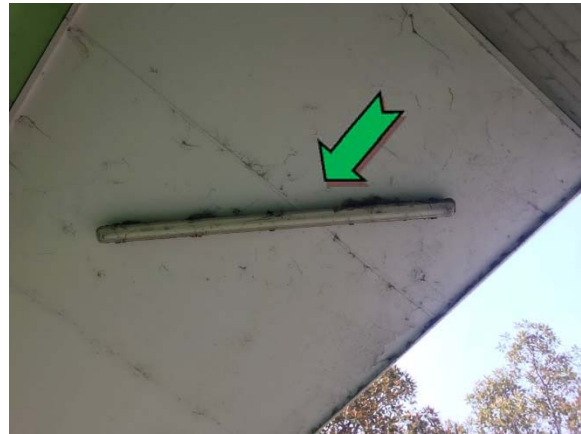
| Area / Level | Room & Location | Feature | Item Description | Hazard Type | Sample No. | Sample Status | Friability | Disturb. Potential | Condition | Risk Status | Approx. Quantity | Recommendations & Comments | Control Priority | Reinspect Date | Photo No. |
|---|---|---|---|---|---|---|---|---|---|---|---|---|---|---|---|
| Exterior | South-east elevation | Fluorescent light fitting - single tube | Capacitor | PCBs | Not sampled: Electrical hazard | Suspected Negative | - | - | - | - | - | Suspected negative due to age and appearance. | - | - | 4 |

Photo 4. Exterior, throughout, single tubed fluorescent light fitting – suspected non PCB-containing capacitor.

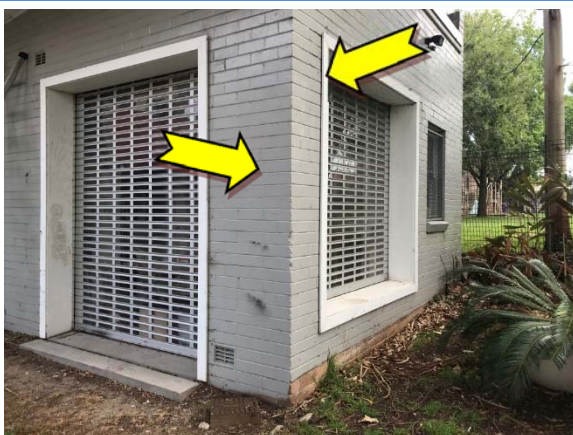
| Area / Level | Room & Location | Feature | Item Description | Hazard Type | Sample No. | Sample Status | Friability | Disturb. Potential | Condition | Risk Status | Approx. Quantity | Recommendations & Comments | Control Priority | Reinspect Date | Photo No. |
|---|---|---|---|---|---|---|---|---|---|---|---|---|---|---|---|
| Exterior | Throughout | Walls | Grey - upper coloured paint system | Lead Paint - Swab | - | Suspected Positive | - | Low | Good | Low | 70 m ² | Confirm status by quantitative test method, maintain in current condition, over paint with a lead-free paint as part of ongoing maintenance. Remove under controlled conditions in accordance with AS 4361.2:2017 Guide to hazardous paint management prior to renovation or demolition works. | - | - | 5 |
| Exterior | Throughout | Window frames | White - upper coloured paint system | Lead Paint - Swab | - | Suspected Positive | - | Low | Good | Low | 15 m | Confirm status by quantitative test method, maintain in current condition, over paint with a lead-free paint as part of ongoing maintenance. Remove under controlled conditions in accordance with AS 4361.2:2017 Guide to hazardous paint management prior to renovation or demolition works. | - | - | 5 |

Photo 5. Exterior, throughout, walls and frames – suspected lead-containing grey and white upper coloured paint systems.

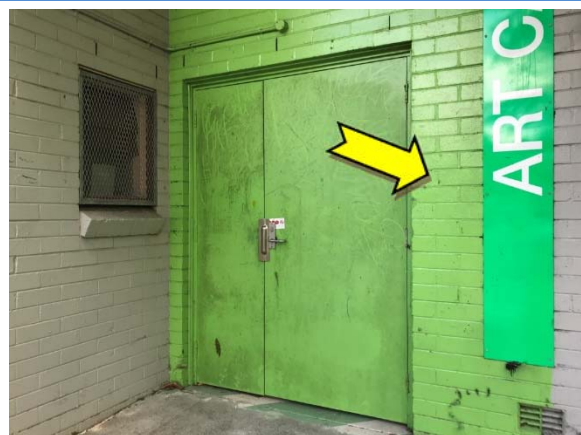
| Area / Level | Room & Location | Feature | Item Description | Hazard Type | Sample No. | Sample Status | Friability | Disturb. Potential | Condition | Risk Status | Approx. Quantity | Recommendations & Comments | Control Priority | Reinspect Date | Photo No. |
|---|---|---|---|---|---|---|---|---|---|---|---|---|---|---|---|
| Exterior | South-east elevation | Door & Wall feature | Green (light) - upper coloured paint system | Lead Paint - Swab | - | Suspected Positive | - | Low | Good | Low | 8 m ² | Confirm status by quantitative test method, maintain in current condition, over paint with a lead-free paint as part of ongoing maintenance. Remove under controlled conditions in accordance with AS 4361.2:2017 Guide to hazardous paint management prior to renovation or demolition works. | - | - | 6 |

Photo 6. Exterior, throughout, feature wall – suspected lead-containing light green upper paint systems.

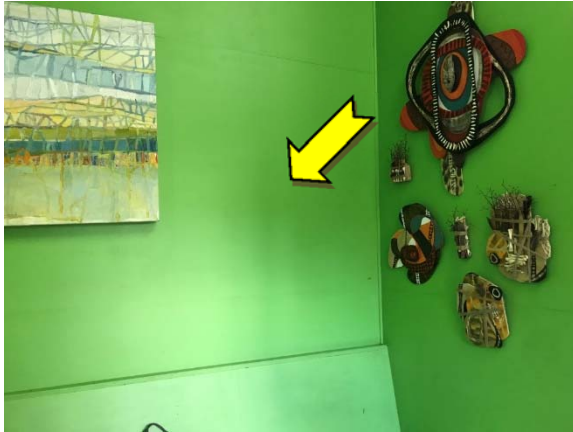
| Area / Level | Room & Location | Feature | Item Description | Hazard Type | Sample No. | Sample Status | Friability | Disturb. Potential | Condition | Risk Status | Approx. Quantity | Recommendations & Comments | Control Priority | Reinspect Date | Photo No. |
|---|---|---|---|---|---|---|---|---|---|---|---|---|---|---|---|
| Interior | Main room | Walls | Green (light) - upper coloured paint system | Lead Paint - Swab | - | Suspected Positive | - | Low | Good | Low | 50 m ² | Confirm status by quantitative test method, maintain in current condition, over paint with a lead-free paint as part of ongoing maintenance. Remove under controlled conditions in accordance with AS 4361.2:2017 Guide to hazardous paint management prior to renovation or demolition works. | - | - | 7 |

Photo 7. Interior, throughout, walls – suspected lead-containing light green upper paint systems.

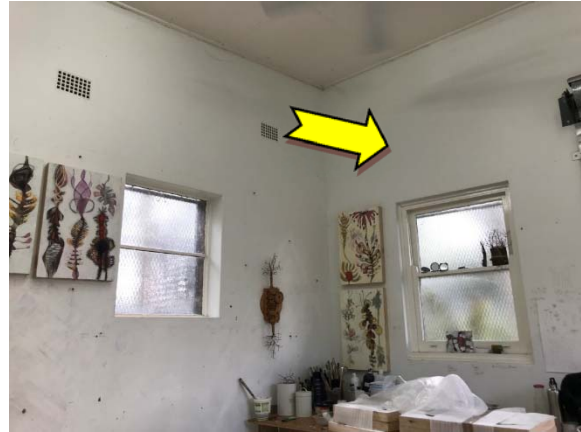
| Area / Level | Room & Location | Feature | Item Description | Hazard Type | Sample No. | Sample Status | Friability | Disturb. Potential | Condition | Risk Status | Approx. Quantity | Recommendations & Comments | Control Priority | Reinspect Date | Photo No. |
|---|---|---|---|---|---|---|---|---|---|---|---|---|---|---|---|
| Interior | Studio | Walls and ceiling | White - upper coloured paint system | Lead Paint - Swab | - | Suspected Positive | - | Low | Good | Low | 200 m ² | Confirm status by quantitative test method, maintain in current condition, over paint with a lead-free paint as part of ongoing maintenance. Remove under controlled conditions in accordance with AS 4361.2:2017 Guide to hazardous paint management prior to renovation or demolition works. | - | - | 8 |

Photo 8. Interior, throughout, walls – suspected lead-containing grey upper paint systems.
